ICS Class

2B: Machinery Systems In compliance with the IMO resolution MSC.349(92) and MEPC.237(65), RO Code, Appendix 2.

The following Module 2B: Machinery Systems is based on several Example Cases of Machinery Damages. This has the purpose and objective to give a clear example on the survey check points.

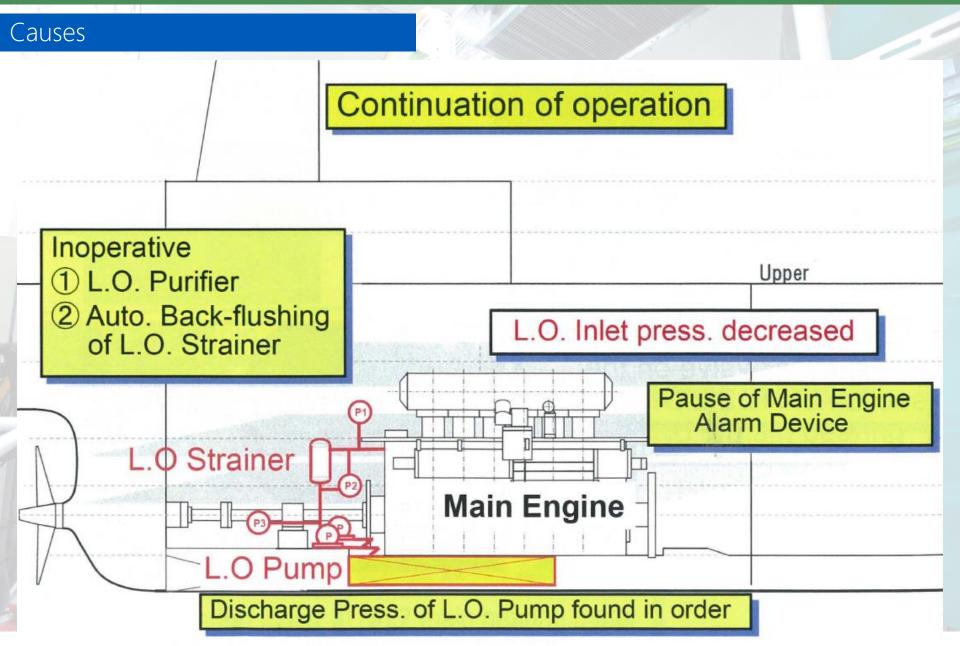
Burning of Crankshaft, Main Bearing Metal and Crank Pin Metal

Repairs

- No.1,2,3,5,6 Main Bearing Metal: Replacement (Under Size)
- Others: Renewed (Original Size)
- No.3,4 Crank Pin Bearing Metal: Renewed (Under Size)
- Other than the above: Renewed (Original Size)

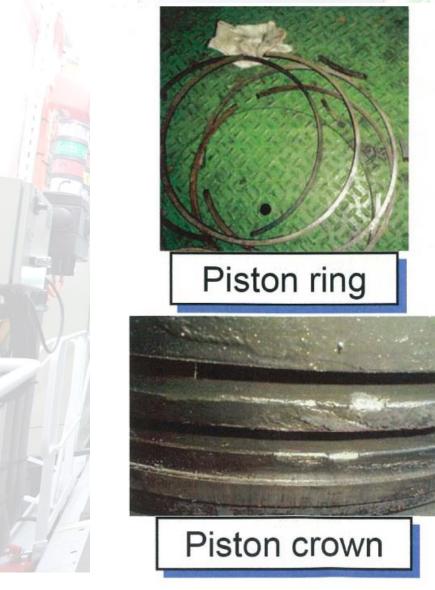
Decrease of revolution speed with increase of exhaust gas temperature in service.

Piston Crown: Burnout

Piston Skirt and Cylinder Liner: Burnout and Scratches

- 1. Abnormal wear (vertical scratching) on sliding surface
- 2. Uneven wear at each rings
- 3. Spherical particles (alumina and silica) in scratches on sliding surface
- 4. No Abnormalities in material composition and hardness

Engine damage occurred due to insufficient elimination of alumina and silica at F.O. purifiers.

Temporary Repair Onboard

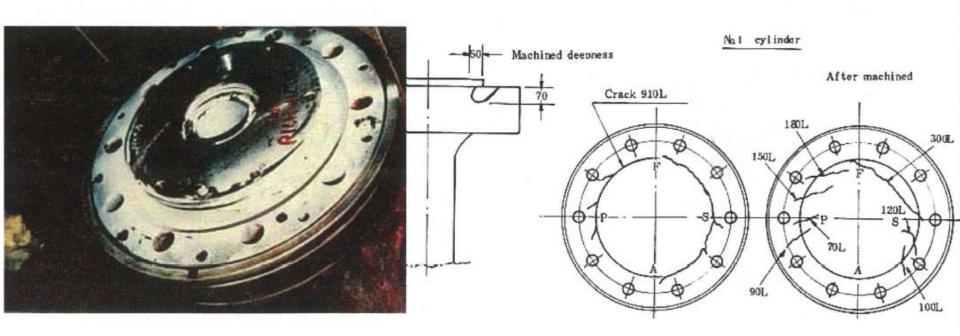
Cracks on No.1,4,6 Piston Rods
Cracks going through bolt holes on No.1 piston rod

Fretting occurred on the contact face between No.1,4,6 Piston Rods and piston crowns

Cracks occurred due to insufficient tightening of the fitting bolts of the piston crown

Insufficient tightening was suspected when the piston was restored during the last overhaul

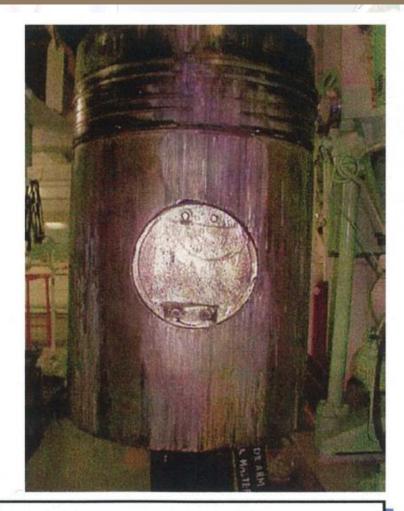
Damage was found upon inspection
No.B-5 Piston: Worn and scratched
Lower part of No.B-5 Cylinder Liner: Worn and scratched

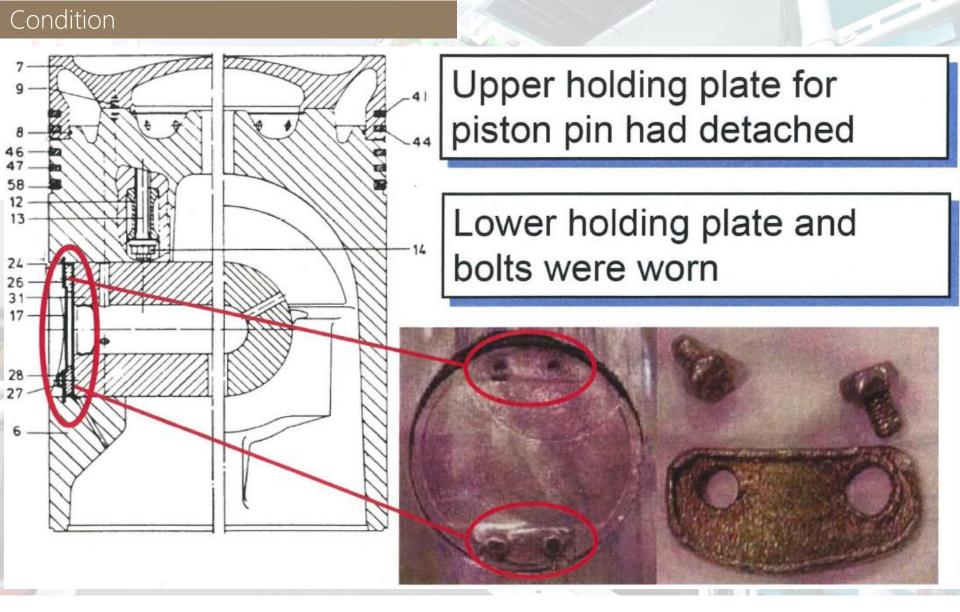
Deep cut of No.B-5 Cylinder Liner

Fitting bolts on upper holding plate were loosened

Insufficient tightening of the fitting bolts on the upper holding plate was suspected after the overhauls

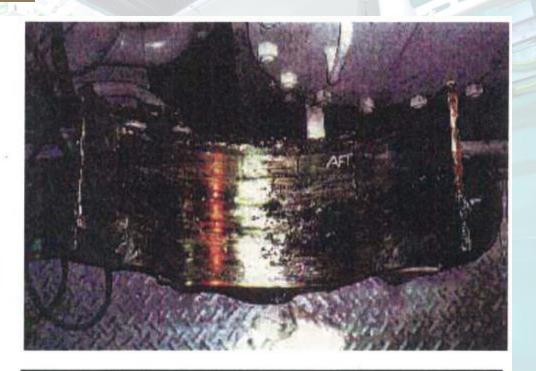
Upper Shaking Lever and Pin

The bolts to the fix pins and the plates to prevent turning were missing at the connection between the upper side and the lower side of shaking levers for supplying oil to the crosshead.

Bolts for fixing pin at connecting part of shaking lever were missing.

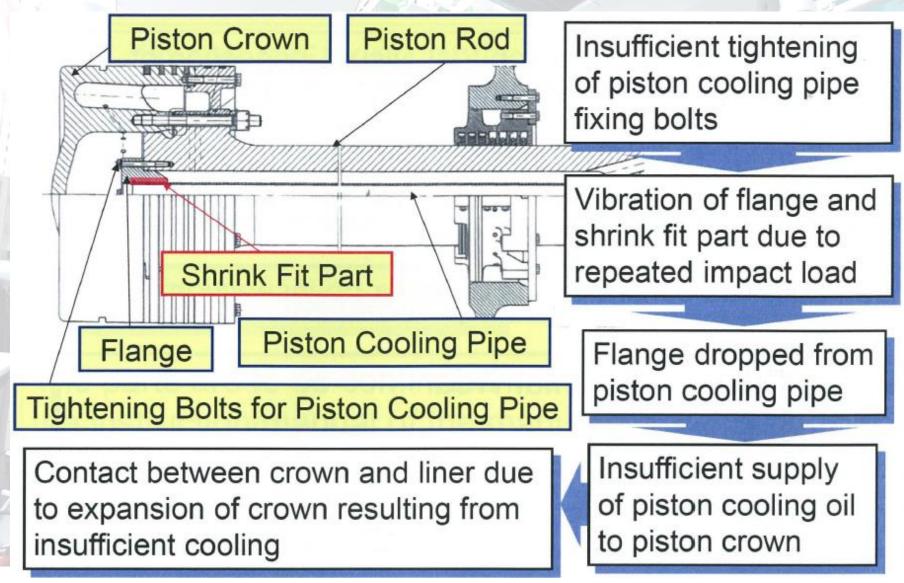
Bent Tightening Bolts for Piston Cooling Pipe

Cooling oil outlet temperature of damaged cylinder: 4 degrees lower than other cylinders at 100% load operation.

Tightening record of Tightening Bolts for Piston Cooling Pipe could not be found

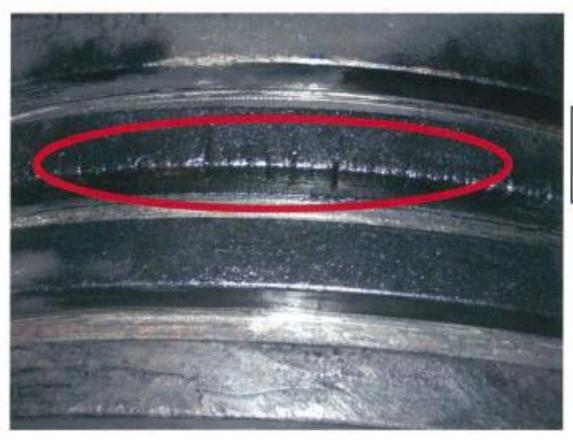
No.5 Piston Ring Groove

- Crack at No.5 & 6 Piston Ring Groove
- Scavenging space was dirty with oil

Poor maintenance of M/E and failure to comply with manufacturer's instructions

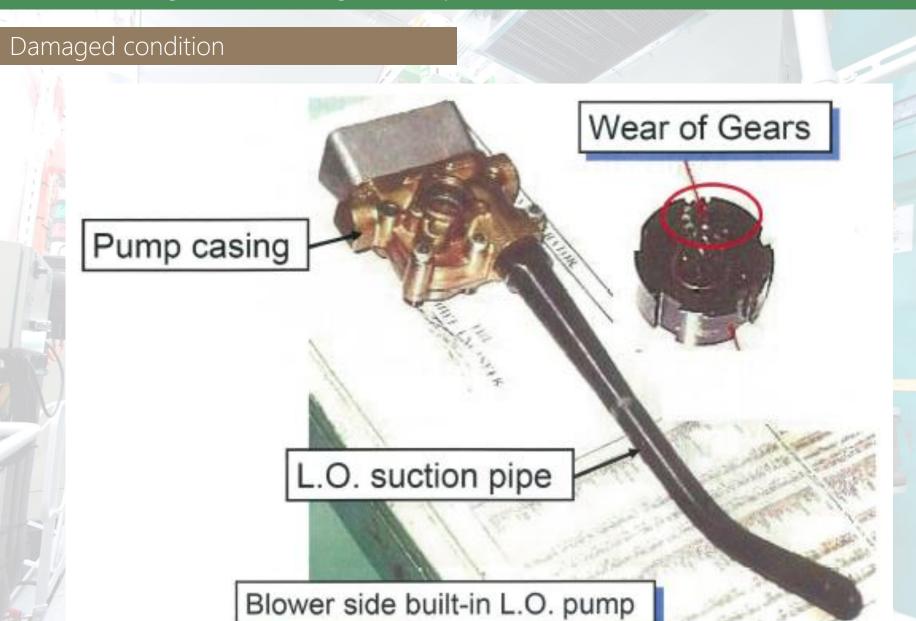
Damages were found at built-in LO pump, rotor shaft etc.

Breakage of drive shaft due to drive gear wear

Rotor shaft bearing burn out

The damage occurred due to contact of blower impeller to casing.

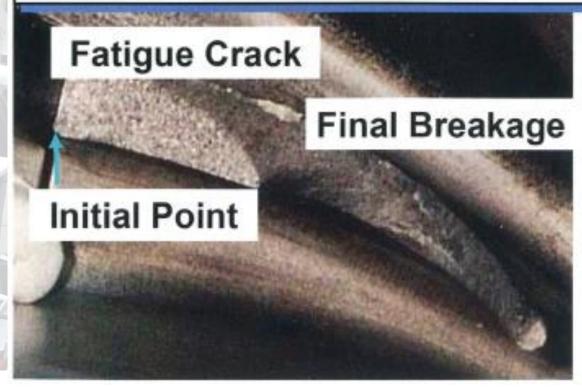
Broken Inducer Intermediate blade

Corrosion pits on the intermediate blade

→ a crack developed rapidly from the resonance of the blade, and as a result, a fatigue fracture occurred.

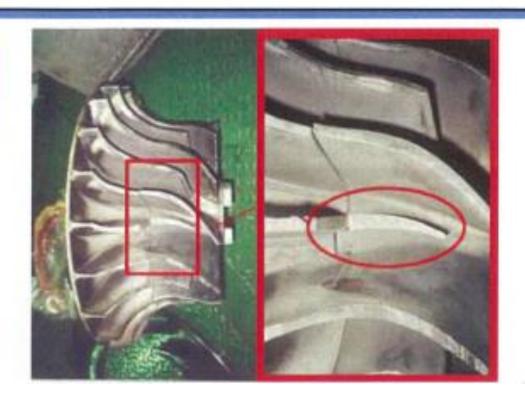
Broken Intermediate Blade

Striation → the crack was propagated by fatigue

- → The crack propagated from the corrosion pit
- → Fatigue failure occurred.

But after the first damage, air intake socket was replaced with an older type of air socket

- Keep corrosive exhaust gas and sea water away from entering through the ventilation duct (in order to prevent corrosion pits at turbine blades)
- 2) Carrying out NDT on the blower side of blade
- 3) Check latest maker's service news

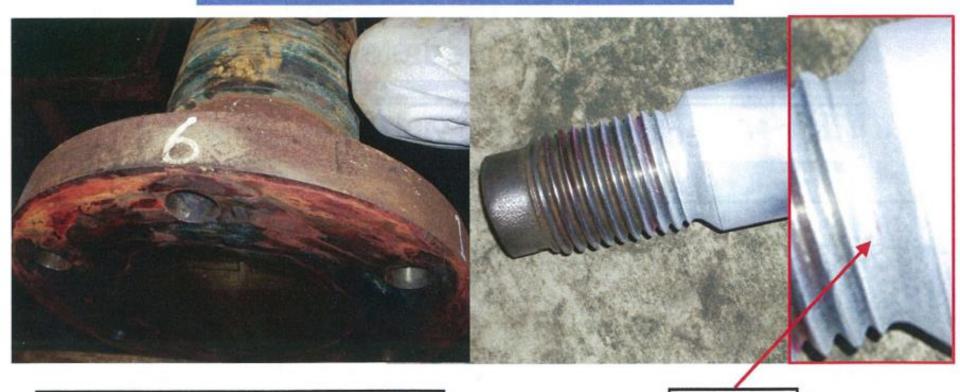
Fretting corrosion at prop. shaft and interm. shaft flanges

Confirmation of cracks at Bolt neck end of thread

Fretting on connection part of flange

Crack

Replacement of all coupling bolts

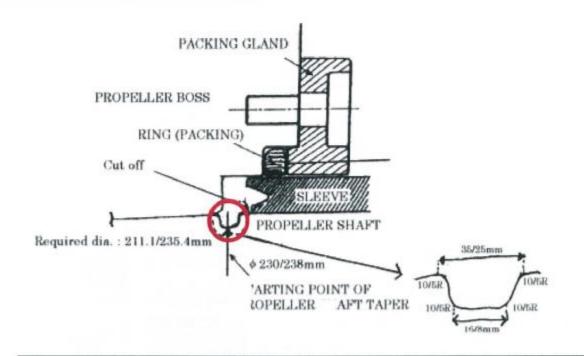
Original diameter: 260 mm → 230 mm Required diameter: 211 mm

Repair

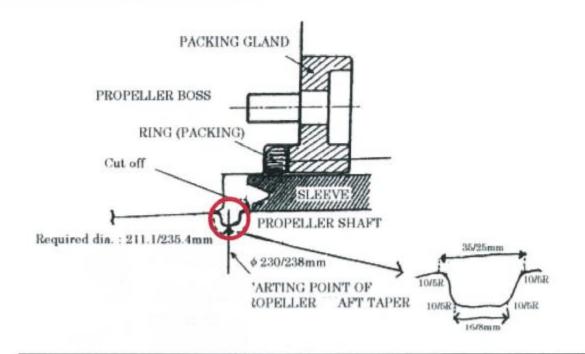
Original diameter: 260 mm → 230 mm

Required diameter: 211 mm

Repair

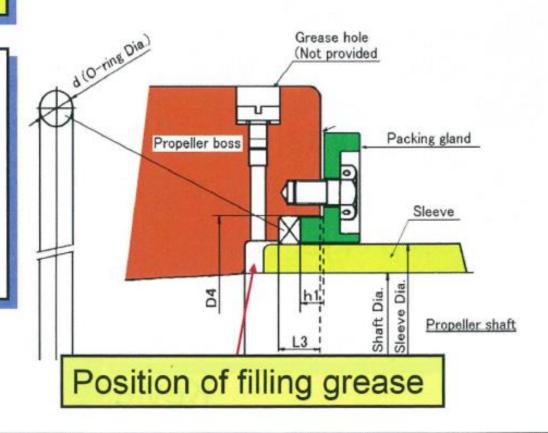
Filling grease

No filling of grease (No grease hole for this ship)

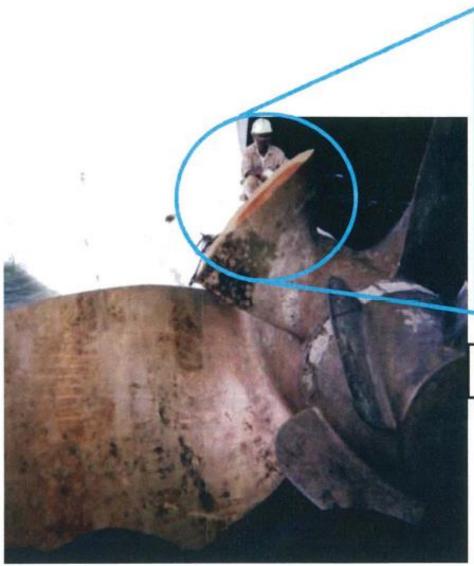
Fracture Surface of Blade "A"

Crack Starting Point = 0.35R

"Beach Mark" = Fatigue Fracture

Cast defect around crack starting point (0.35R)

Sea water entered inside through blowholes open to the surface allowing corrosion and grinding

Minute initial cracks were caused by stress-corrosion fatigue, and the cracks were in a state of stasis for a long period.

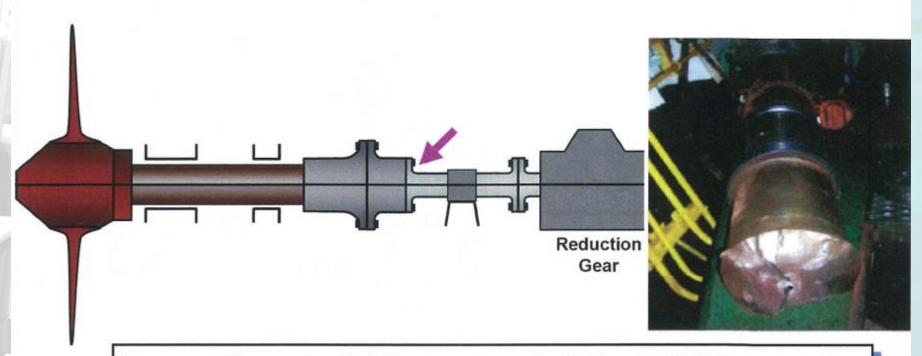
Damage example due to insufficient use of metal resin

Intermediate shaft (oil transfer shaft for CPP) fractured at aft side flange

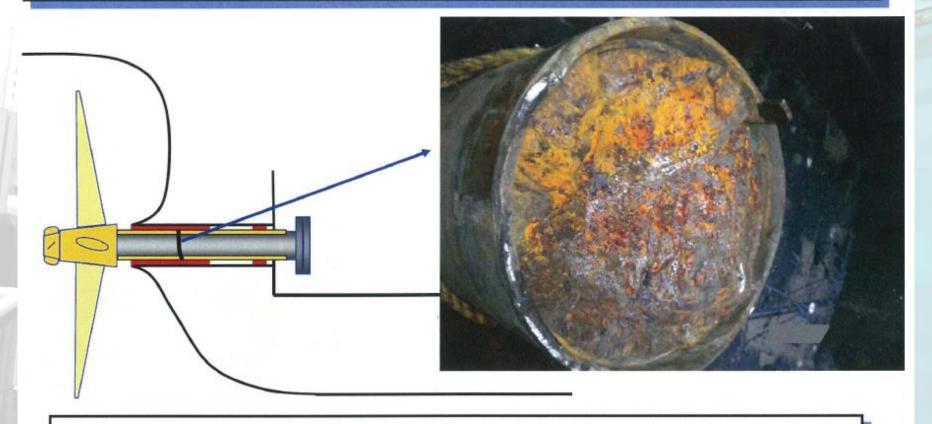
Damage example due to insufficient use of separate type sleeves

The propeller shaft was broken during voyage. Sleeves were connected each other on the stern tube bearing

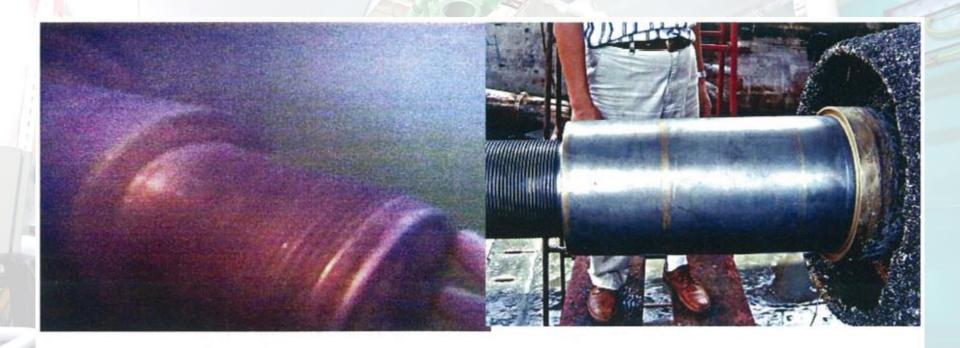
Condition of Corn Part after the propeller loss

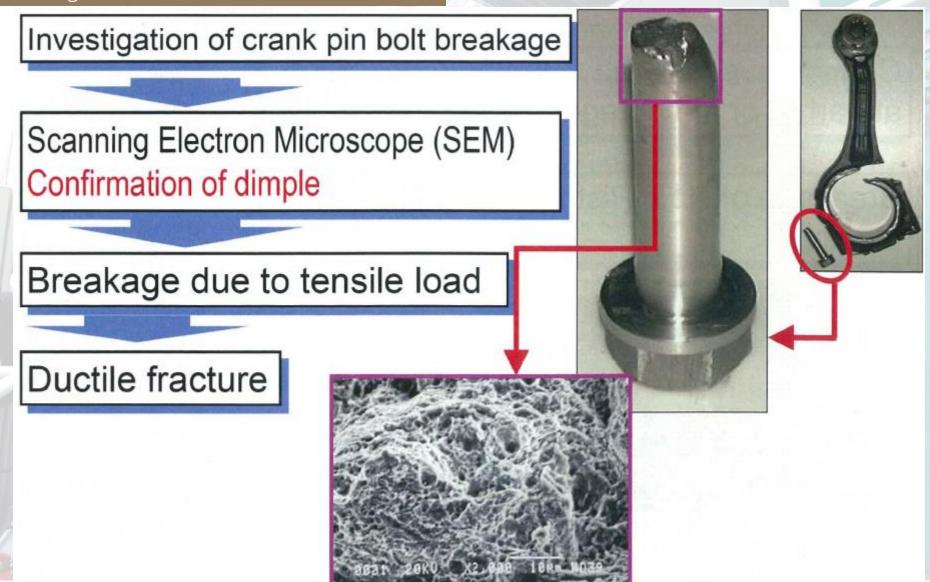
Fatigue failure may occur due to small initial defect because stress around crack starting point is comparatively high.

The initial crack progressed by repetitive stress fluctuation, and breakage of the rod and the bolts occurred.

Insufficient tightening condition due to the seizure

Seizure is thought to have been caused by foreign particles in the screw hole

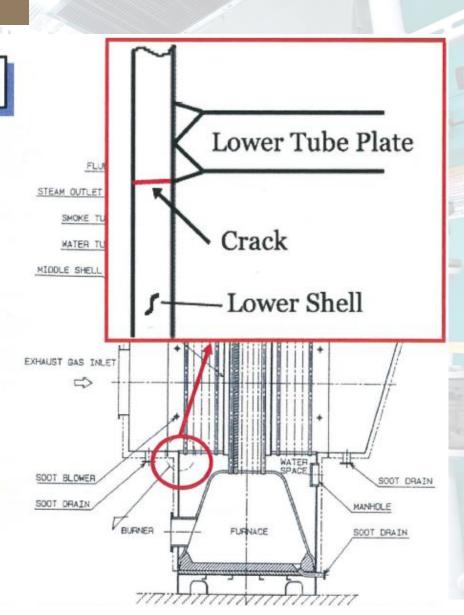
Cracks on the shell plate were found.

Welding of the bolts for prevention of loosening by the ship's crew

- Damaged part, where the tube plate is welded with the shell plate at inside of water drum, is highly stressed area.
- It is possible that cracks are initiated due to welding defects.

Thermal expansion is not absorbed efficiently by the boiler stays due to the welding of the bolts to prevent loosening.

Repair procedure for cracks on boiler shell

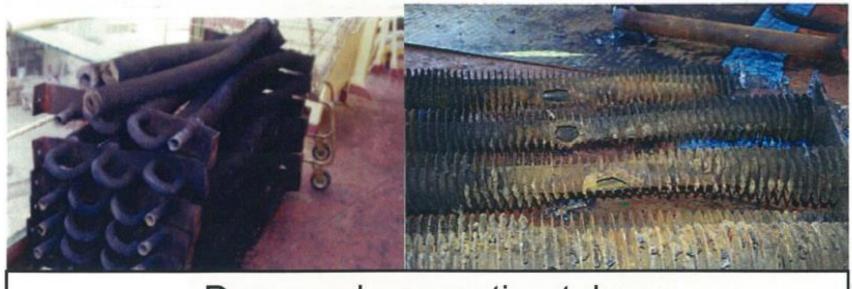
During navigation at NSR, a soot fire took place in the exhaust gas economizer and water leakage was found

Overheat and deformation were found in 80% of generating tubes

Damaged generating tubes

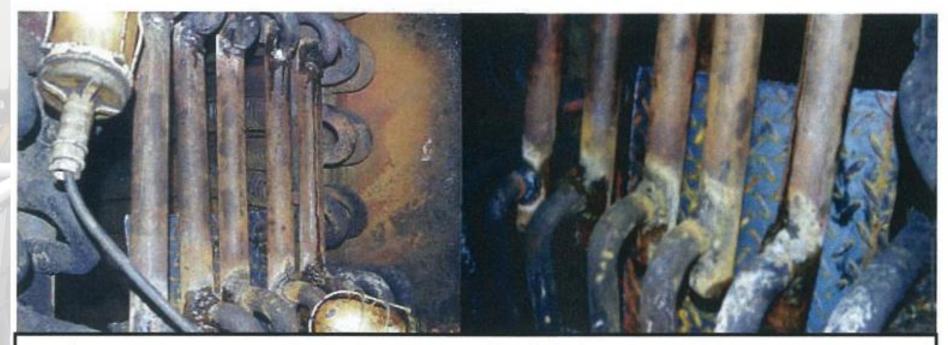
By-pass of generating tubes

All overheated generating tubes were removed and repair via by-pass was carried out.

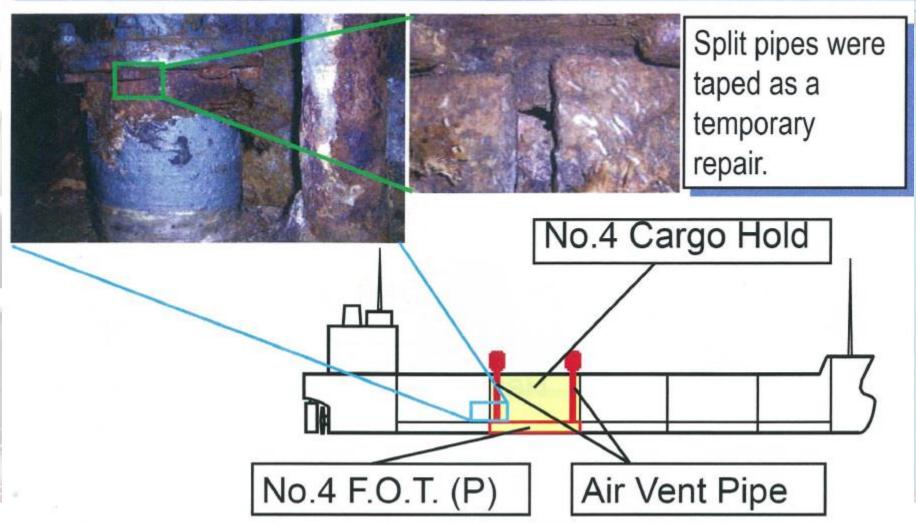
Small holes at temporarily repaired part of air vent pipe for FOT

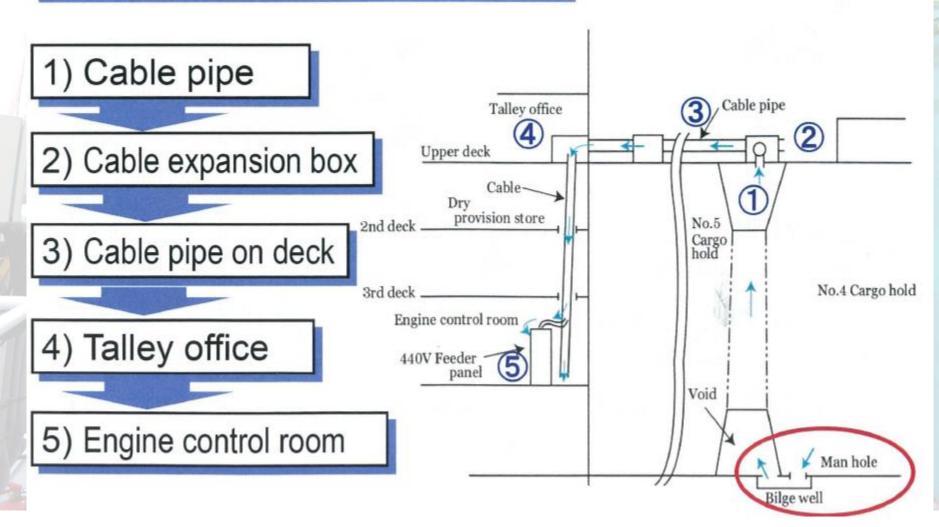
Ballast water invaded the void space
