ICS Class

2A: Hull Structure

In compliance with the IMO resolution MSC.349(92) and MEPC.237(65), RO Code, Appendix 2.

MODULE 2A-Hull Structure (Content)

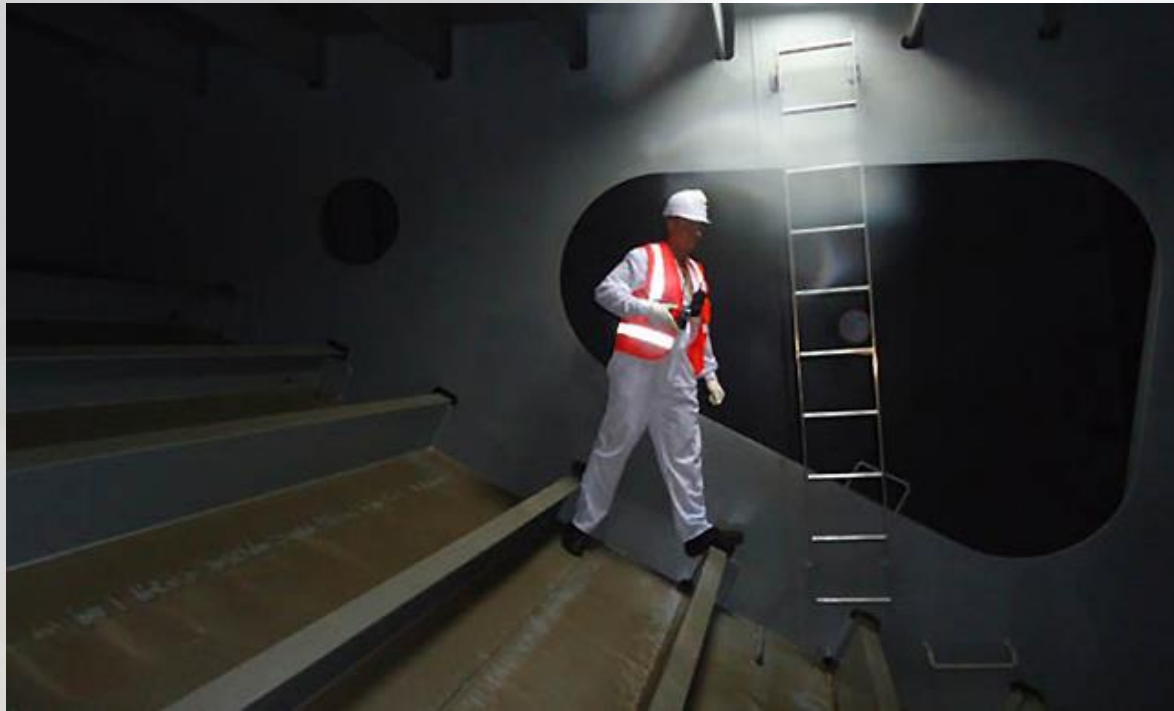
-How to inspect Hull Damages?

Visual Inspection

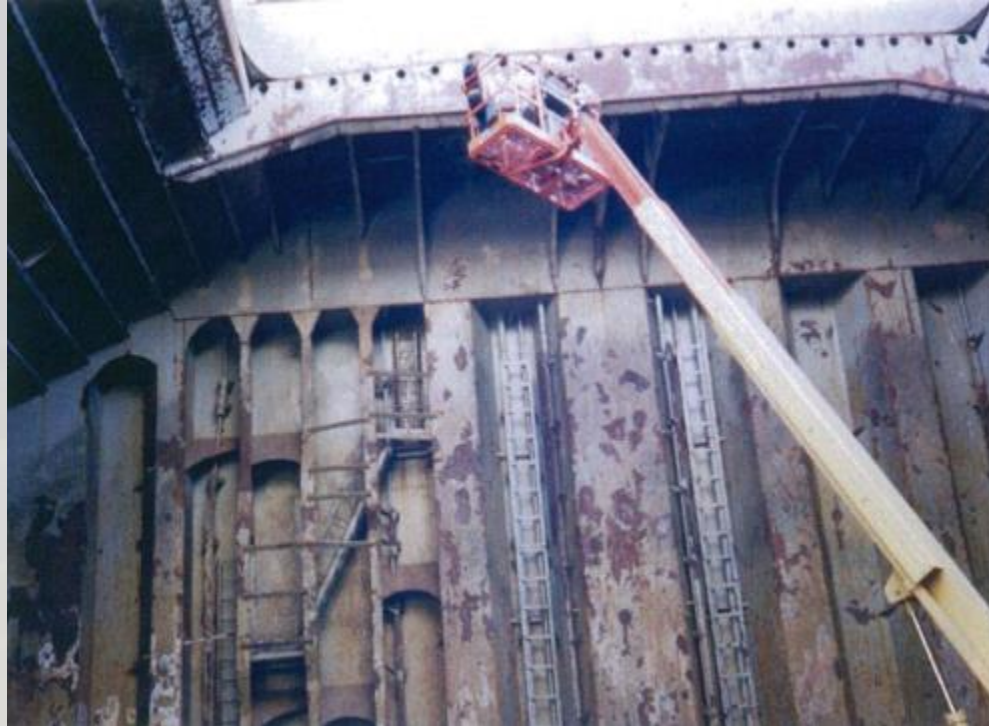
-How to inspect Hull Damages?

Close Up Survey (Cherry Picker)

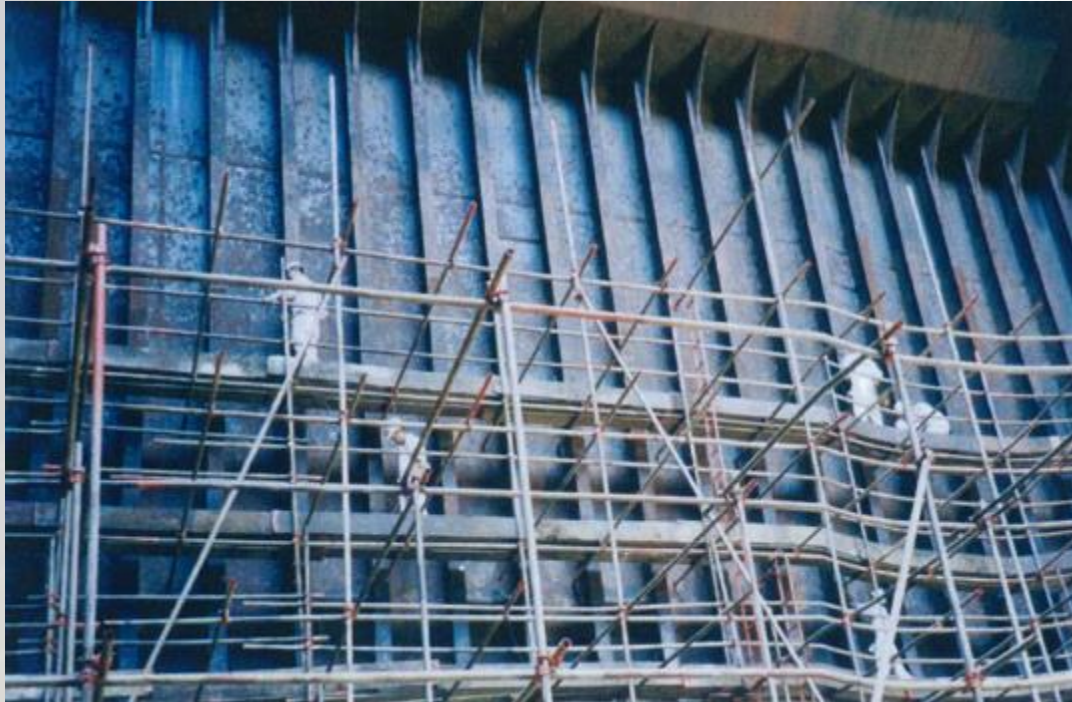
-How to inspect Hull Damages?

Close Up Survey (Temporary Stage)

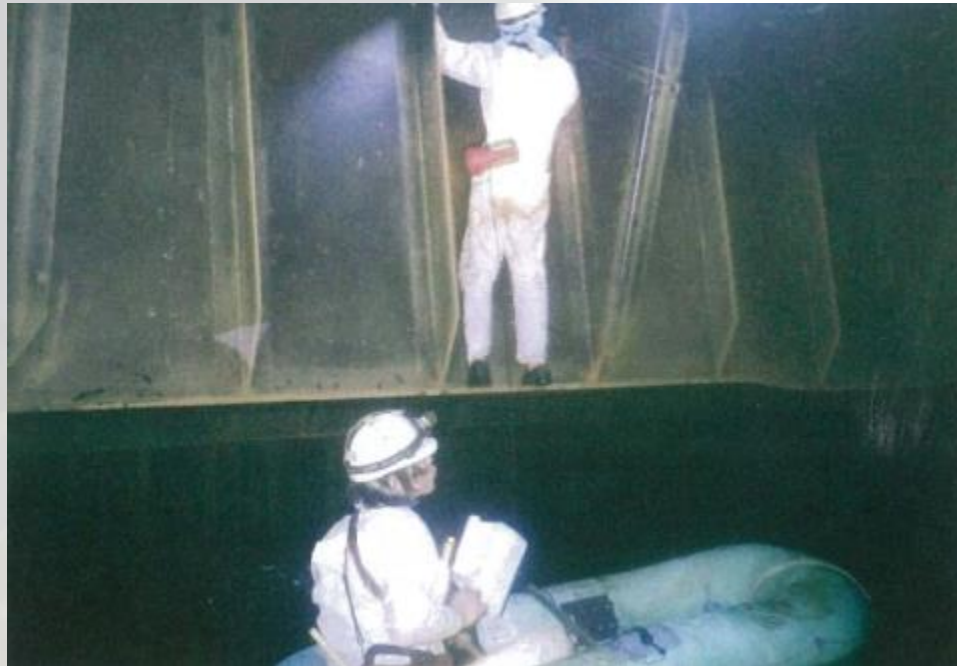
-How to inspect Hull Damages?

Close Up Survey (Raft Survey)

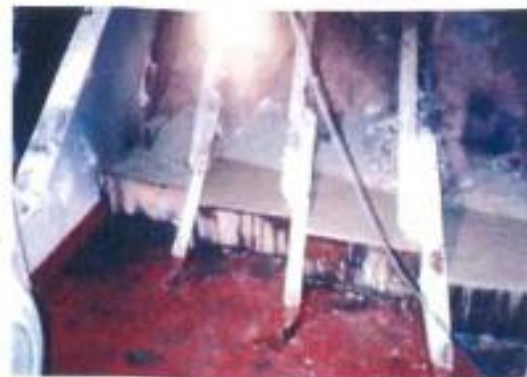
➤ For ensuring water tightness

- Doubling / Patch up (by welding/bolting)
- Cement Box
- Wedge / Caulking

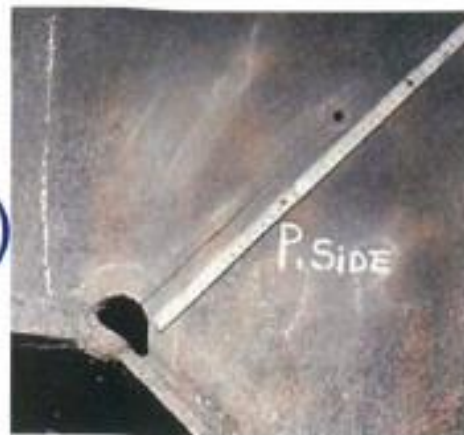
➤ For ensuring strength

- Doubling
- Stiffening
- Stop hole (arresting cracks)
- Welding

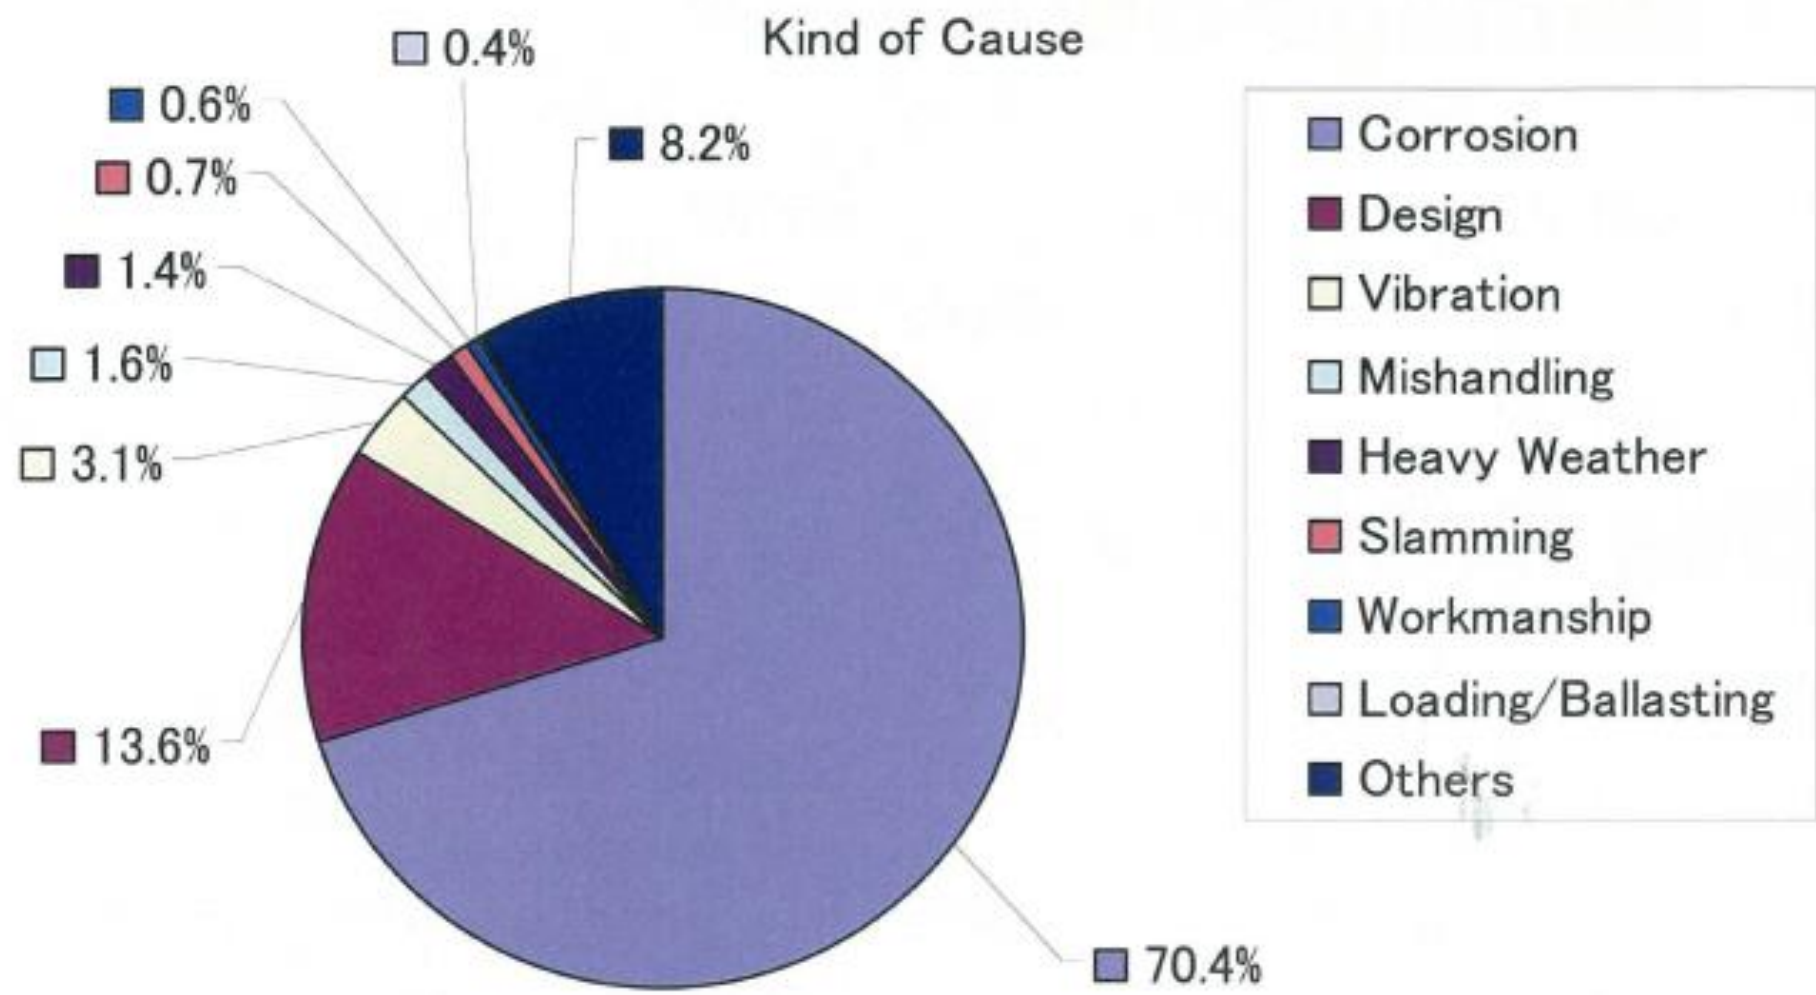
-Cause of damage

Statics taken from ClassNK

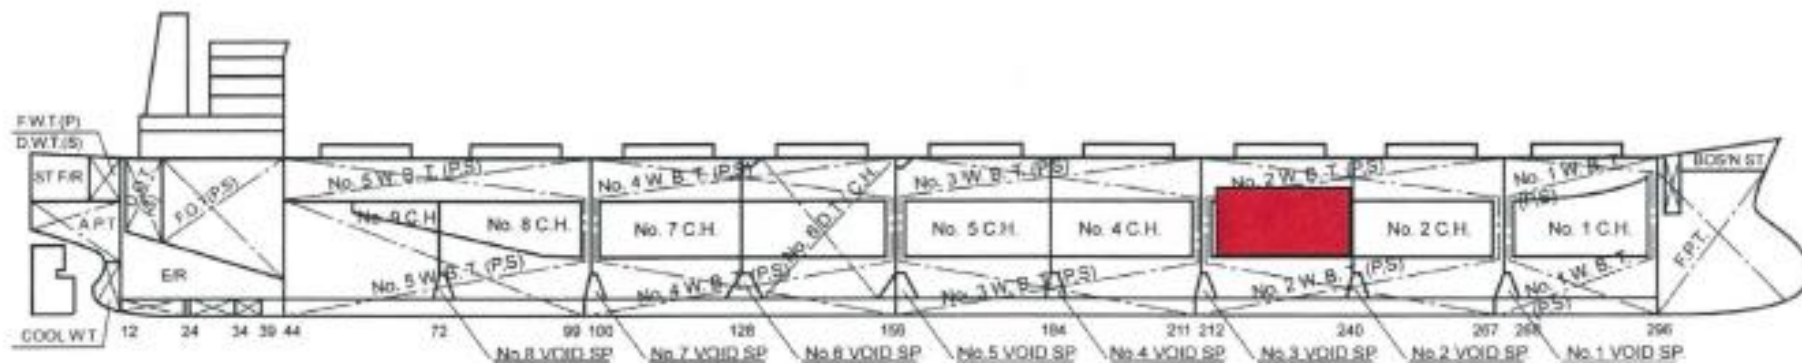
CORROSION IN THE HOLD FRAME OF BULK CARRIERS

Cape Size Bulk Carrier with Single Skin

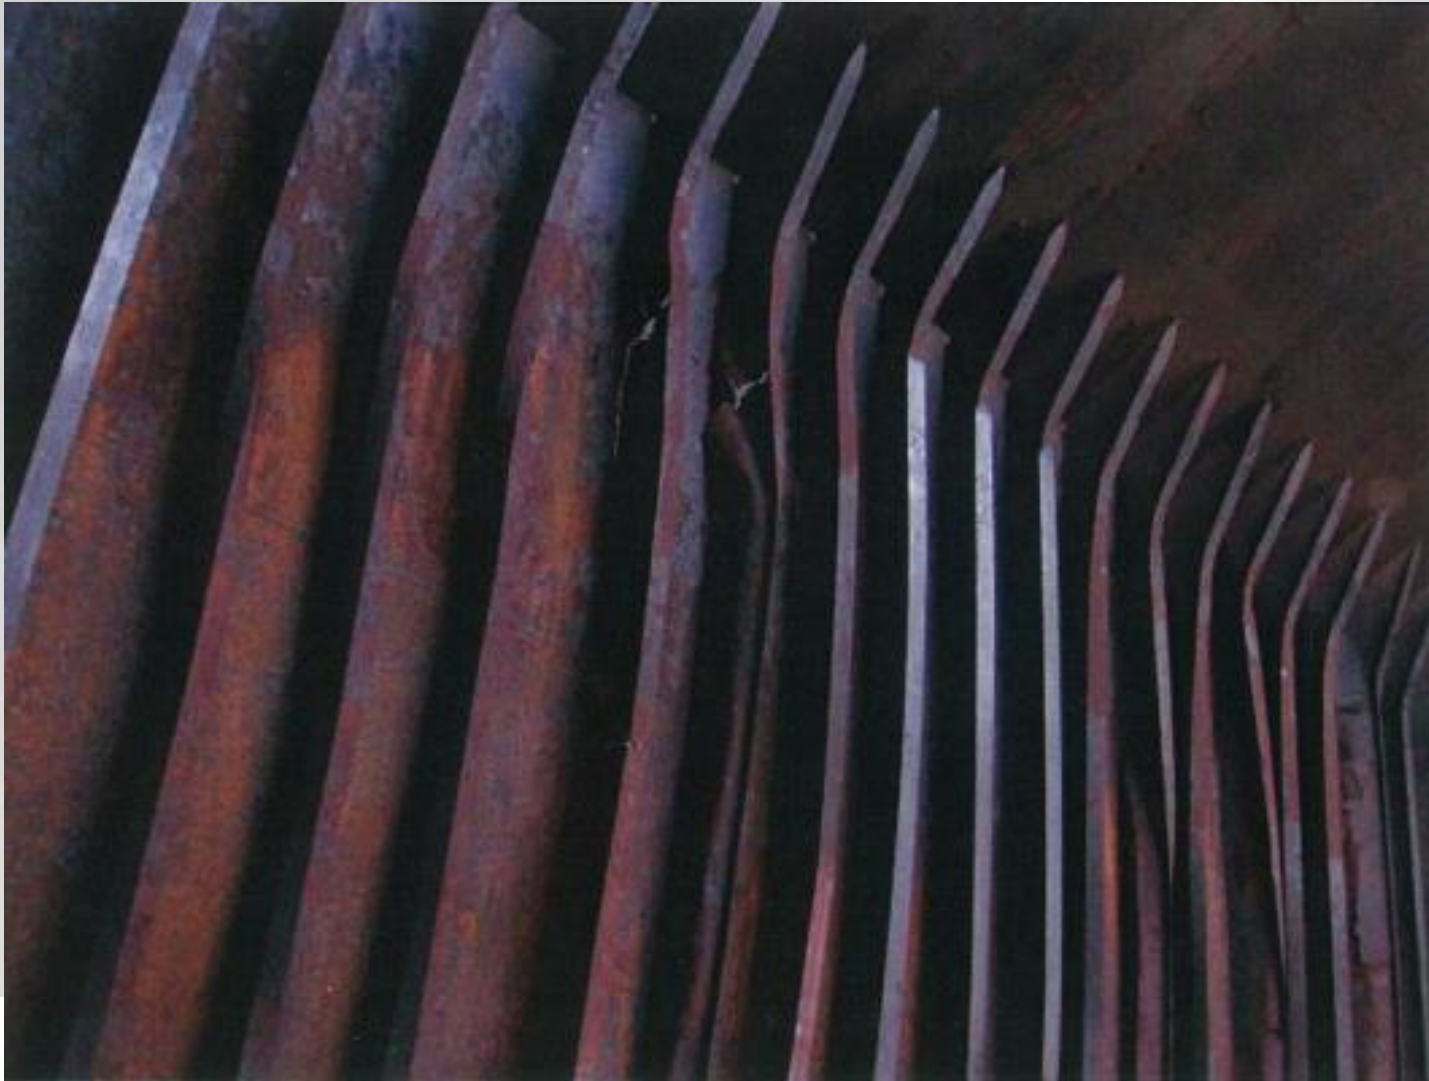
Hold Frame Fracture due to Corrosion

Side Shell Plate Indented

Collapse of Hold Frame

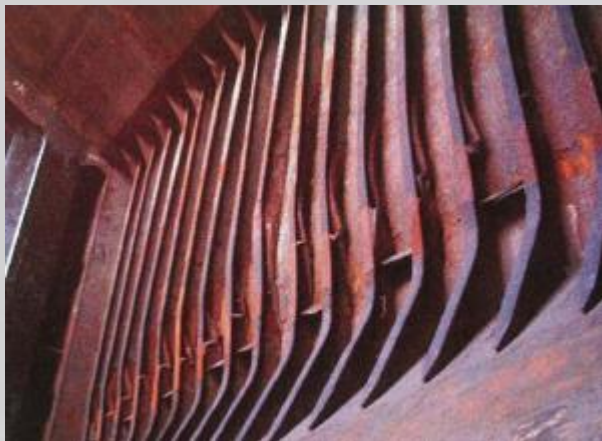
Collapse of Hold Frame

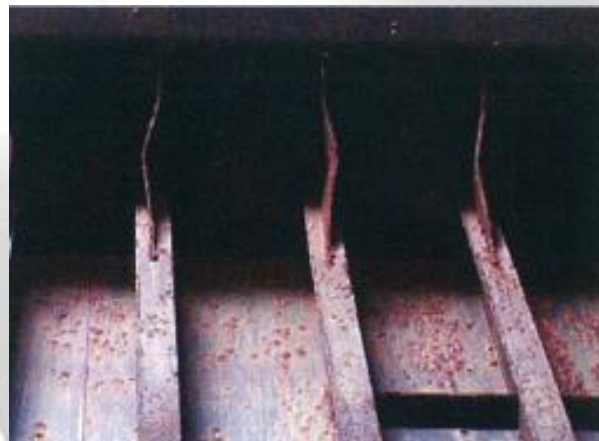
Lower bracket

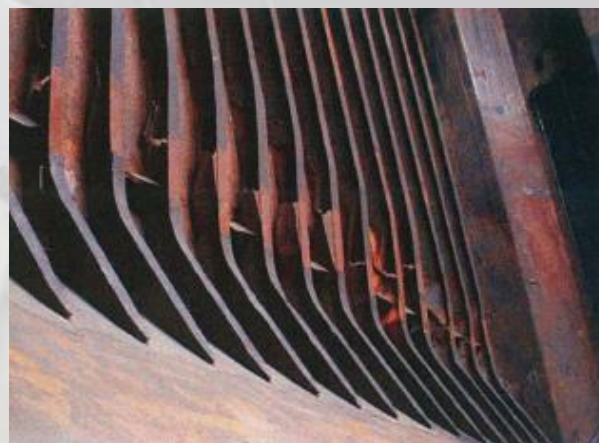
Upper bracket

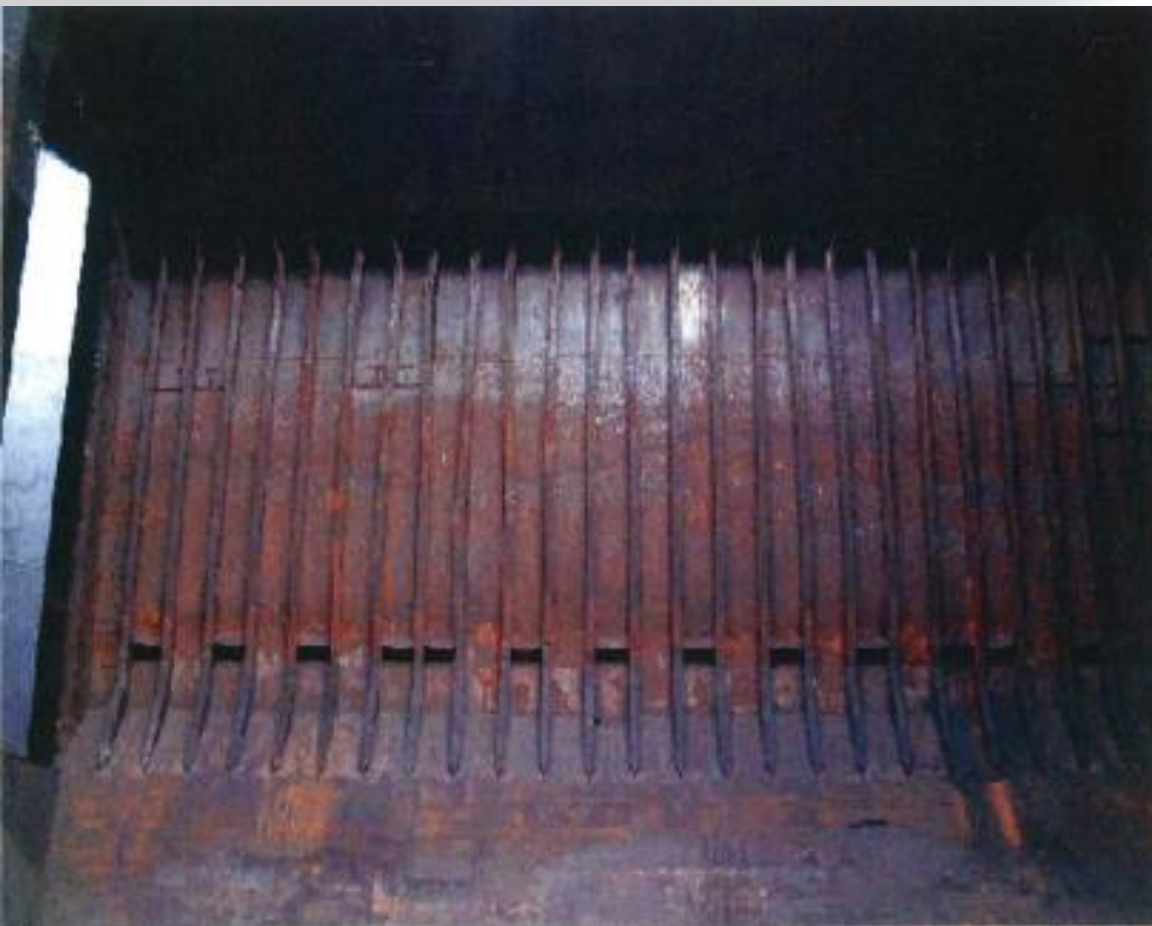
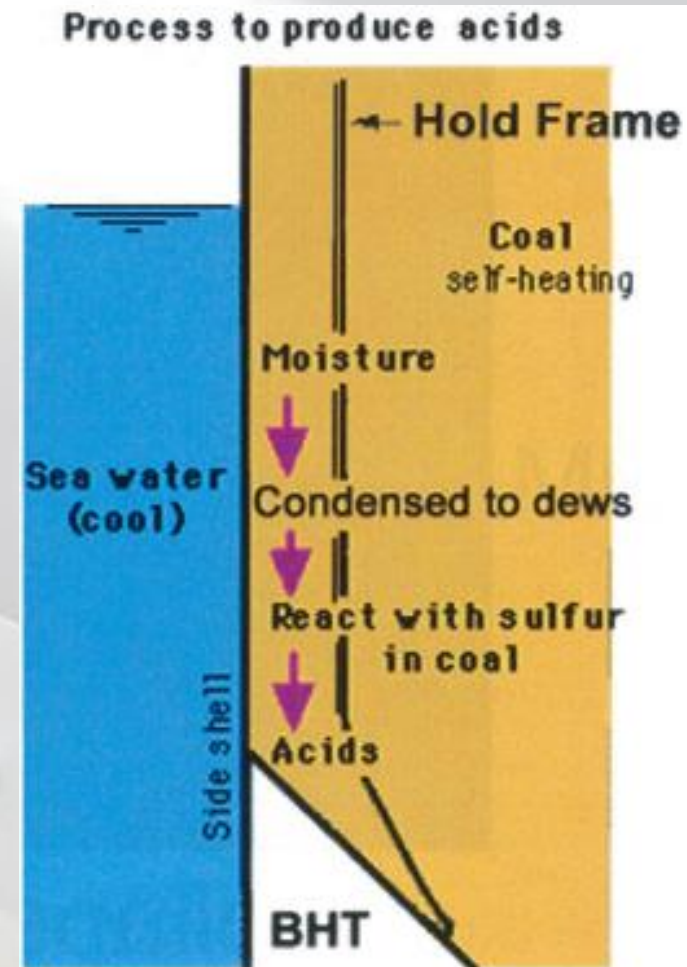
Hold frame corrosion process

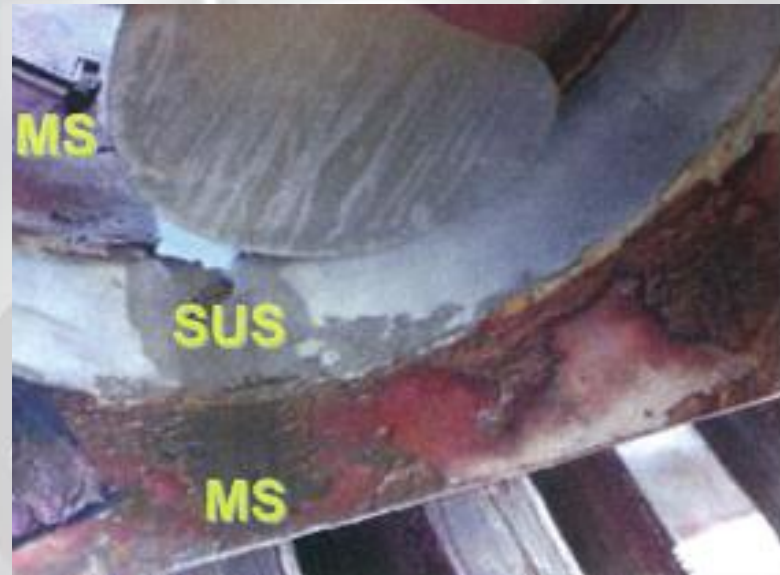
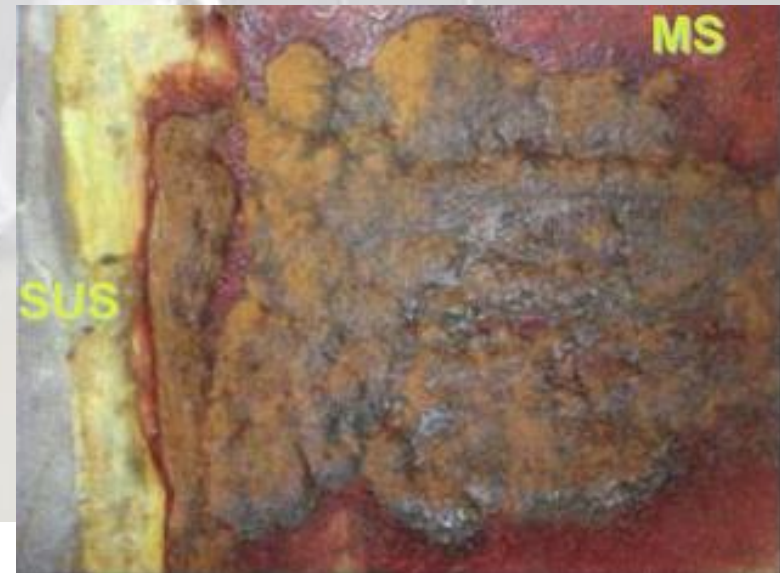
GALVANIC CORROSION IN BOW THRUSTER DUCT

MS: Mild Steel

SUS: SUS stands for Steel Use Stainless (stainless steel Material)

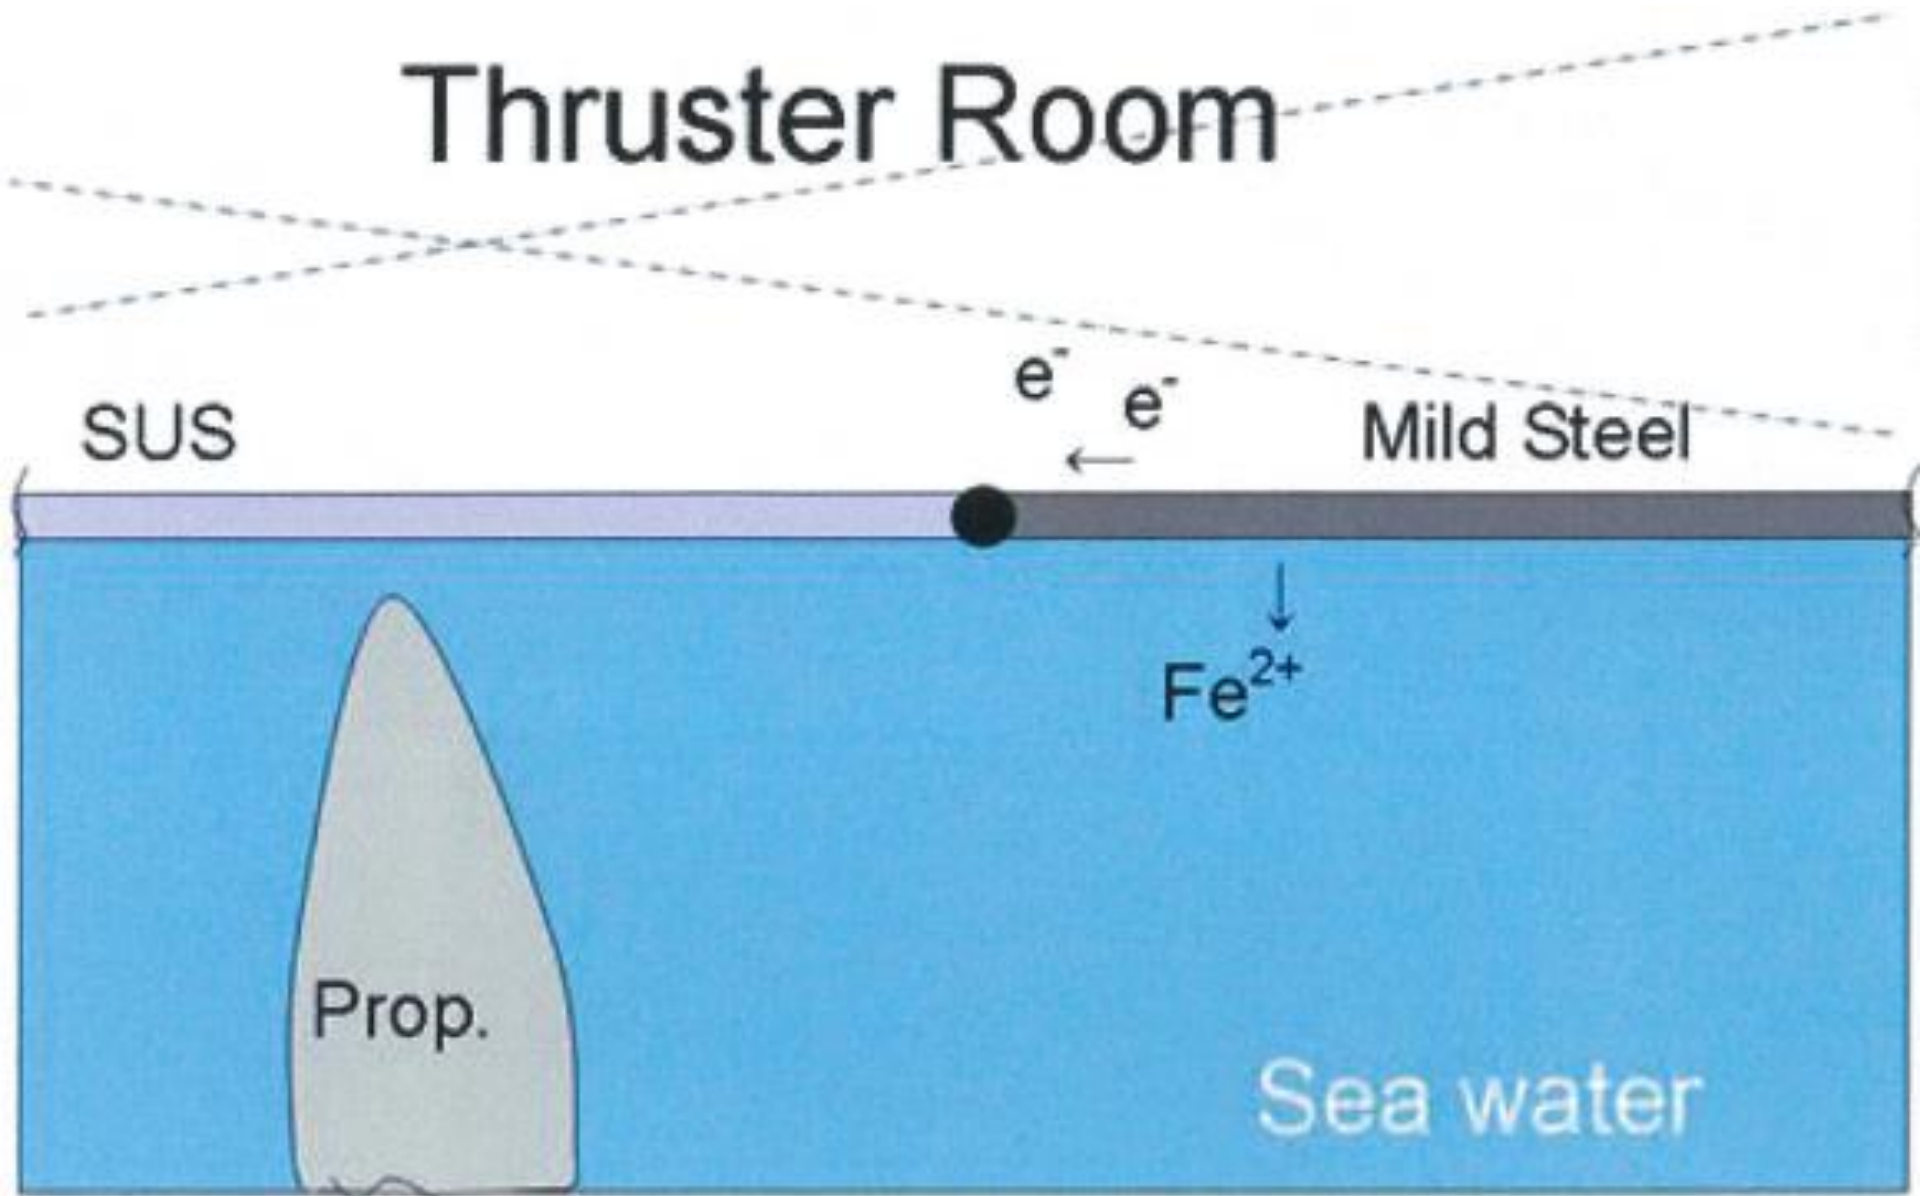
Thruster Room

Examples of Repair

- Both metals are insulated from electrolytes by not only an anodic metal coating but also a cathodic metal coating.
- Different kind metals are made electrically nonconductive via insulation etc.
- If it is not necessary to use several kind materials, it is possible to modify with only a single type of metal.

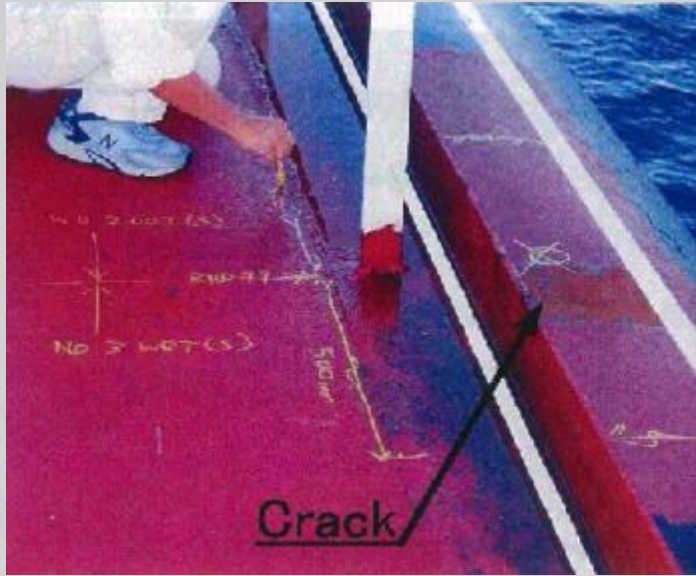
LOCAL CORROSION AROUND UPPER
DECK OF AN OIL TANKER

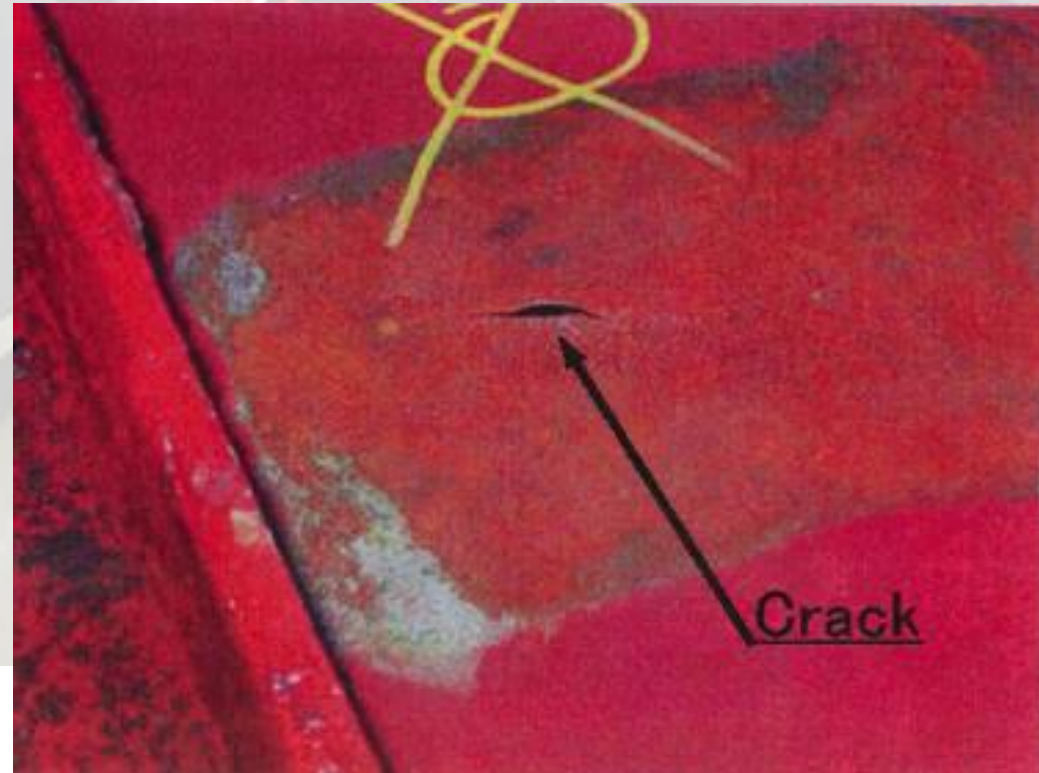
Selectively and Heavily
Corrosion in Water
Ballast Tank

Possibility of
SERIOUS INCIDENT

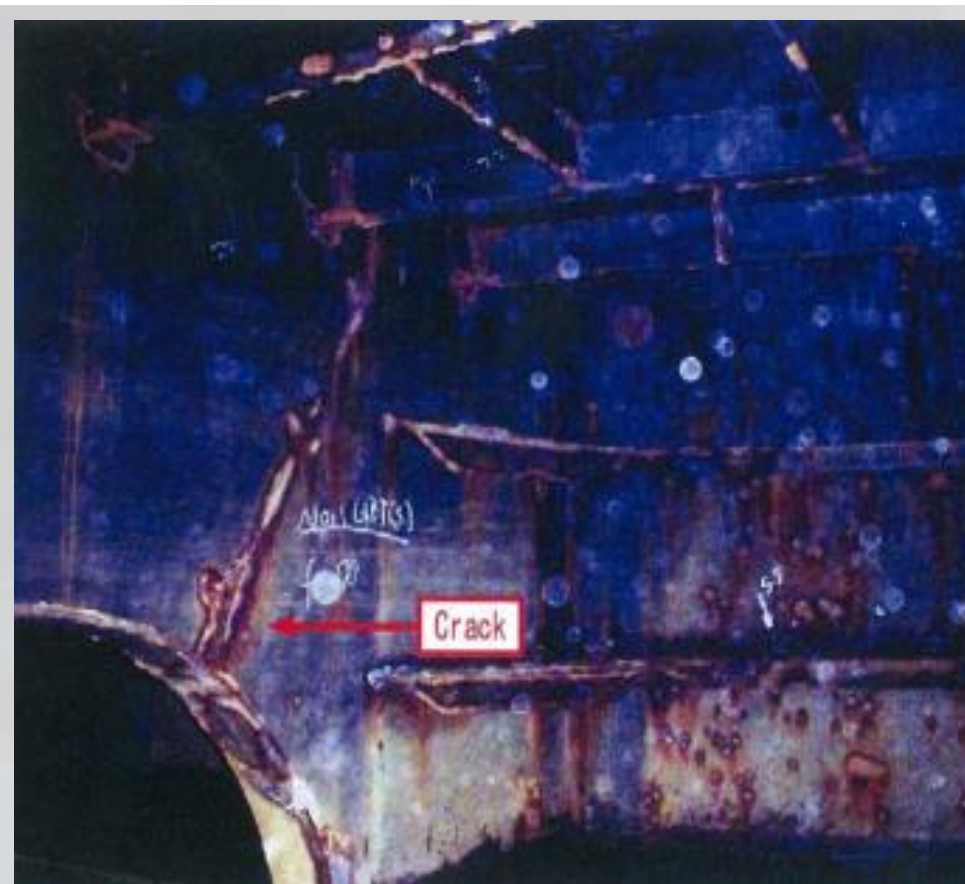
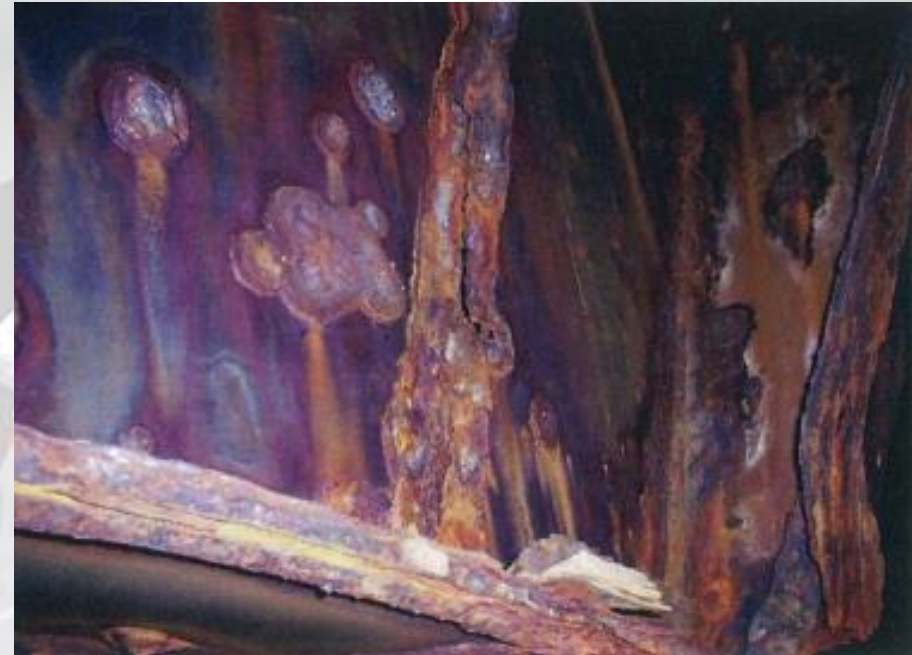
Heavy localized corrosion of the ballast water tank

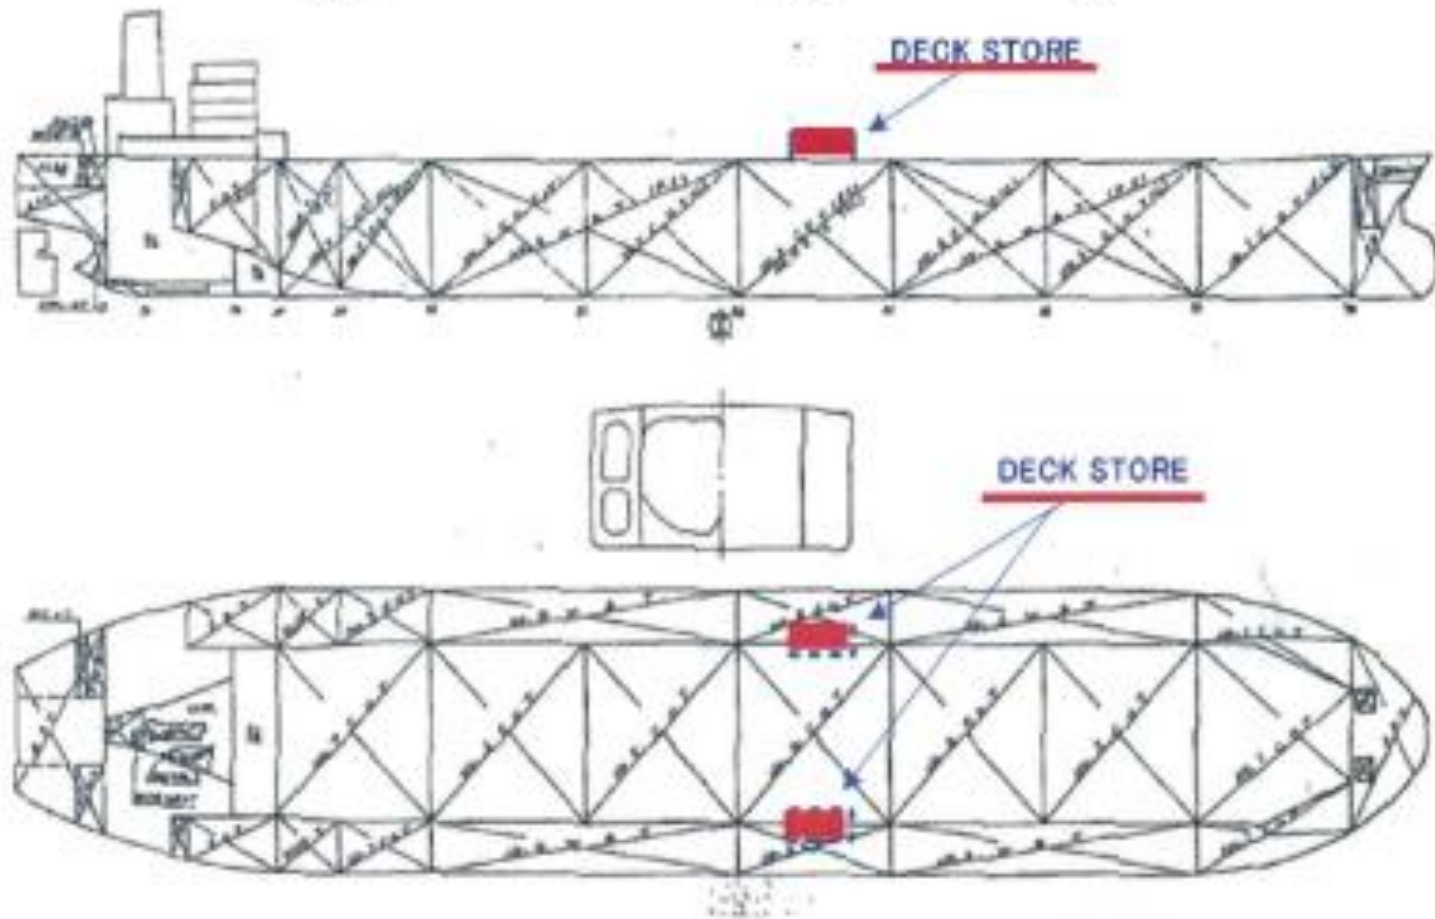
CRACK IN OIL TANKER DECK STORE

Aframax Oil Tanker

Length: 200m Age: 15+ years

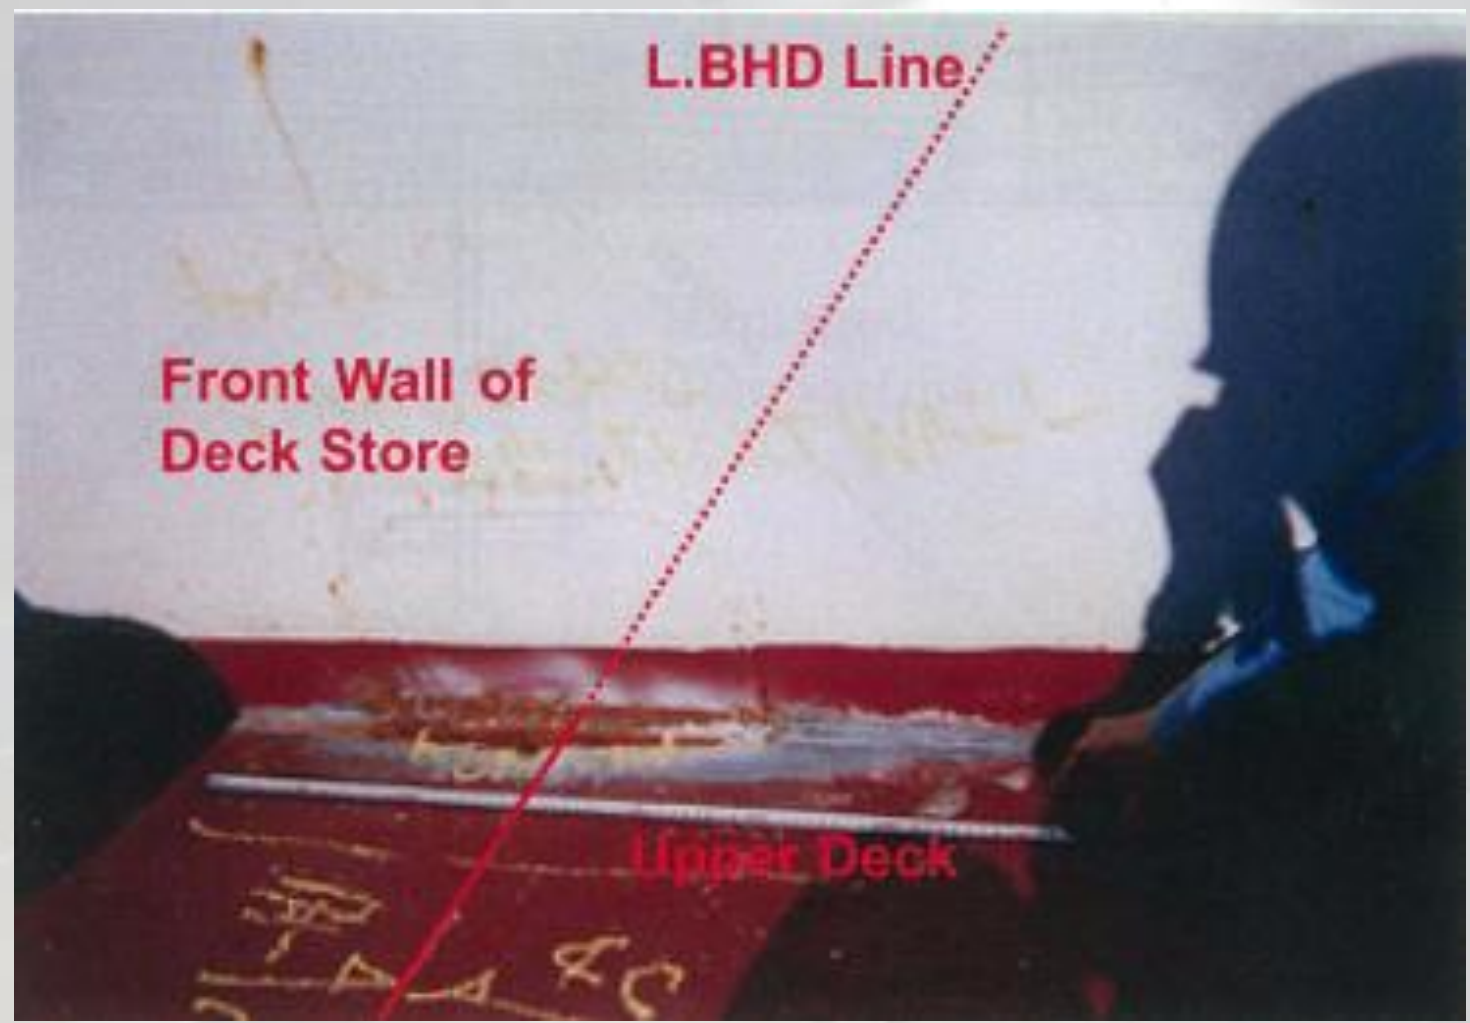
Picture from damaged part

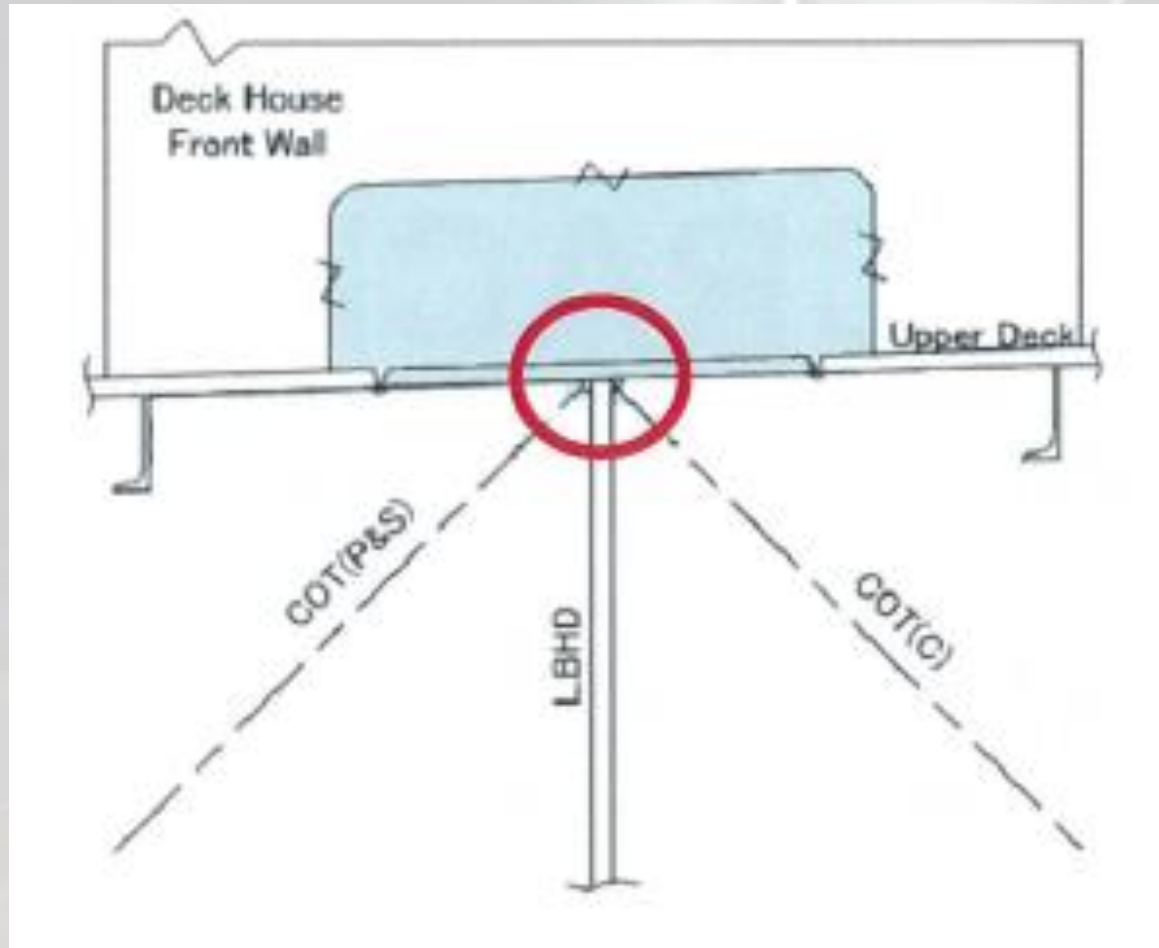
Spot contact of front wall of Deck Store & L.BHD

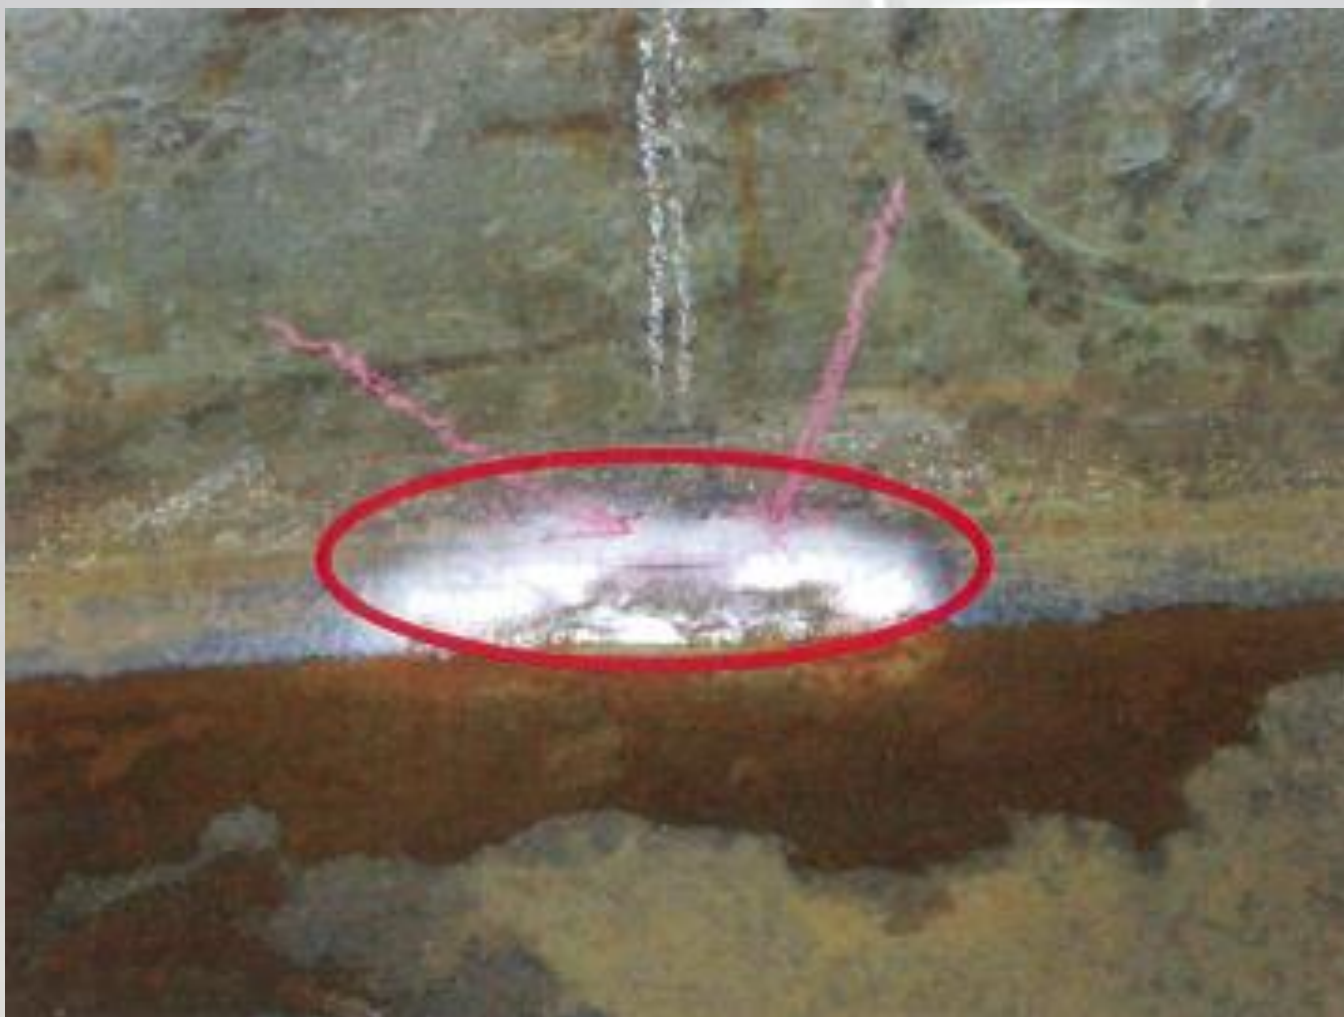
Crack in inner bottom plate at intersection of lower stool, DB floor and DB girder

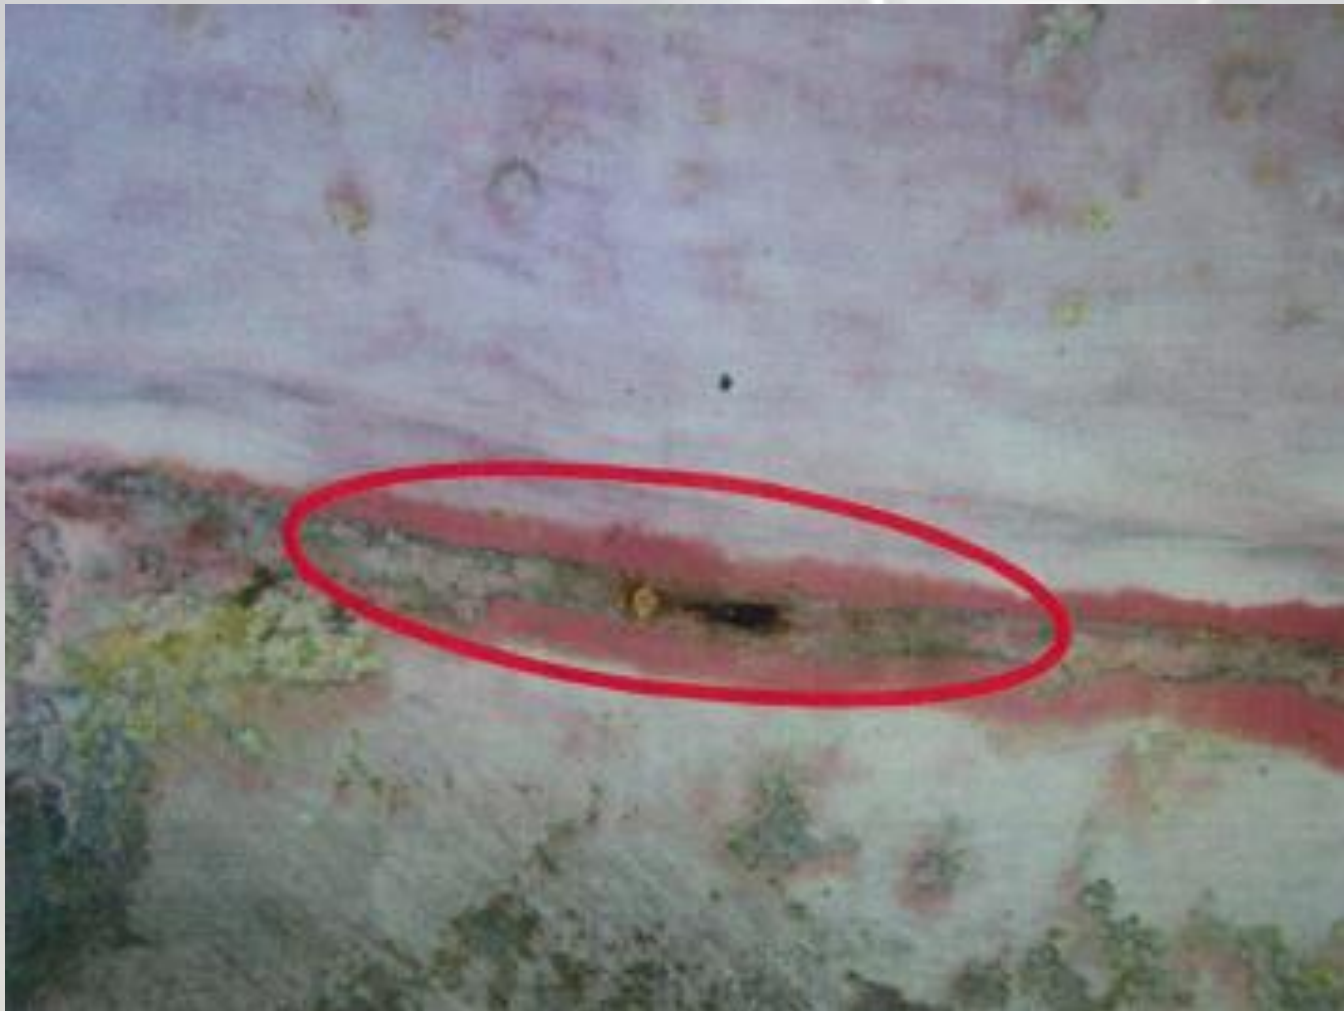
Leakage from Double Bottom Tank

No.4 Cargo/Ballast Hold

Repeated high stress at the connection between lower stool and tank top plate in heavy ballast condition

Fatigue Crack
