ICS Class

2A: Hull Structure

In compliance with the IMO resolution MSC.349(92) and MEPC.237(65), RO Code, Appendix 2.

MODULE 2A-Hull Structure (Content)

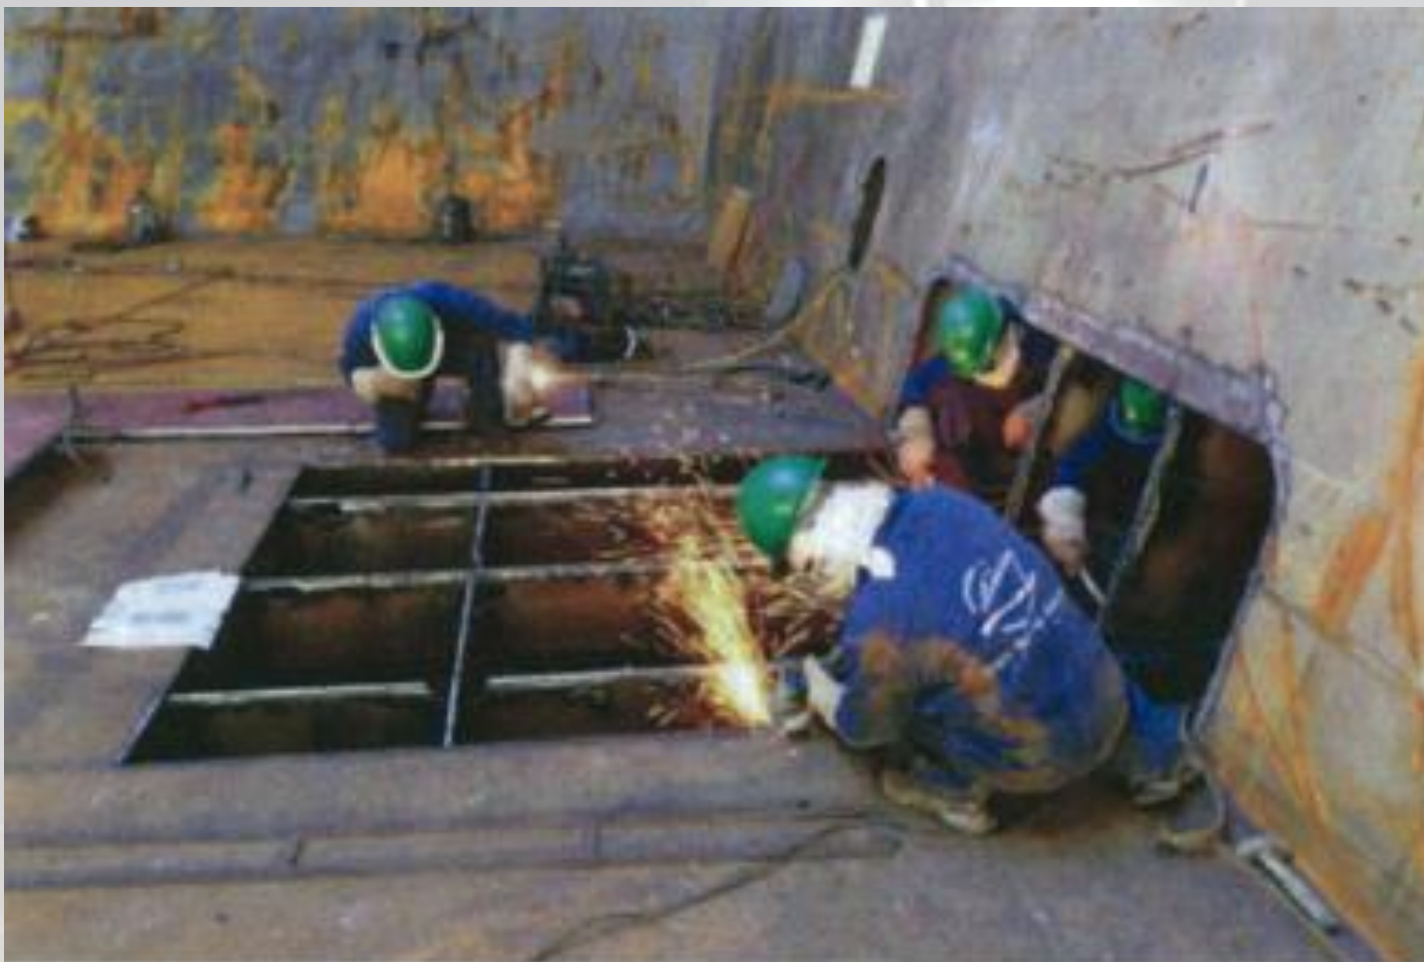
Inner bottom plate should be renewed with thicker plate

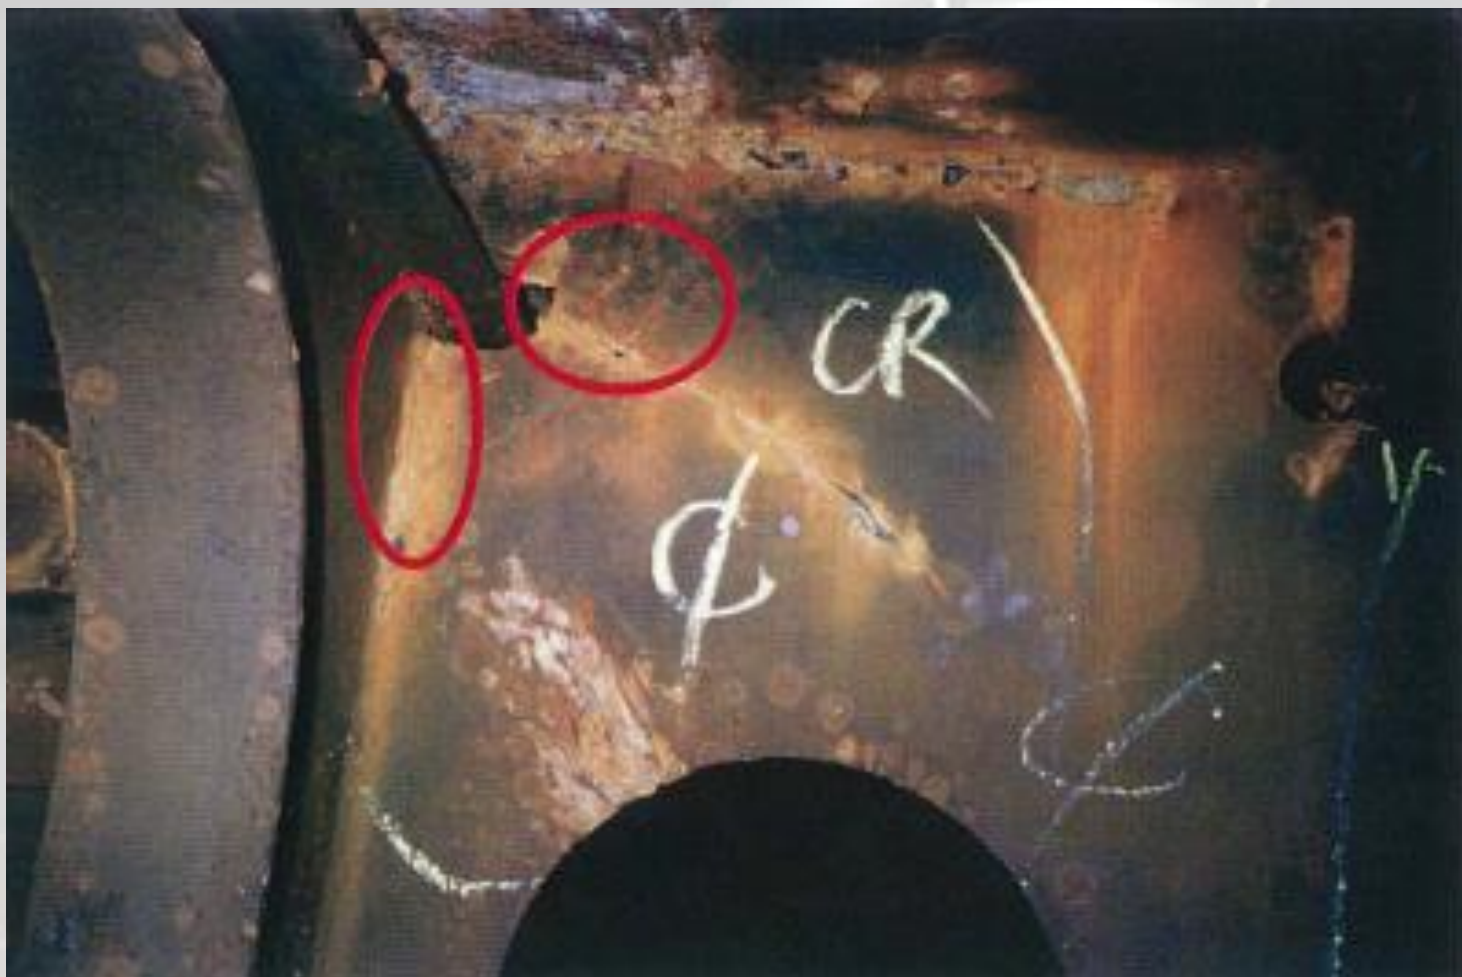
Inner bottom plate should be renewed with thicker plate

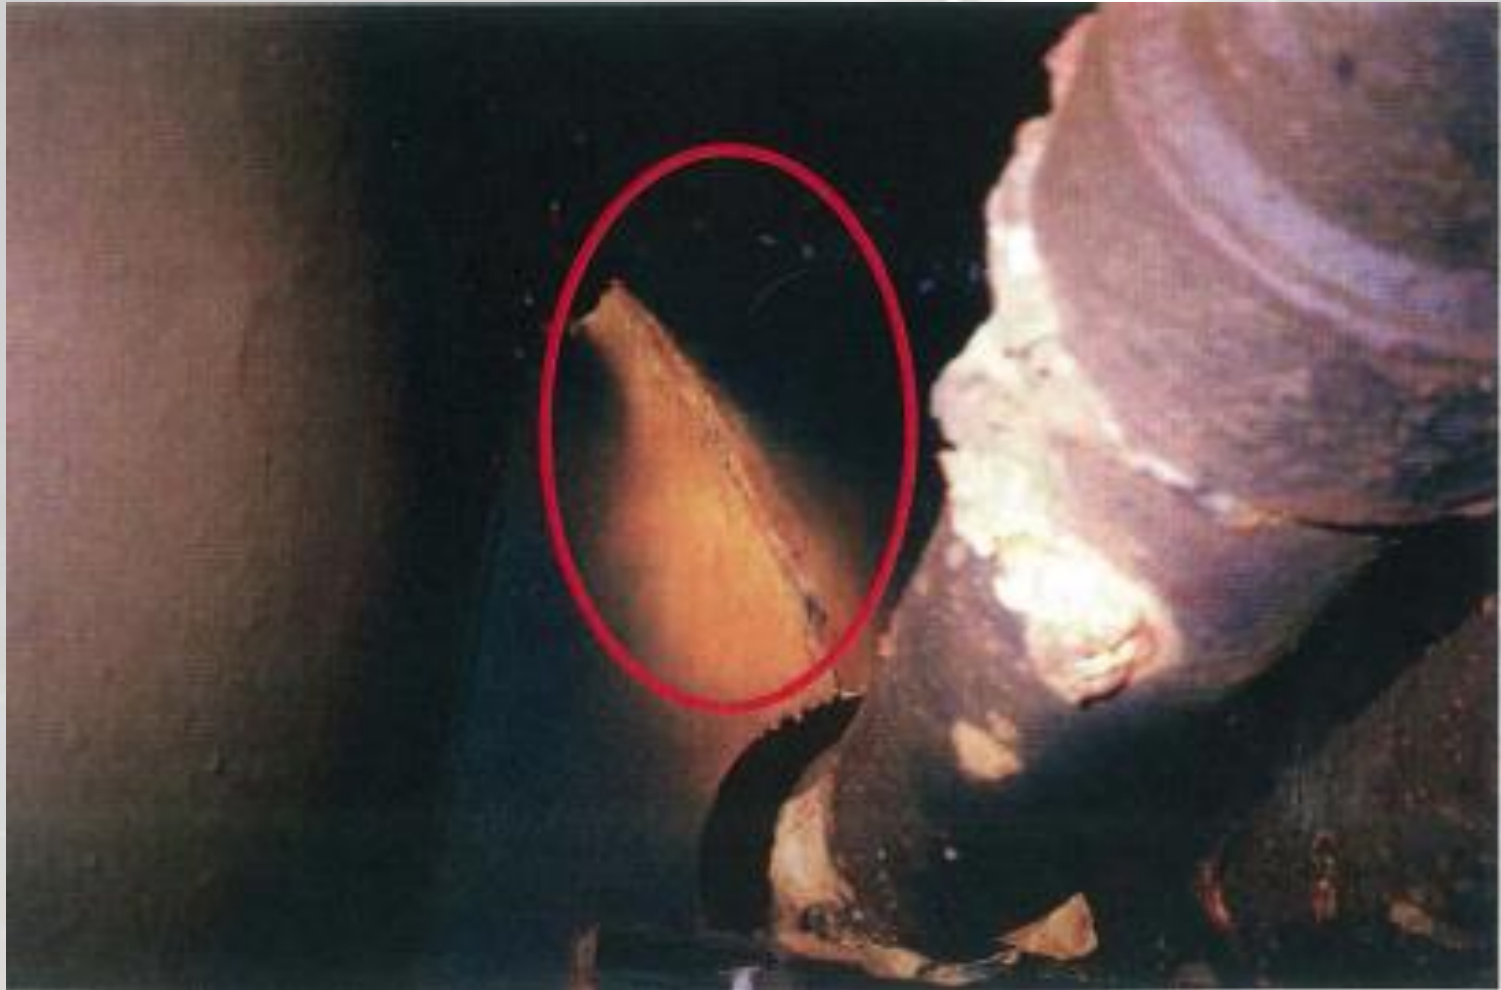
Crack in pipe penetration

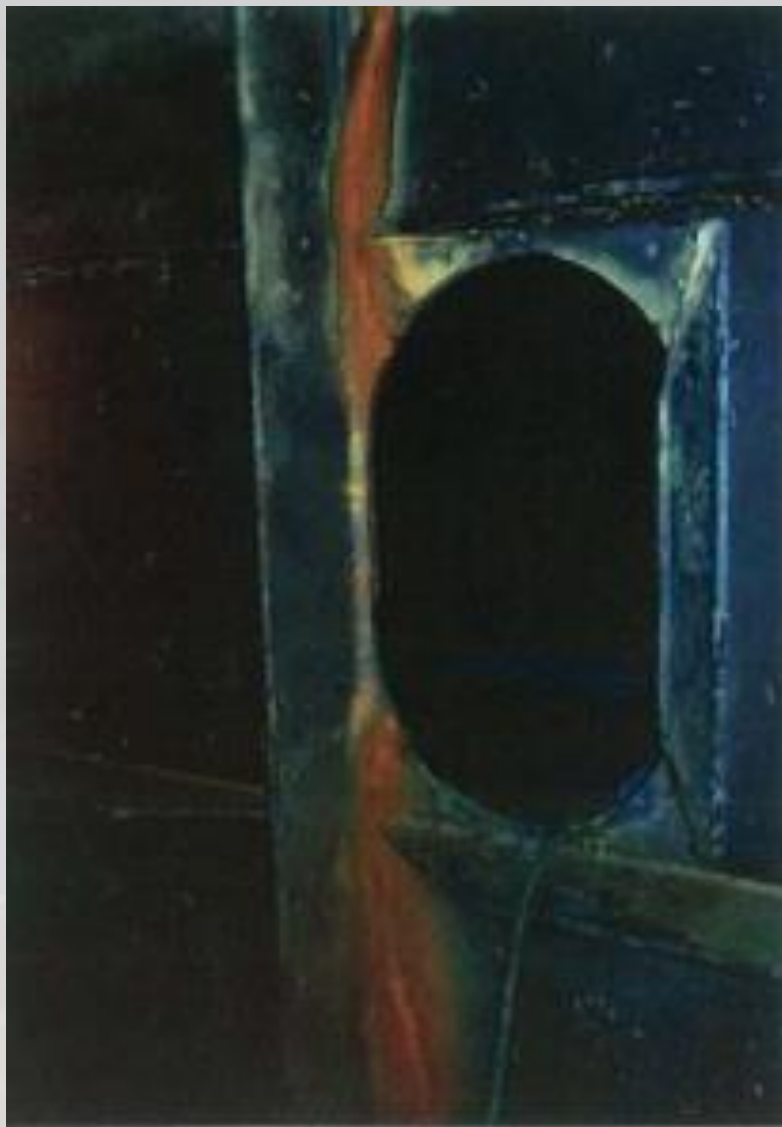
Crack on midship only

- ➡ Due to hull girder stress
- ➡ Due to local shearing stress

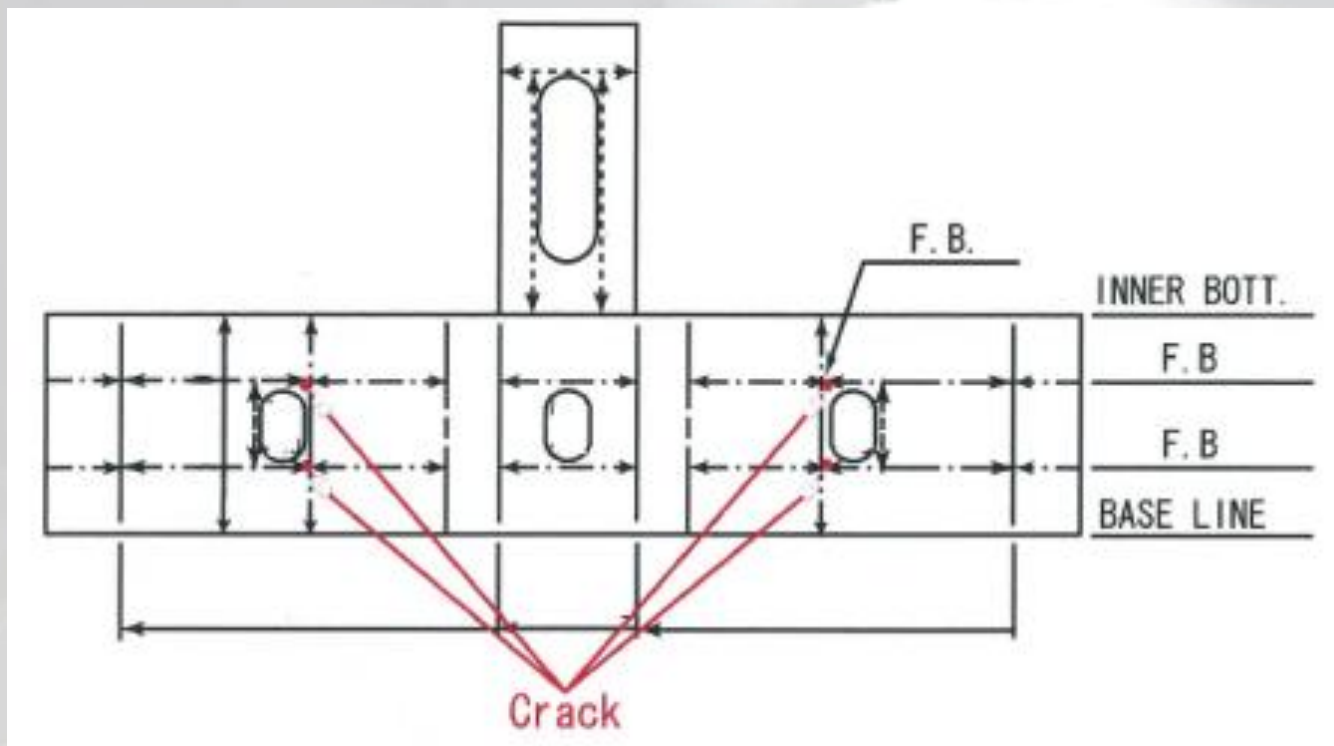
The snip end of L.Stiffener near manhole might cause high stress & cracks and their propagations

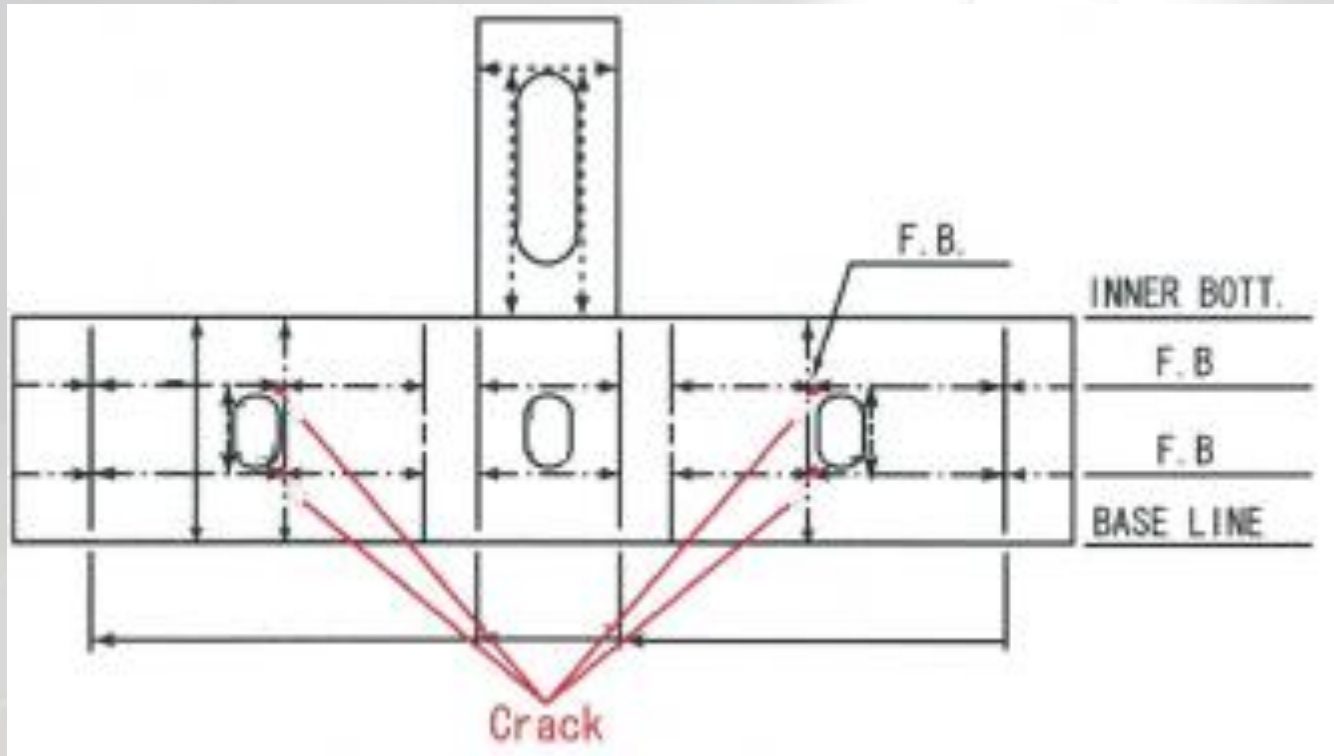
Countermeasure

- ➔ The doubling plates fitted around the manholes
- ➔ The end shape of L.Stiffener changed to clipped end and connected to V.Stiffener

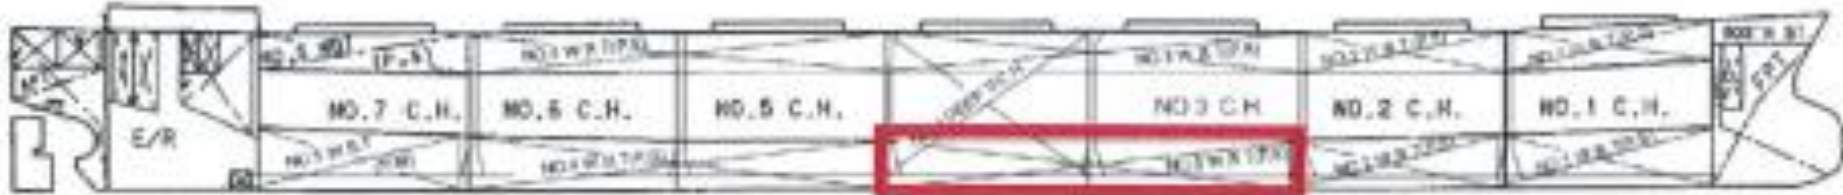
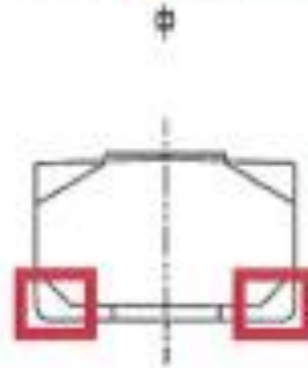
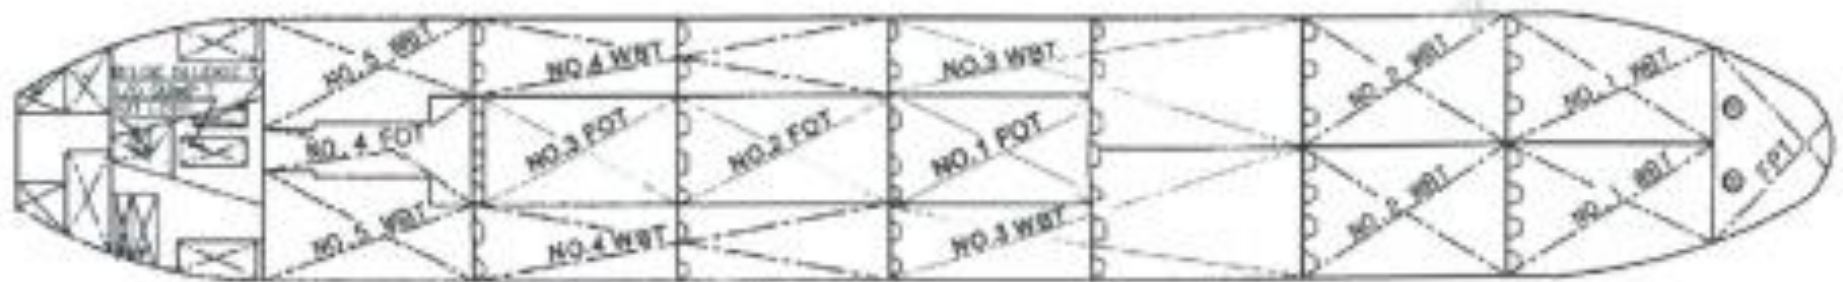
CRACK IN A BULK CARRIER BILGE HOPPER TANK

Panamax Size Bulk Carrier Age: 10 years

**Damaged
Compartment**

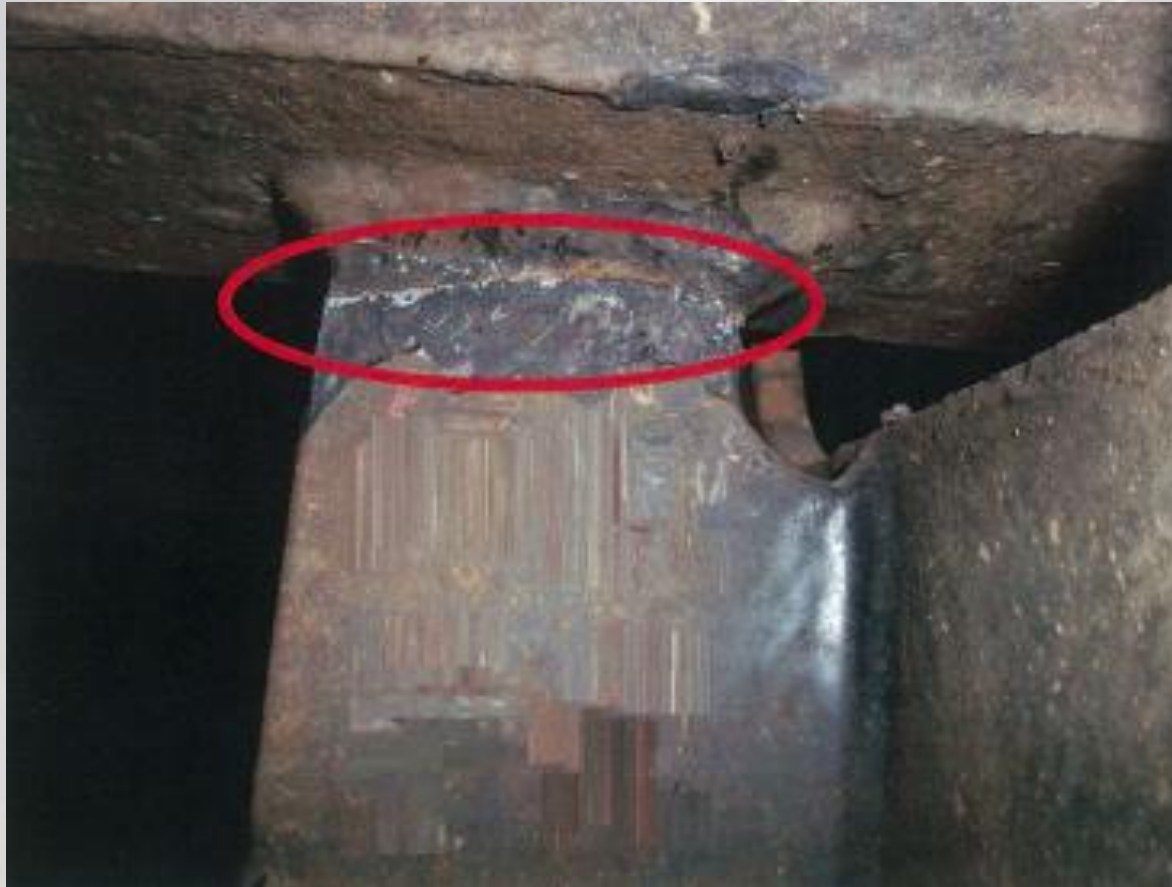
Crack in stiffener on transverse web at slot for bilge hopper longitudinal

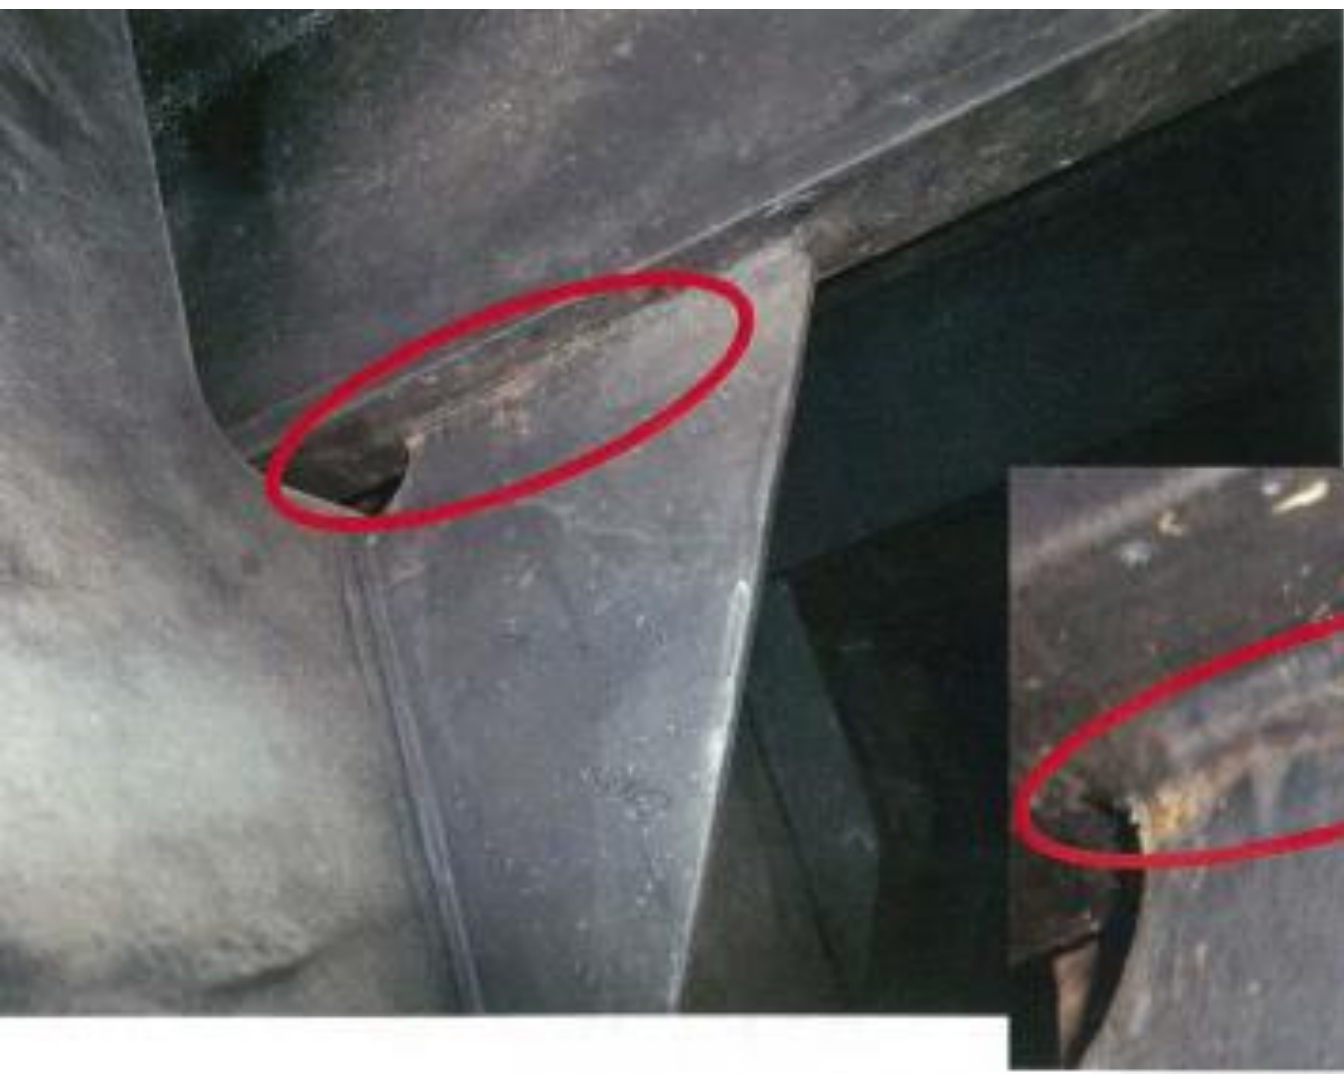
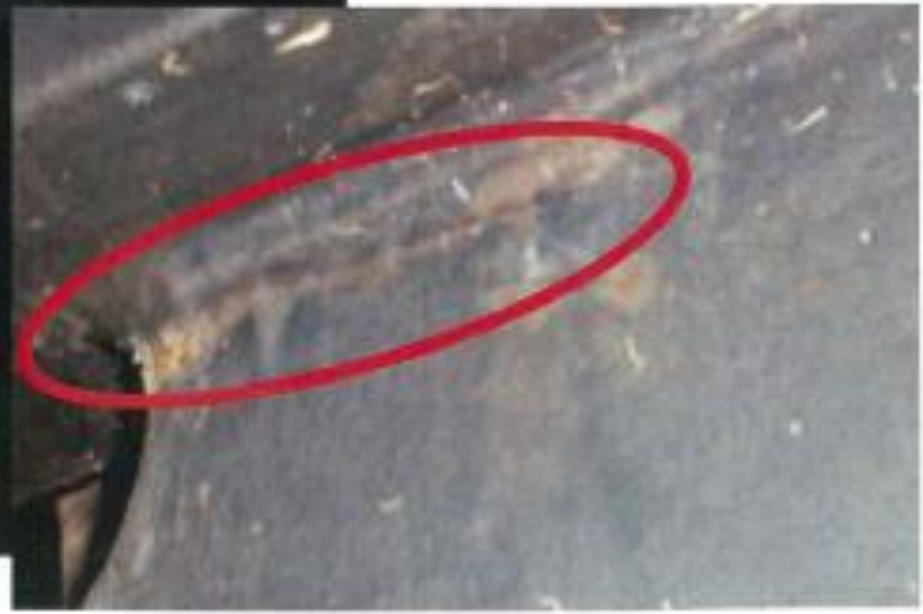
Crack in bracket on trance web at slot for bilge hopper longitudinal

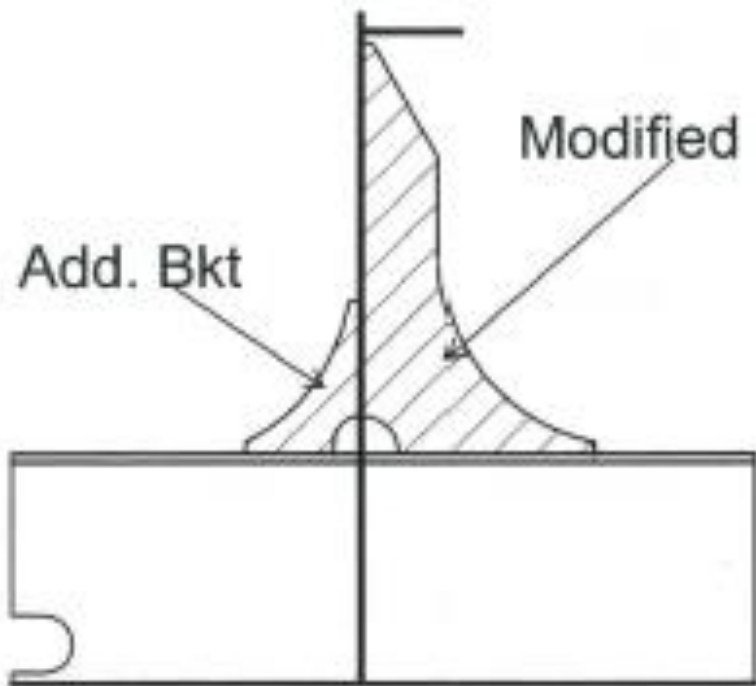
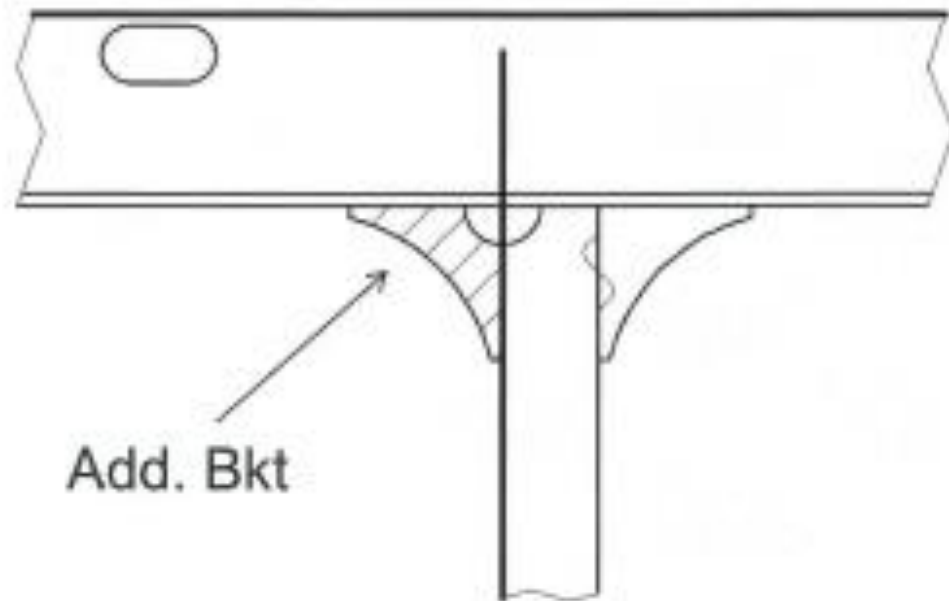
High stress in heavy ballast condition

Fatigue Crack

Effective reinforcement to increase fatigue life

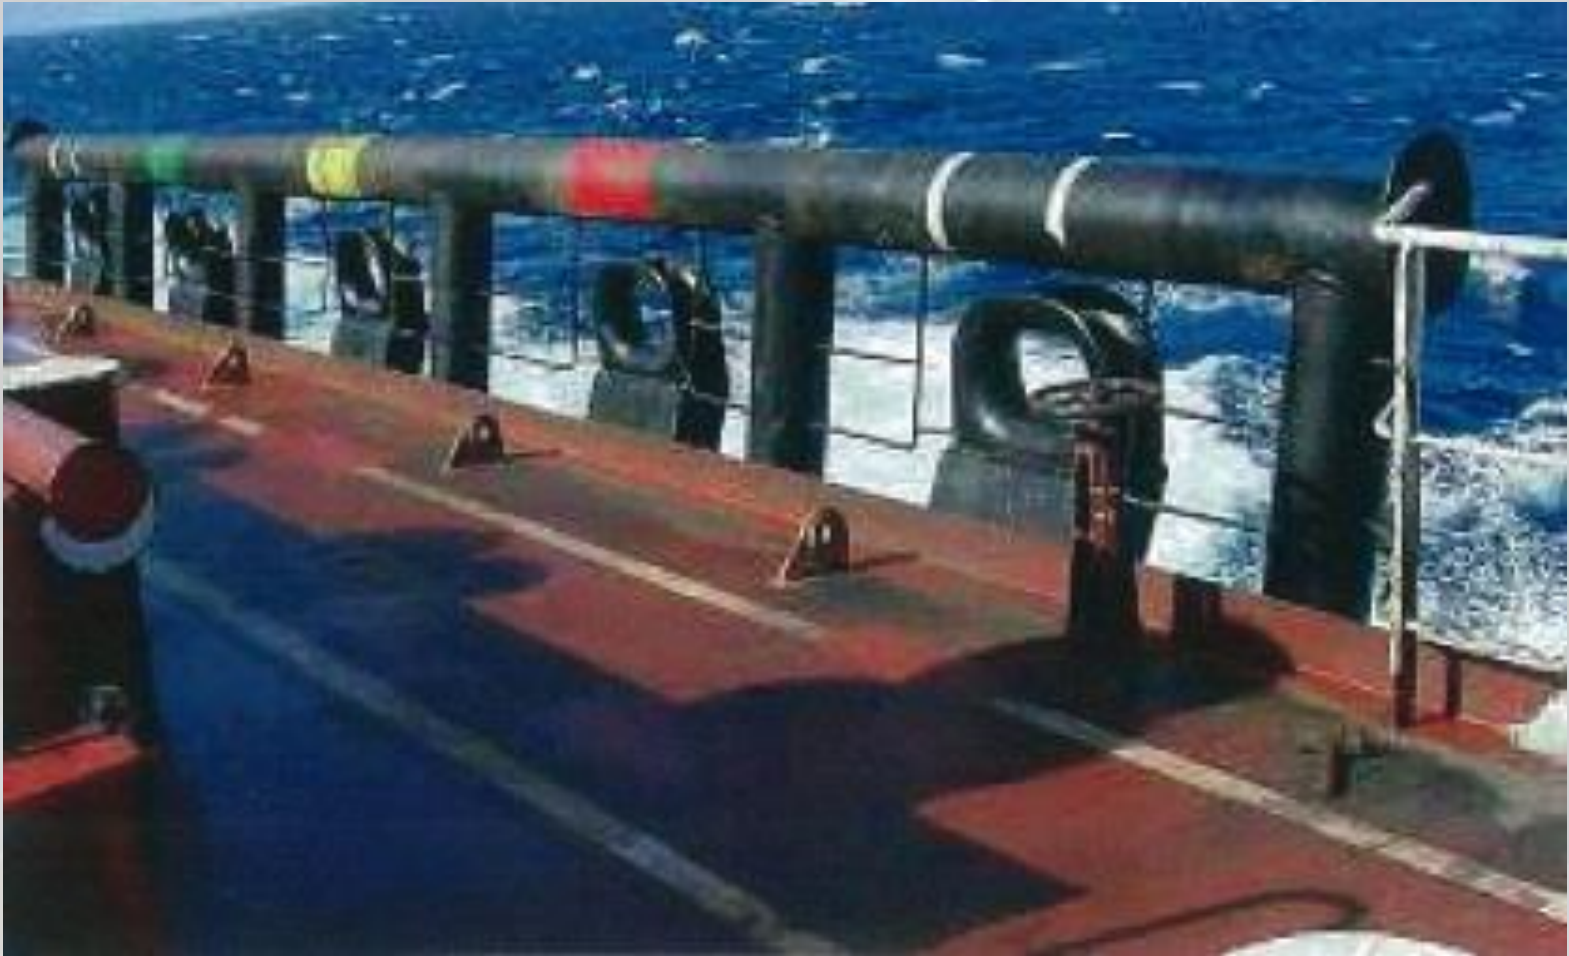
Hose Rail Stanchion

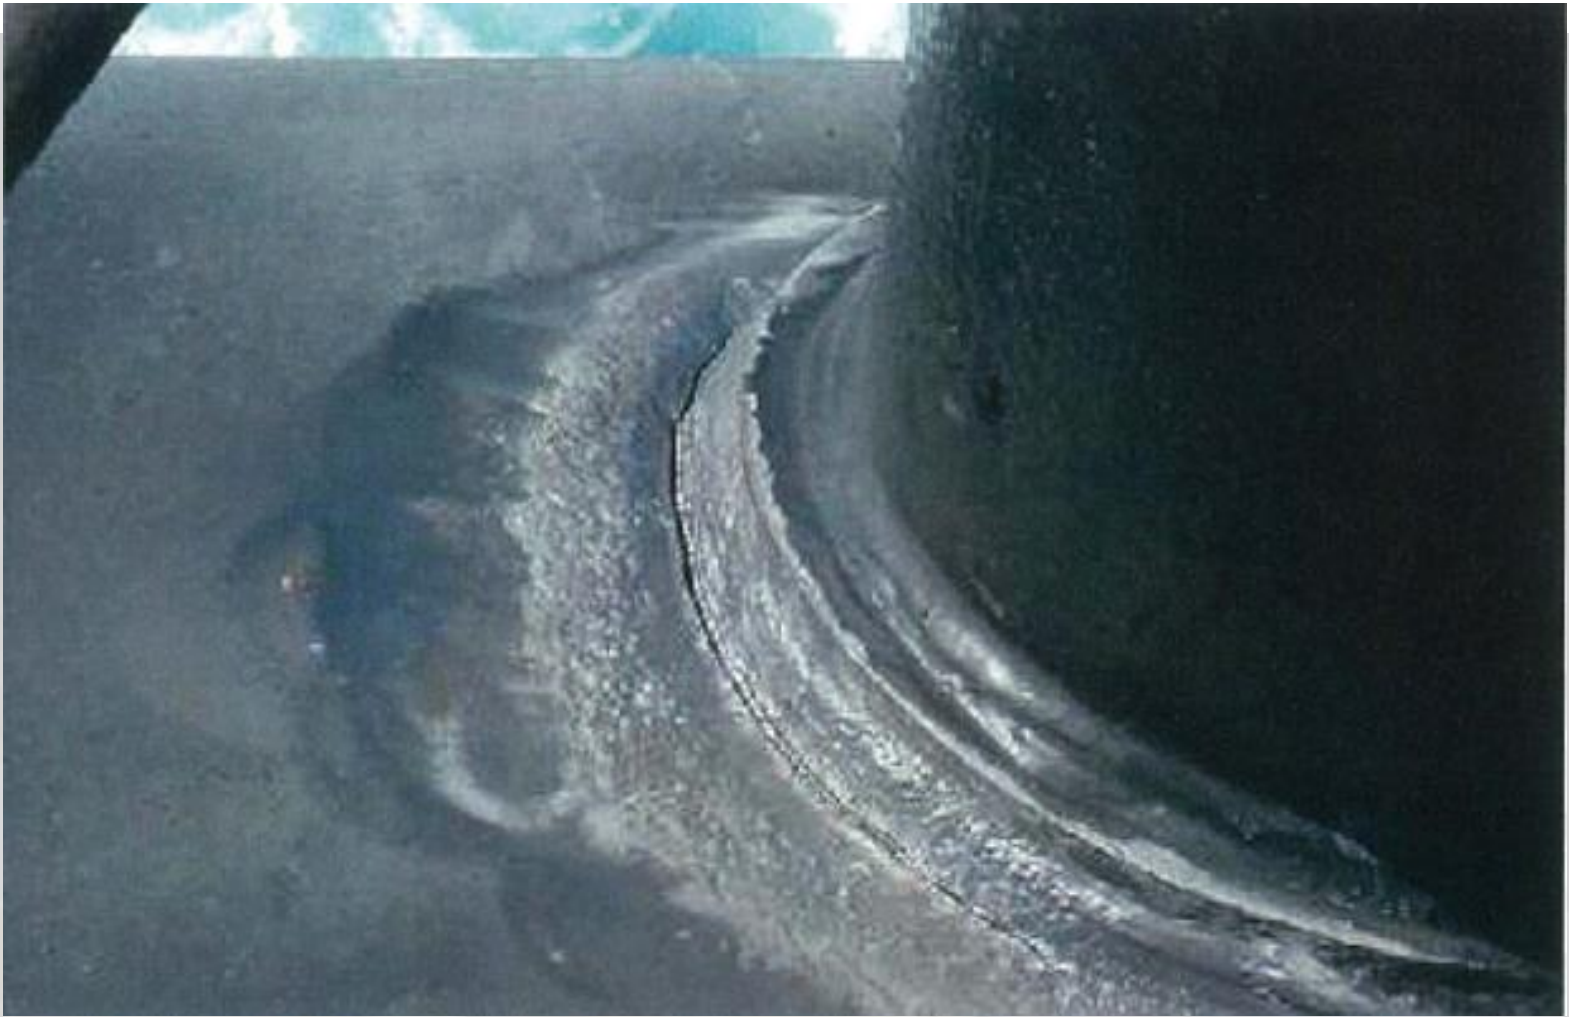
Cracks along fillet weld of pad plates beneath the steel pipe stanchions located at the transverse bulkhead section between the wing ballast and cargo tanks on both sides.

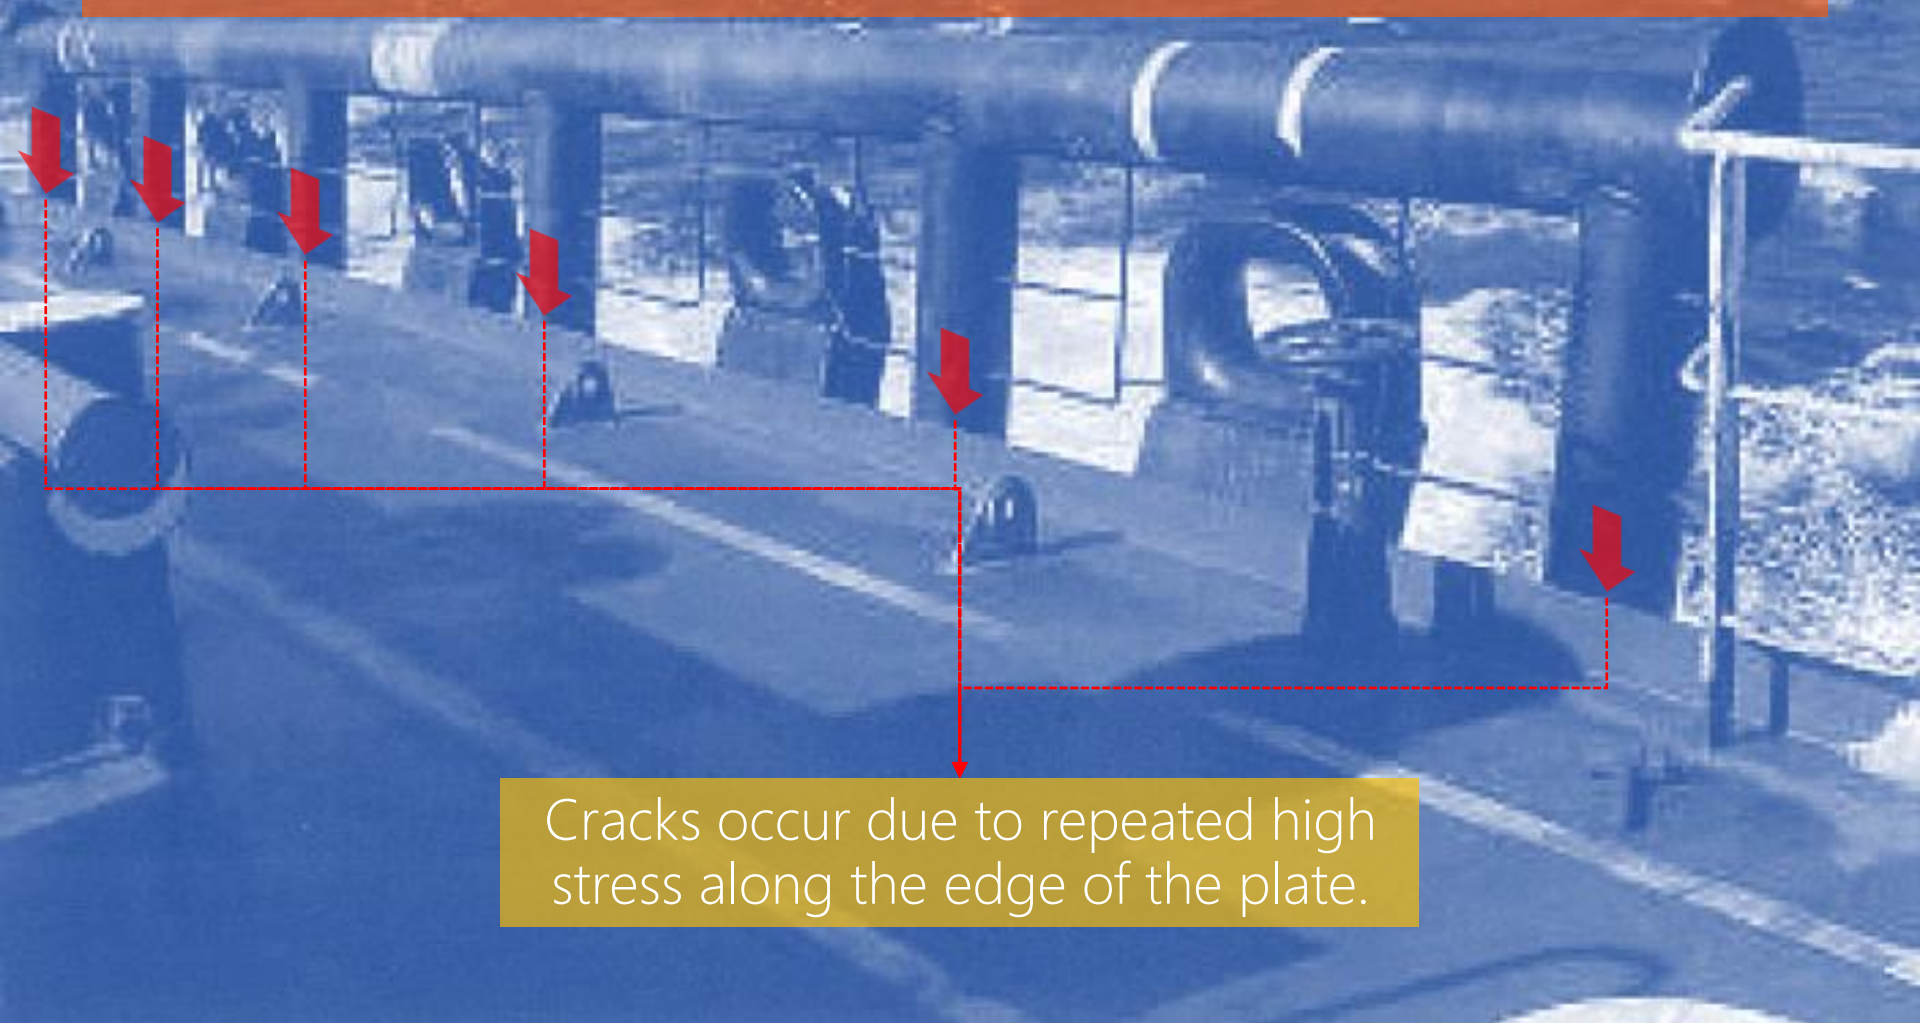
Long hose rails are not capable of responding to hull deformations which occur over time.

Cracks occur due to repeated high stress along the edge of the plate.

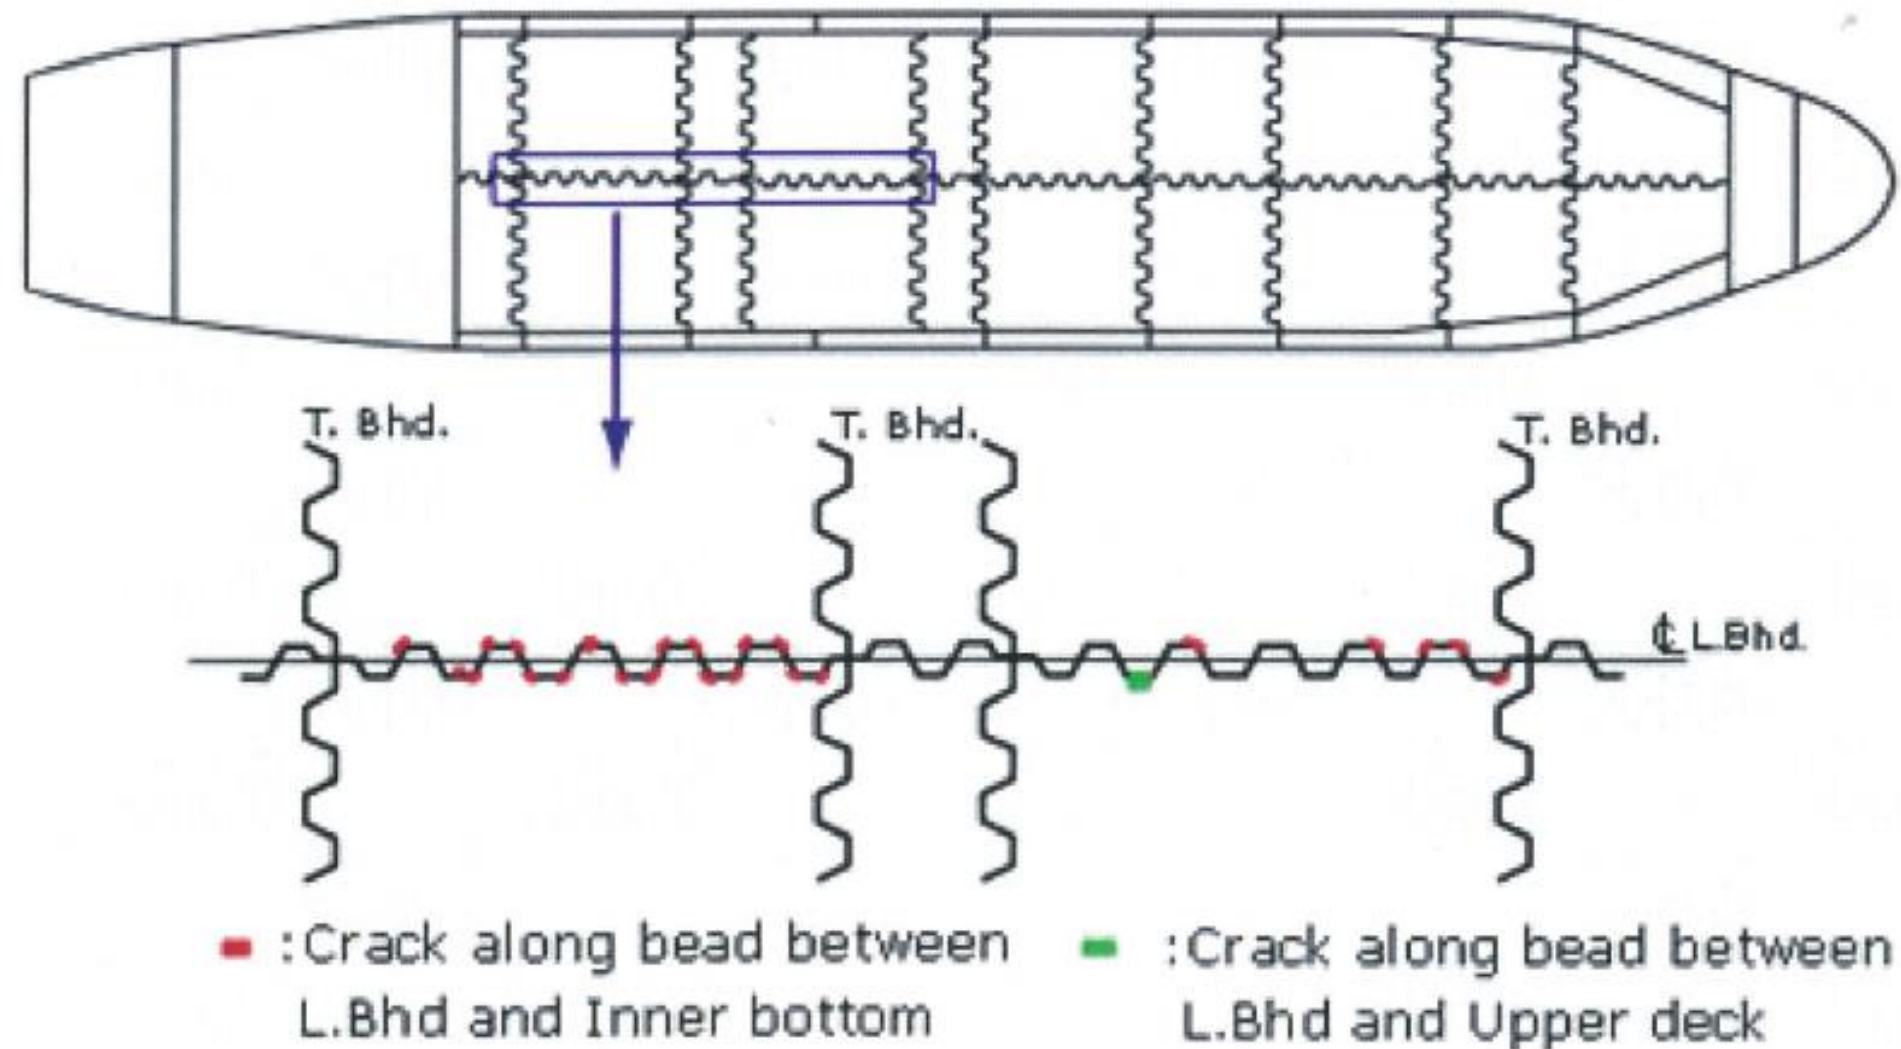
Example of cracked location

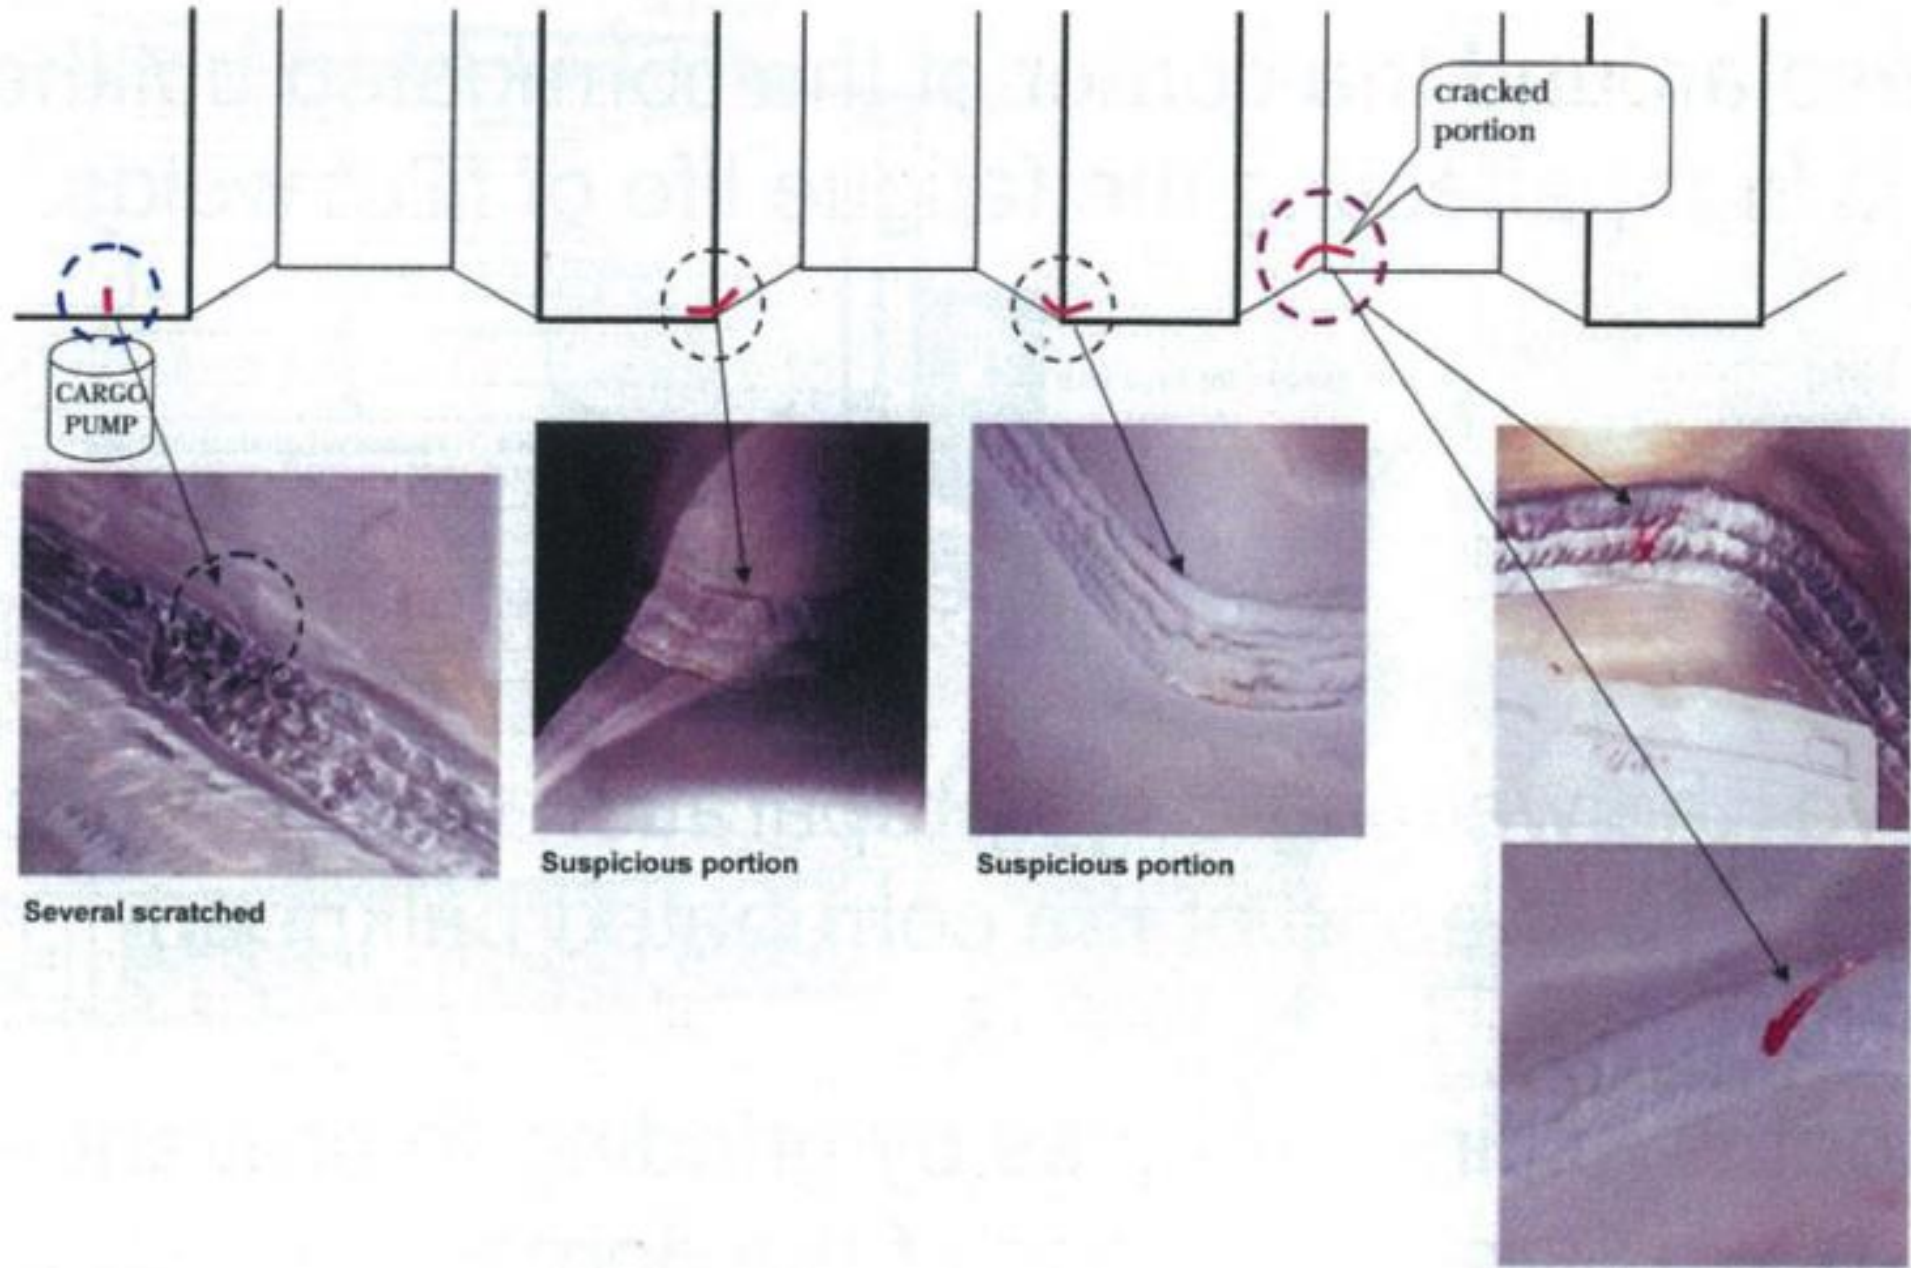
-Examples of Hull Damage (Crack Example 7)
