ICS Class

2A: Hull Structure

In compliance with the IMO resolution MSC.349(92) and MEPC.237(65), RO Code, Appendix 2.

MODULE 2A-Hull Structure (Content)

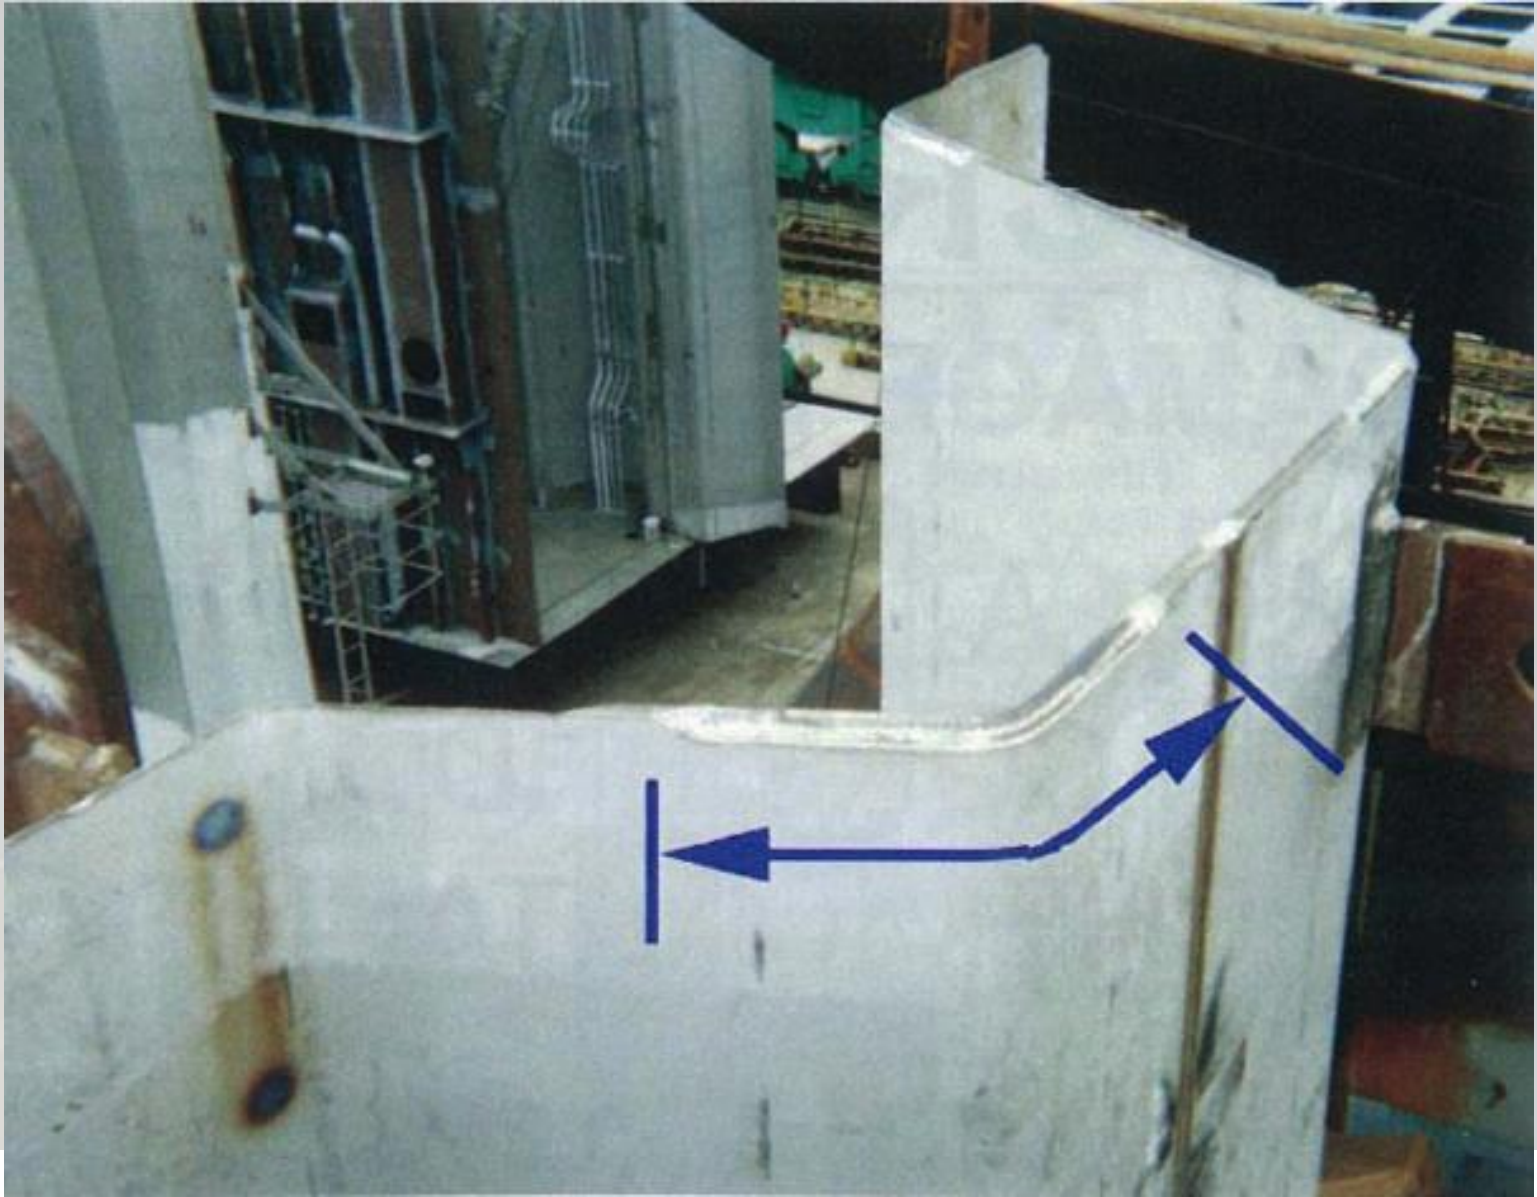
Stress around the corner of the corrugated bulkhead is high, affecting the fatigue life of fillet welds.

- ➡ Improve the welding edge preparation of the upper and lower edge of the corrugated bulkhead; and
- ➡ Smooth welding surfaces by grinding to prevent any reoccurrence of the damage.

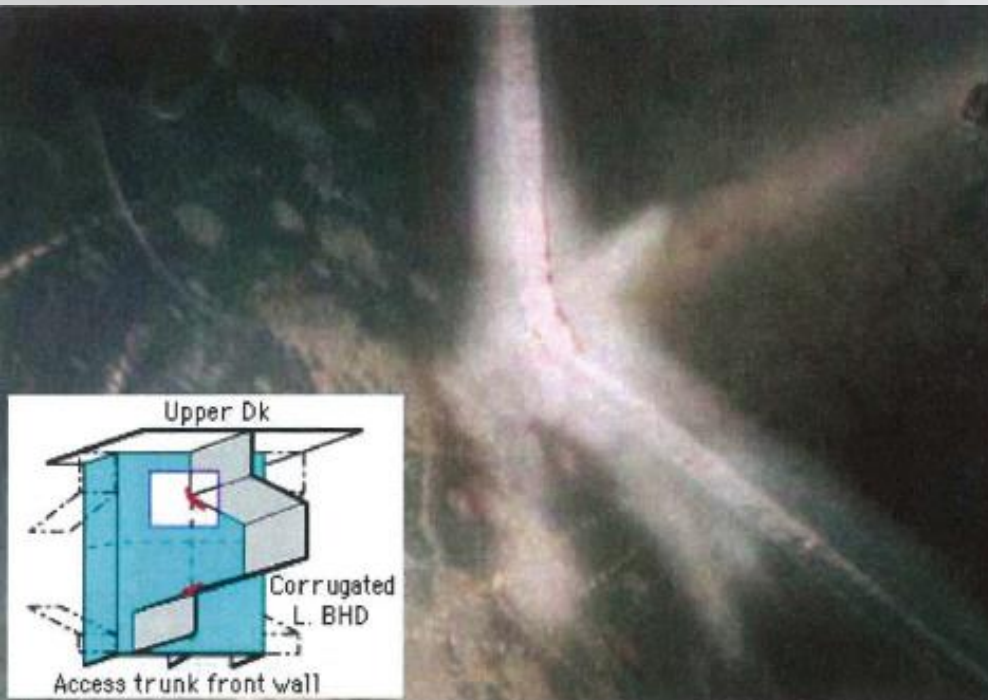
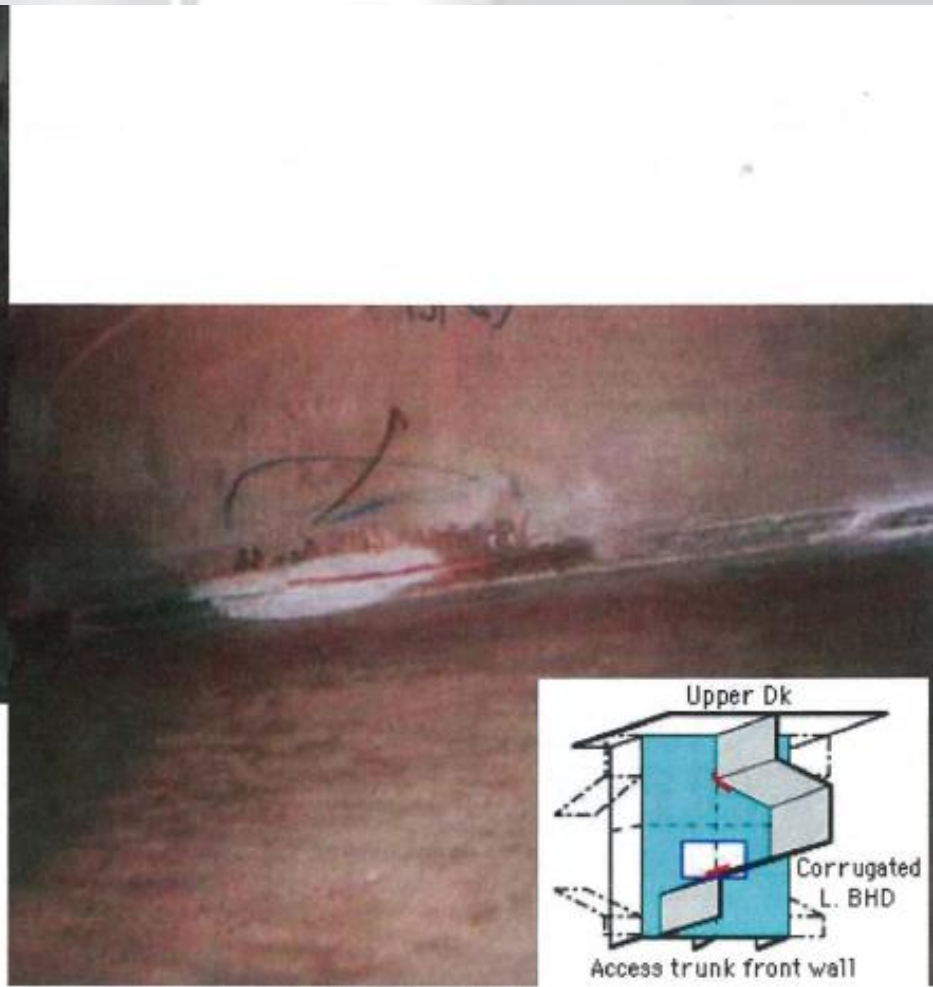
Crack in the vertical web connected to the access trunk

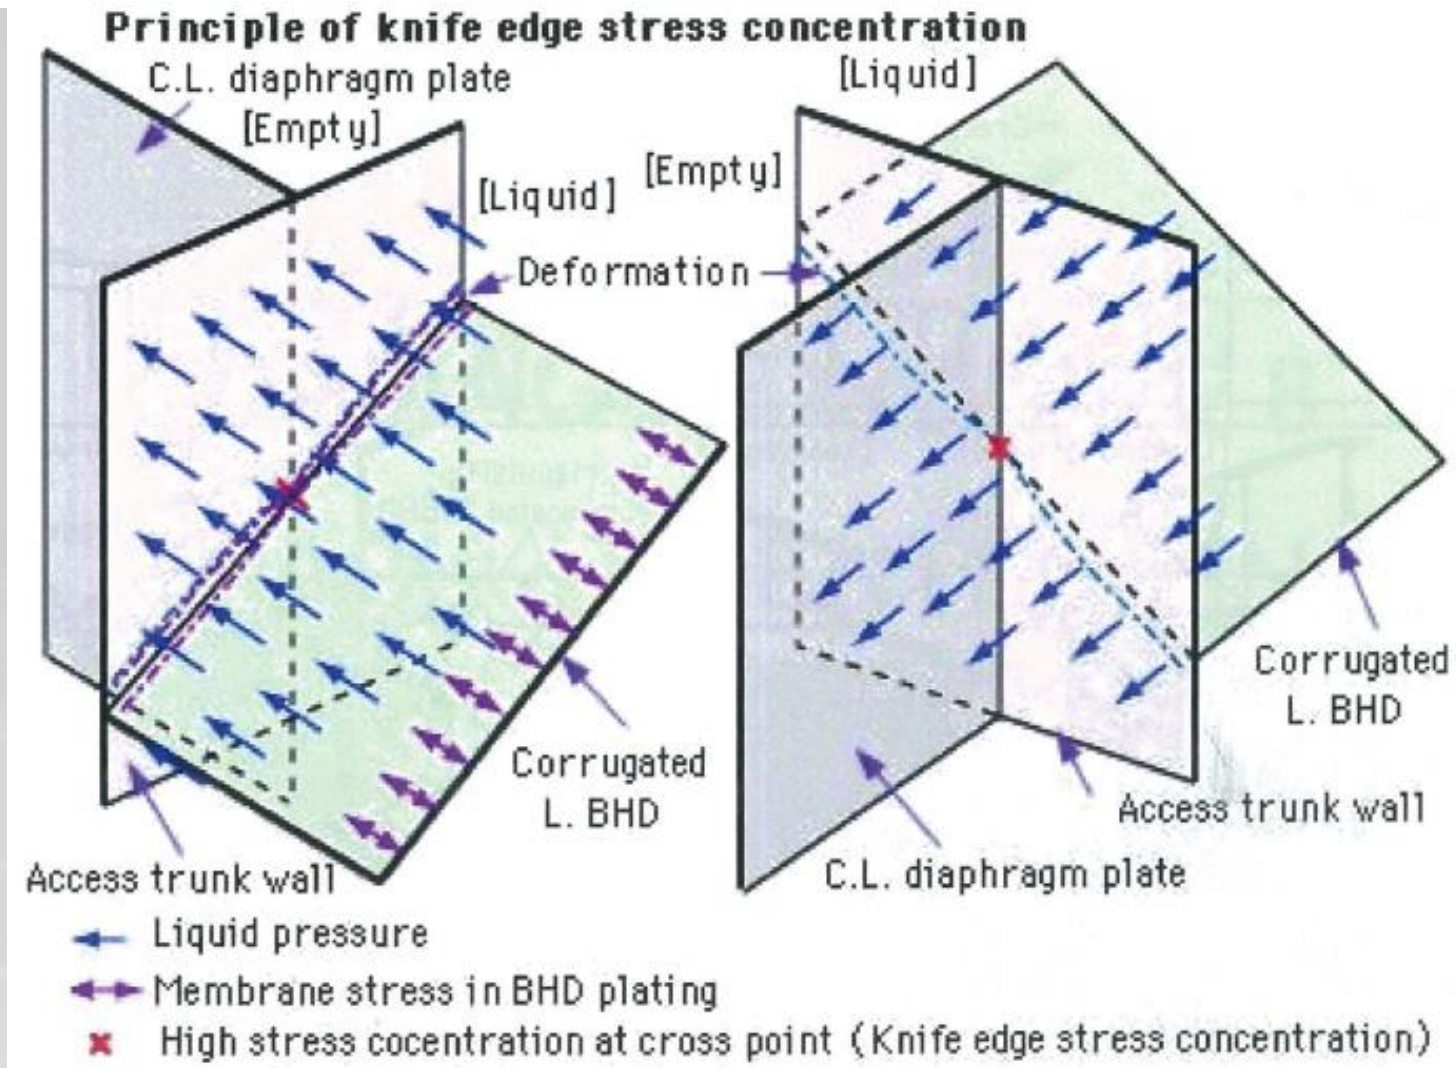
Stress Concentration at cross point

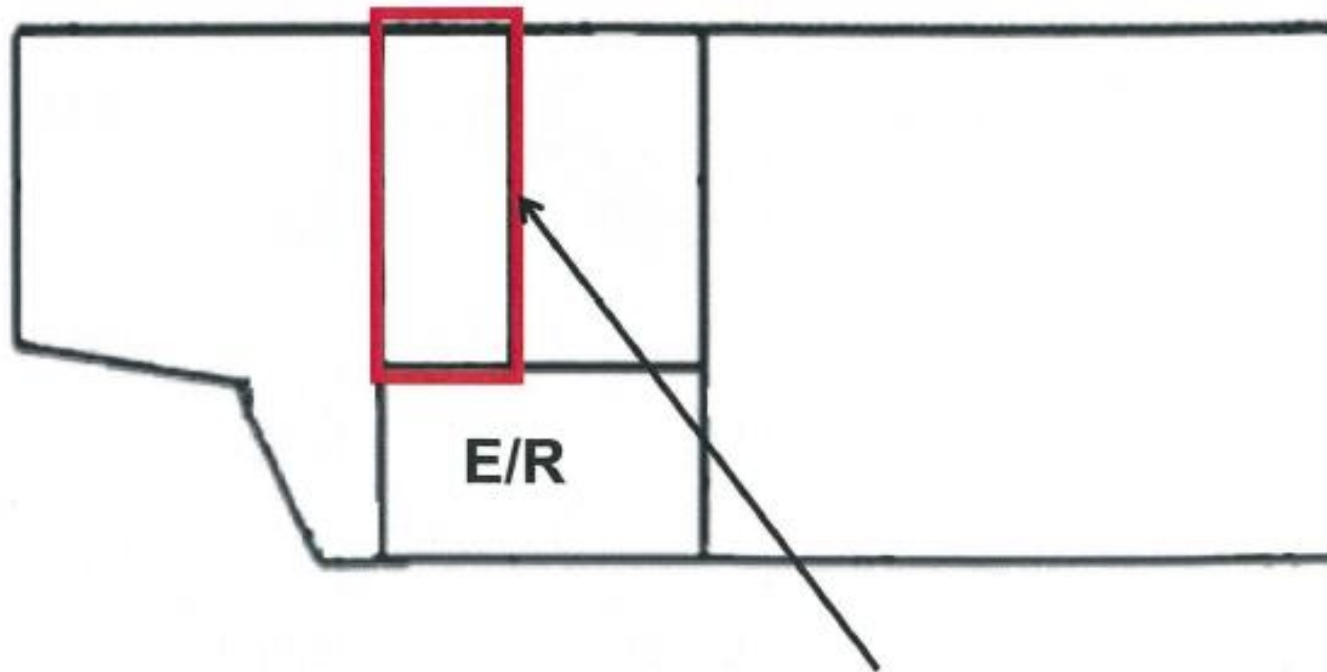
**Damaged
Compartment**

CRACK DUE TO VIBRATION IN
TRANSVERSE BULKHEAD IN FRESH
WATER TANK

**Fresh Water Tank (S)
Fore T. BHD**

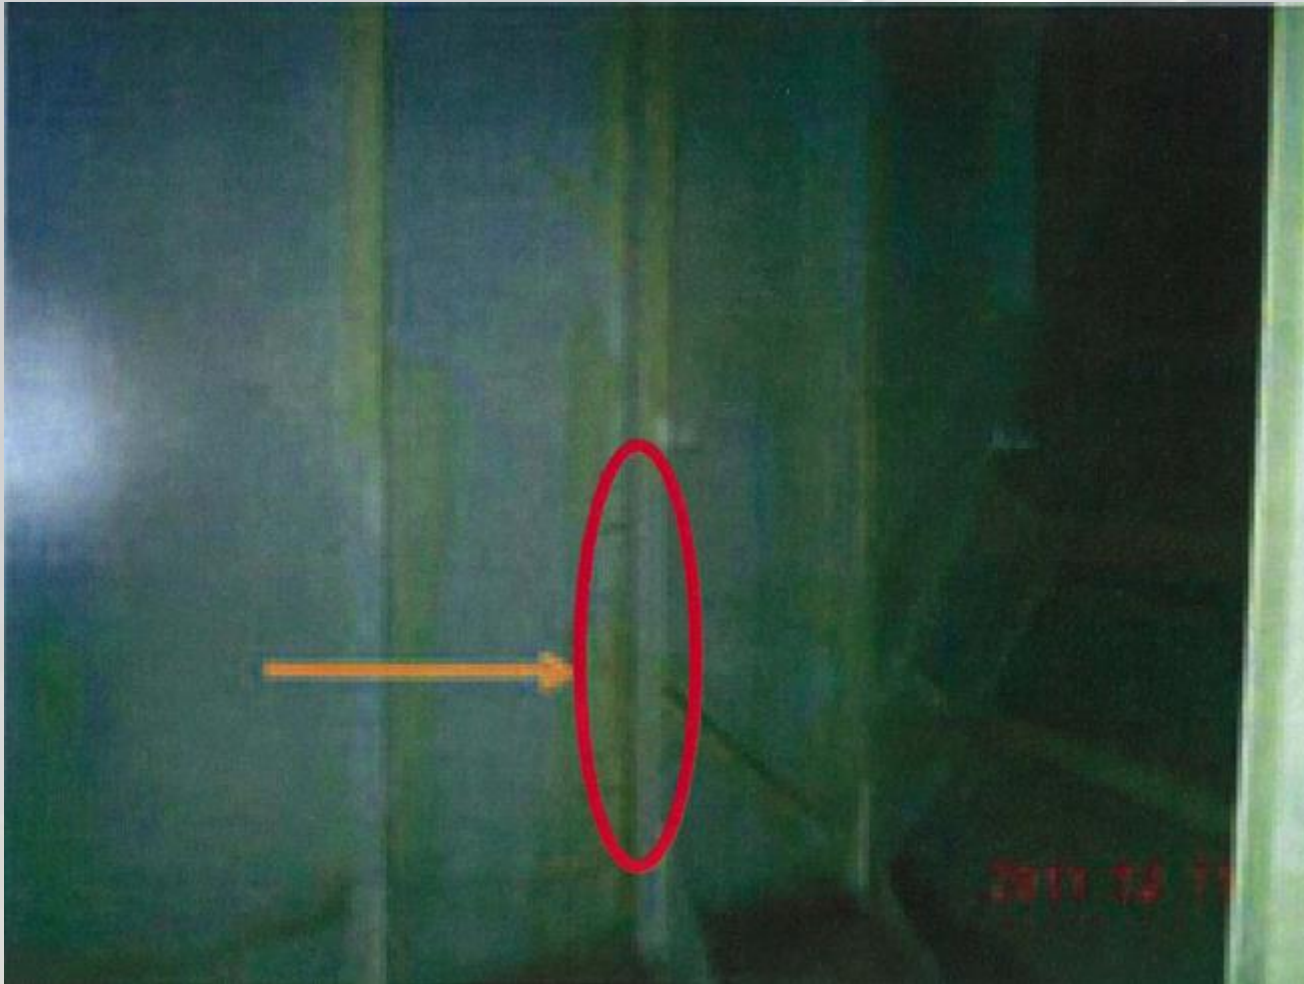
Crack in transverse bulkhead plate of Fresh Water Tank along V.Stiffener on transverse bulkhead.

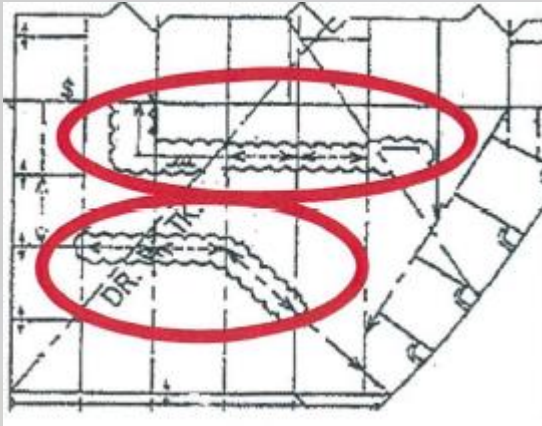
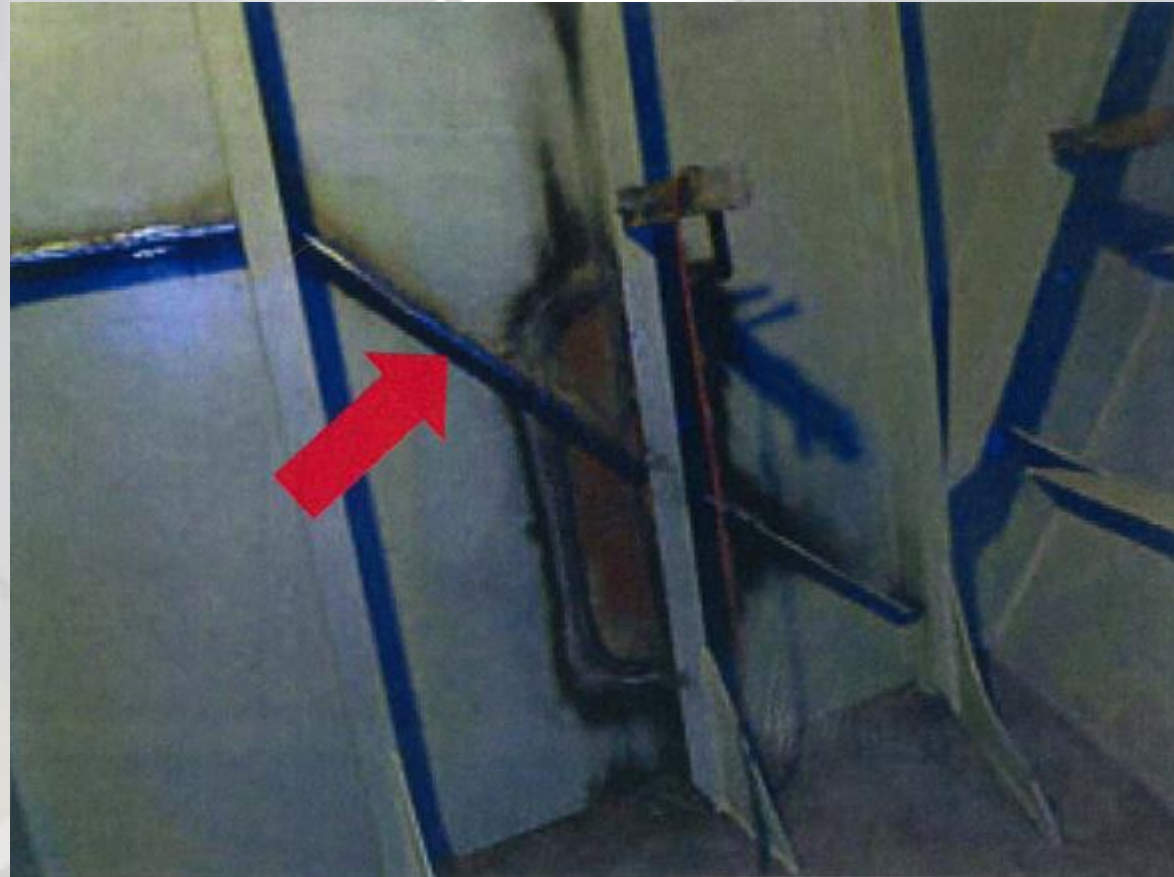
Reinforcement with a carling or stiffener is highly effective.

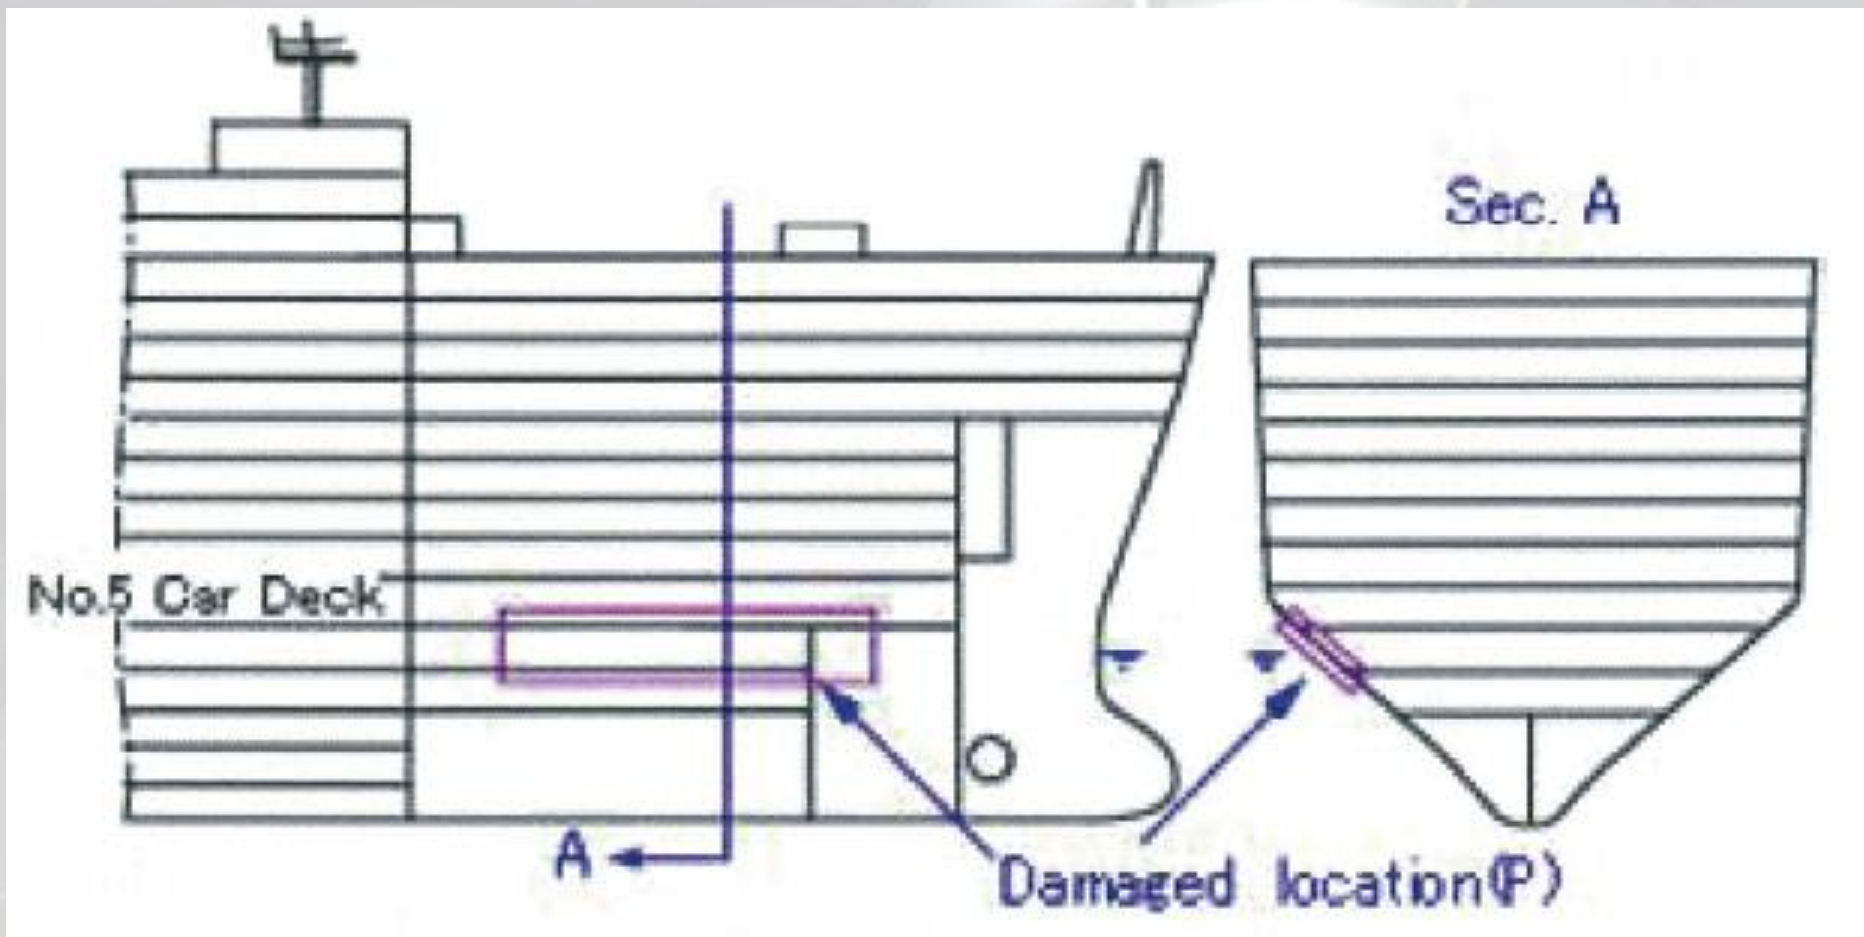
Large flare in the forward body above the deckline.

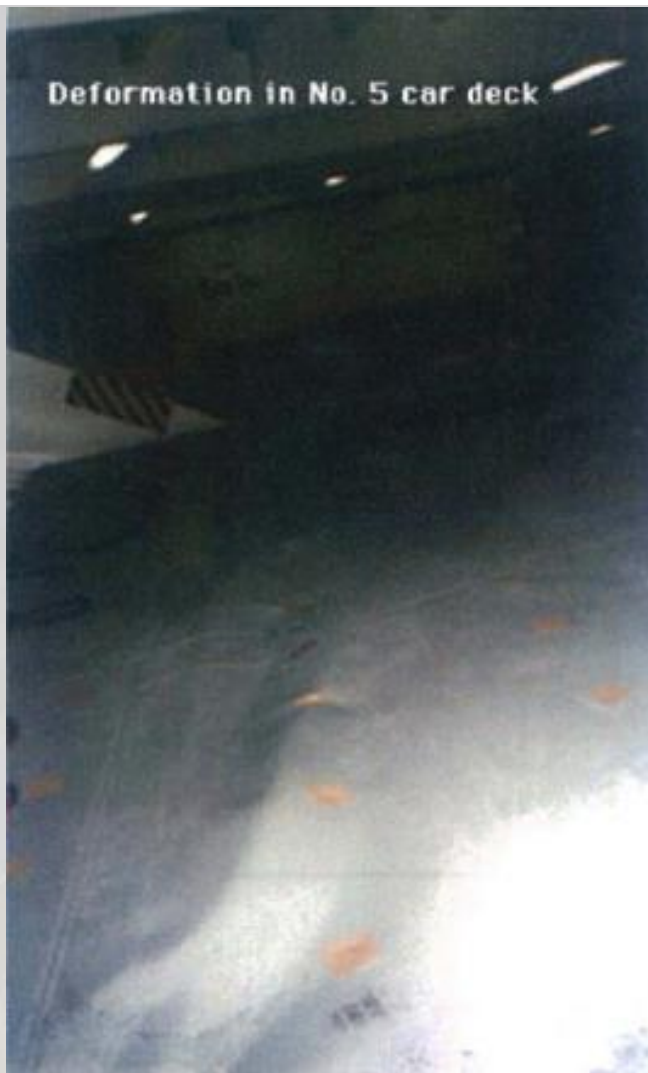
Buckled car deck

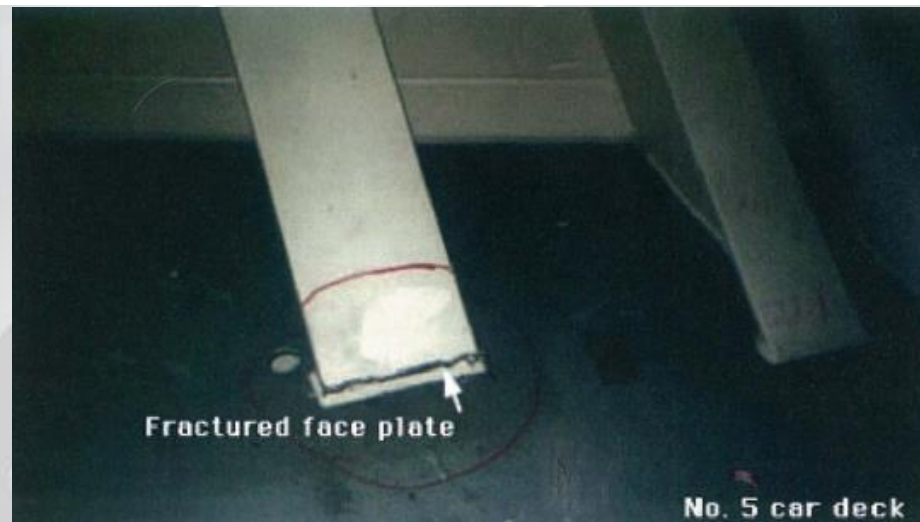
Fractured side Frame

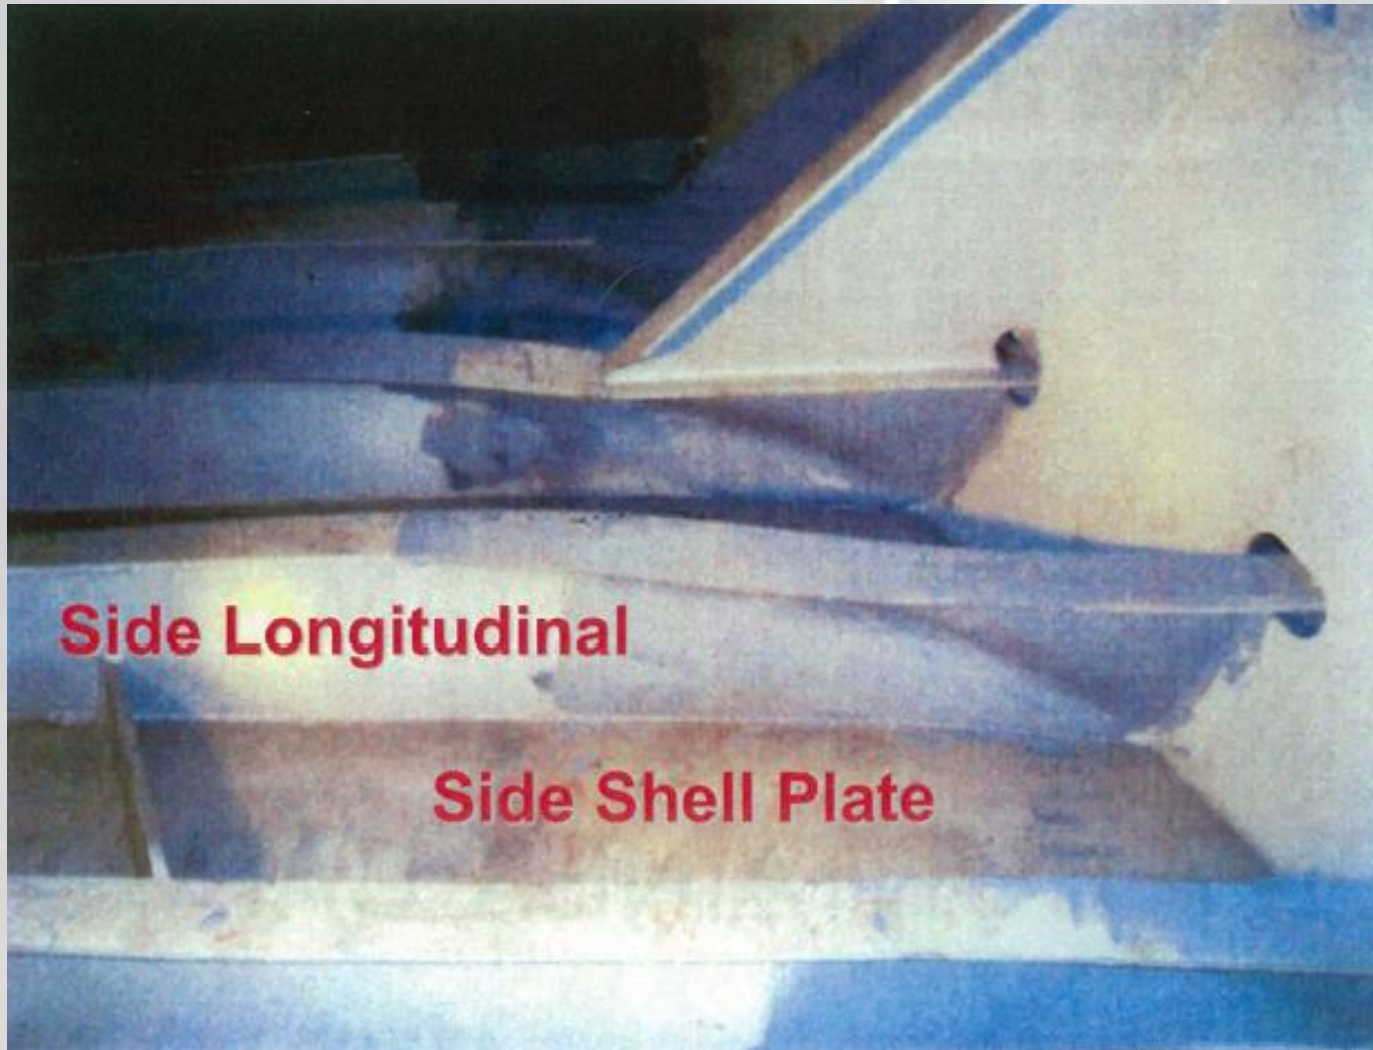
Buckling at Side Longitudinal & Side Shell Plate

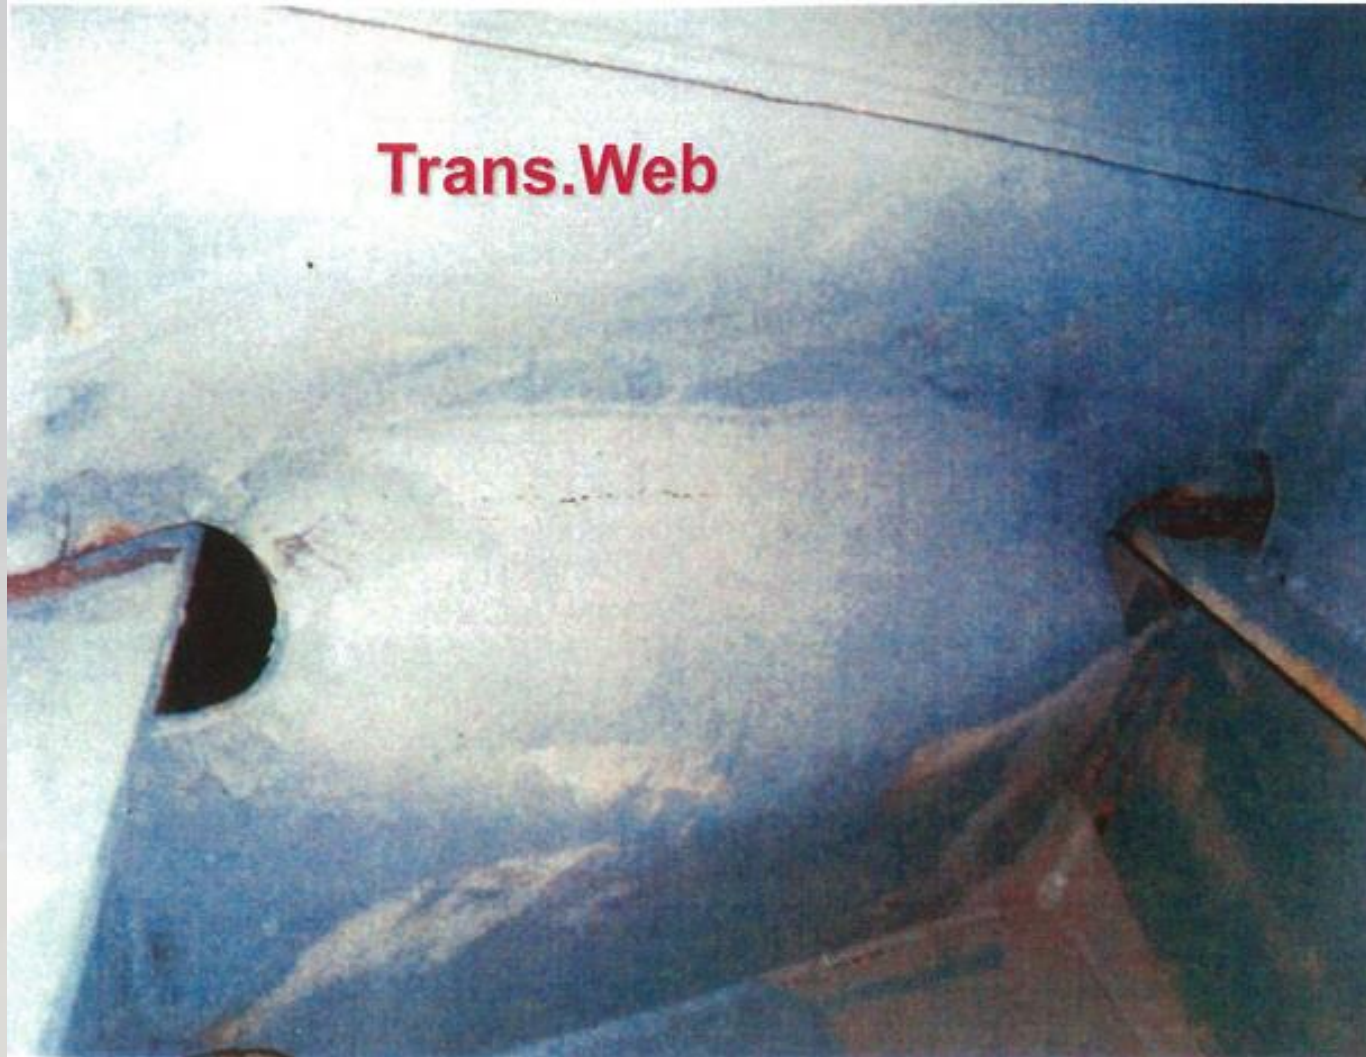
Buckling at T.Ring

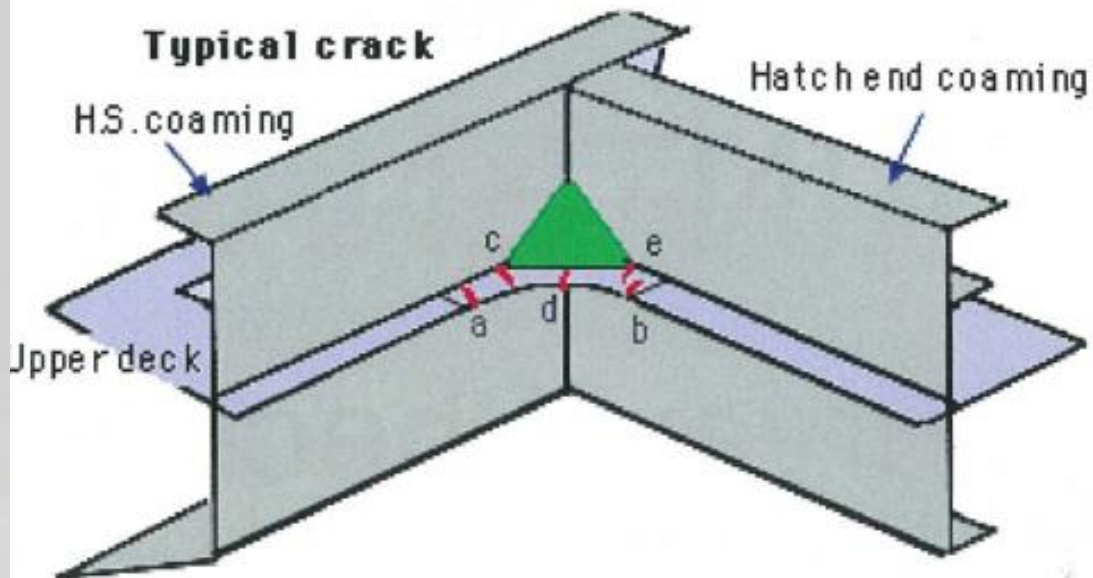
Hatch Opening Corner

Typical crack at hatch corner

- a. Crack along hatch side: due to high tensile stress
- b. Crack along hatch end: due to high torsional stress
- c. Crack at fitting on hatch corner plate
- d. Crack or notch due to corrosion/wastage or rubbing of wire
- e. Crack due to welding defect

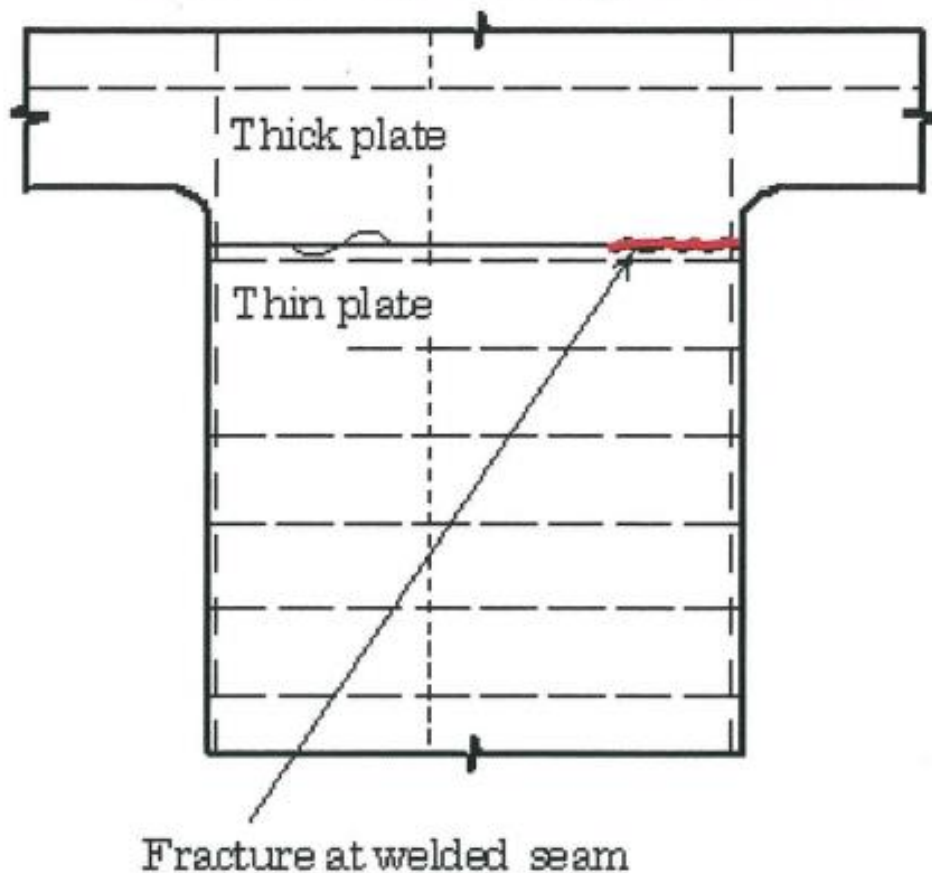
Hatch Opening Corner

Special attention should be given to deck openings; the corners of cargo hatch in particular.

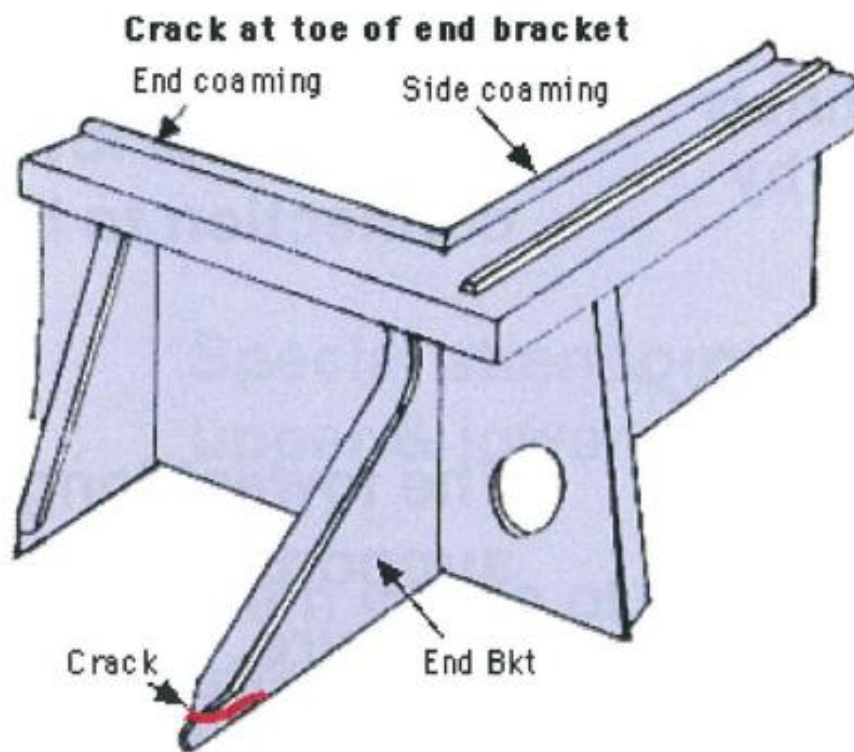
Hatch Side Coaming end bracket

Special attention should be also given to the toe of end bracket of the hatch side coaming. Cracks in the end bracket may lead to more serious damage such as fracture of the deck structure.

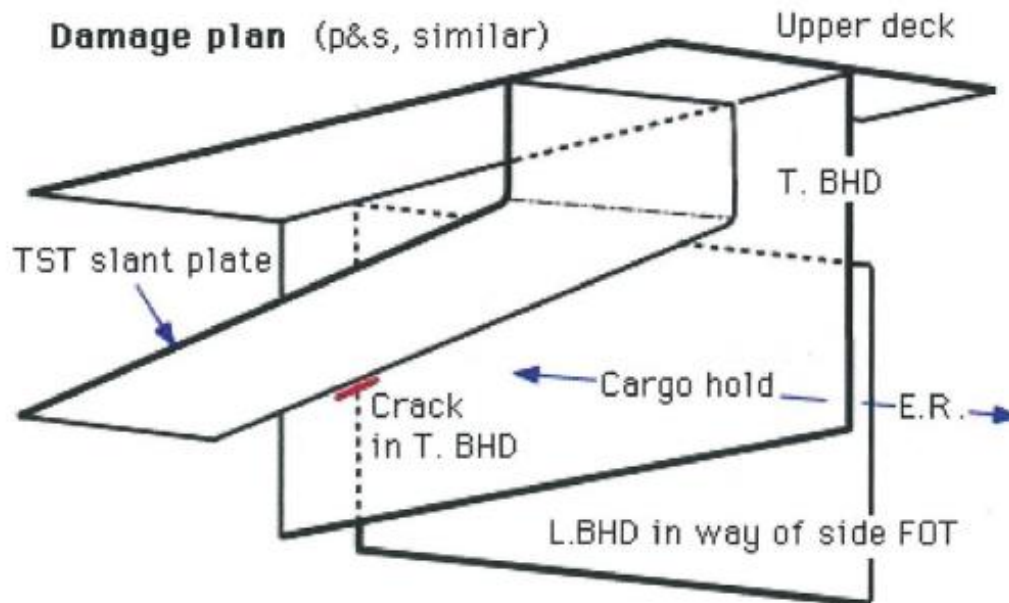
Slant Plate of Top Side Tank

Special attention should be given to the slant plate of top side tank where it connects to the Coll. BHD and E/R Fwd BHD.

The above connections may crack due to the discontinuous structure

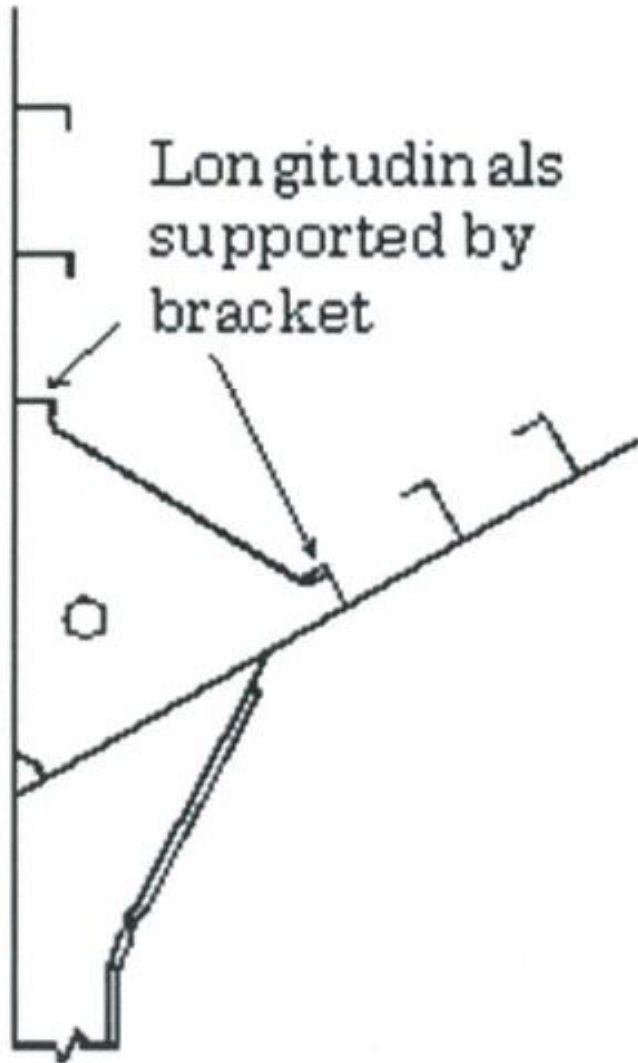
Lowest Longitudinal in TST

Special attention should be given to the lowest longl. at the connection to the trans.web.

The lowest longl. is usually supported by a bracket as shown in figure, therefore a smaller scantling may be adopted.

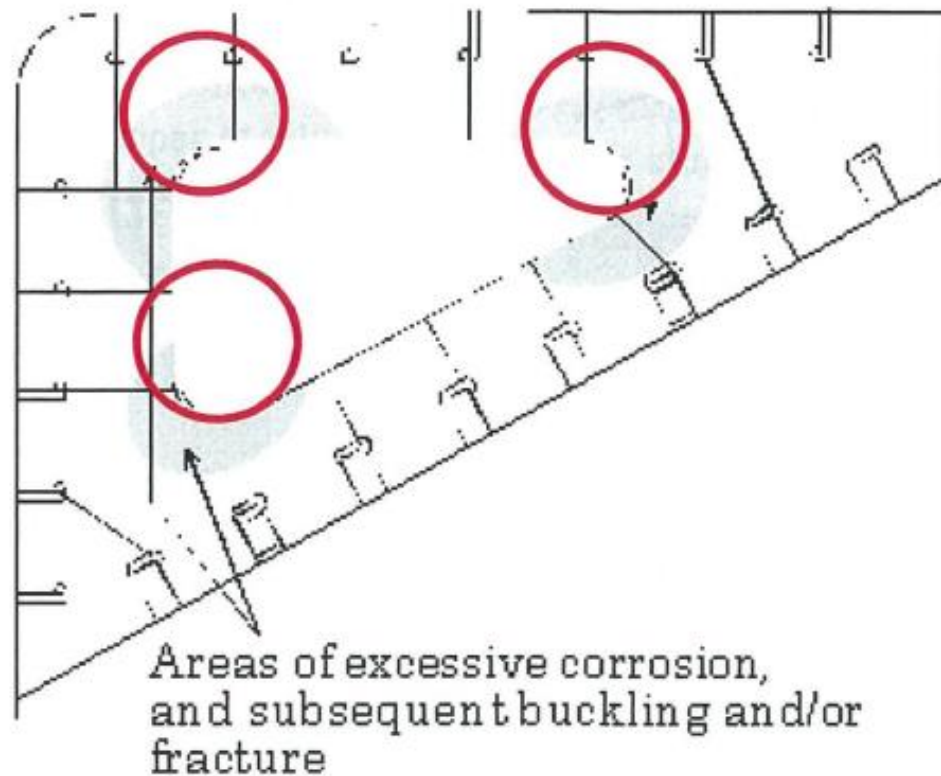
Corner of T.Ring

Special attention should be given to the corner of T.Ring. One possible cause of damage is stress concentration at corner.

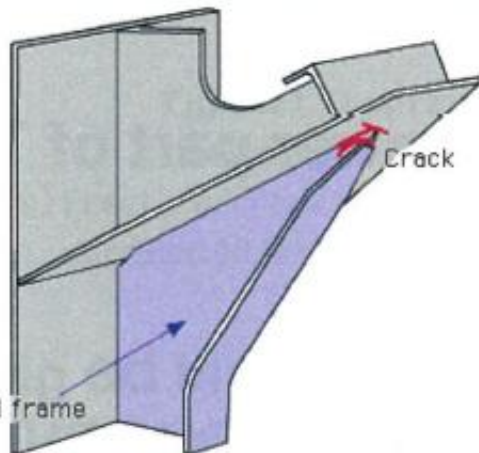
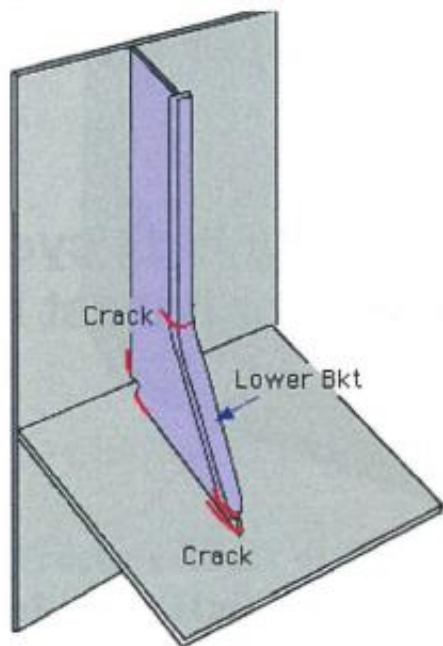
**Upper & Lower toe of Hold Frame
Upper Bracket**

**Special attention should be given to
upper & lower end of hold frame.**

**Main cause of probable damage is
stress concentration of load from sea
wave**

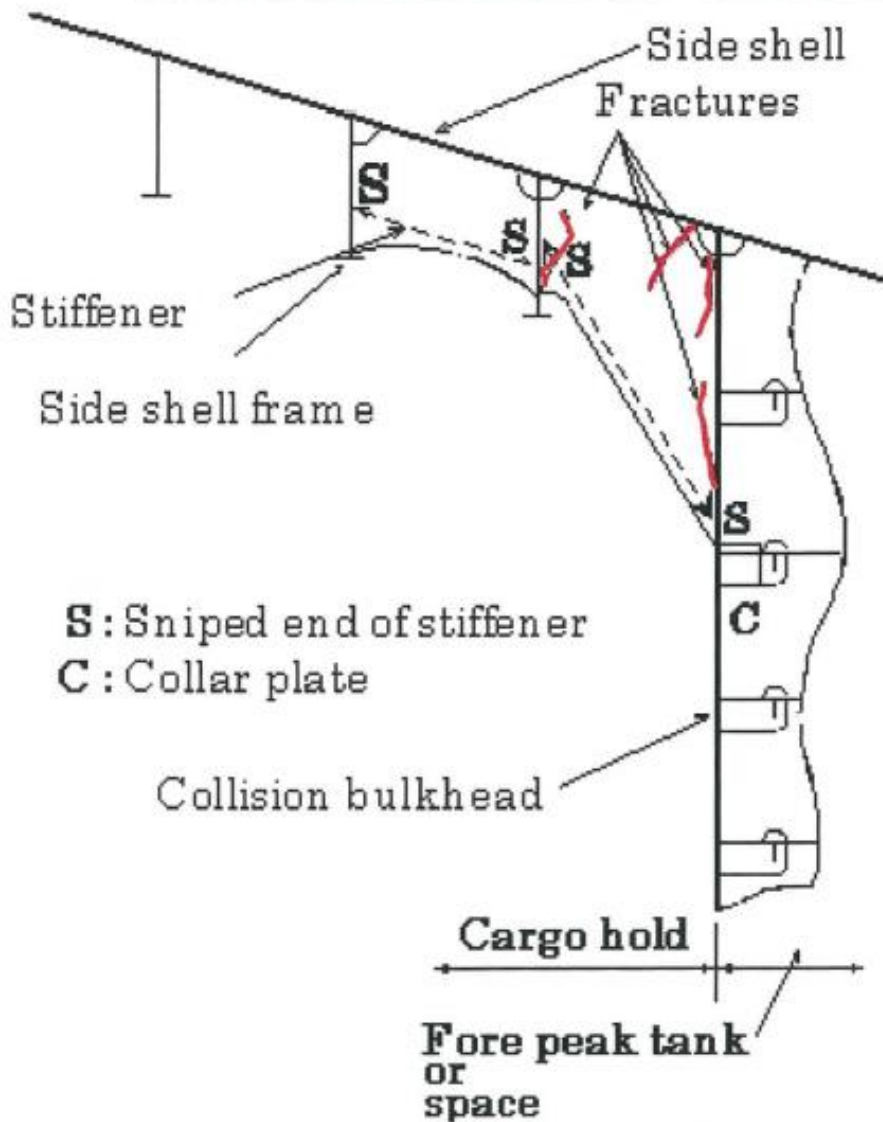
Connection to Coll.BHD

Special attention should be given to the bracket at the connection to Coll.BHD of FPT.

Supporting bracket may be cracked due to discontinuous structure.

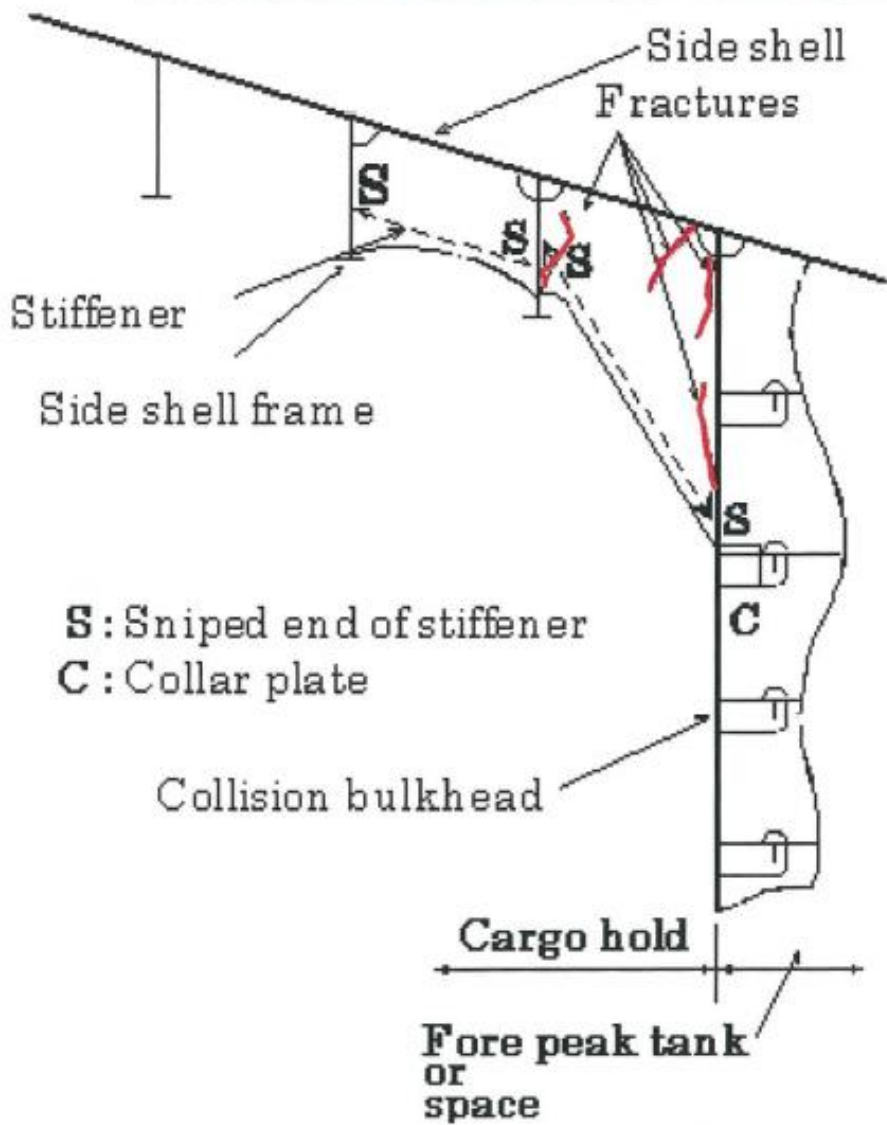
Connection to Coll.BHD

Special attention should be given to the bracket at the connection to Coll.BHD of FPT.

Supporting bracket may be cracked due to discontinuous structure.

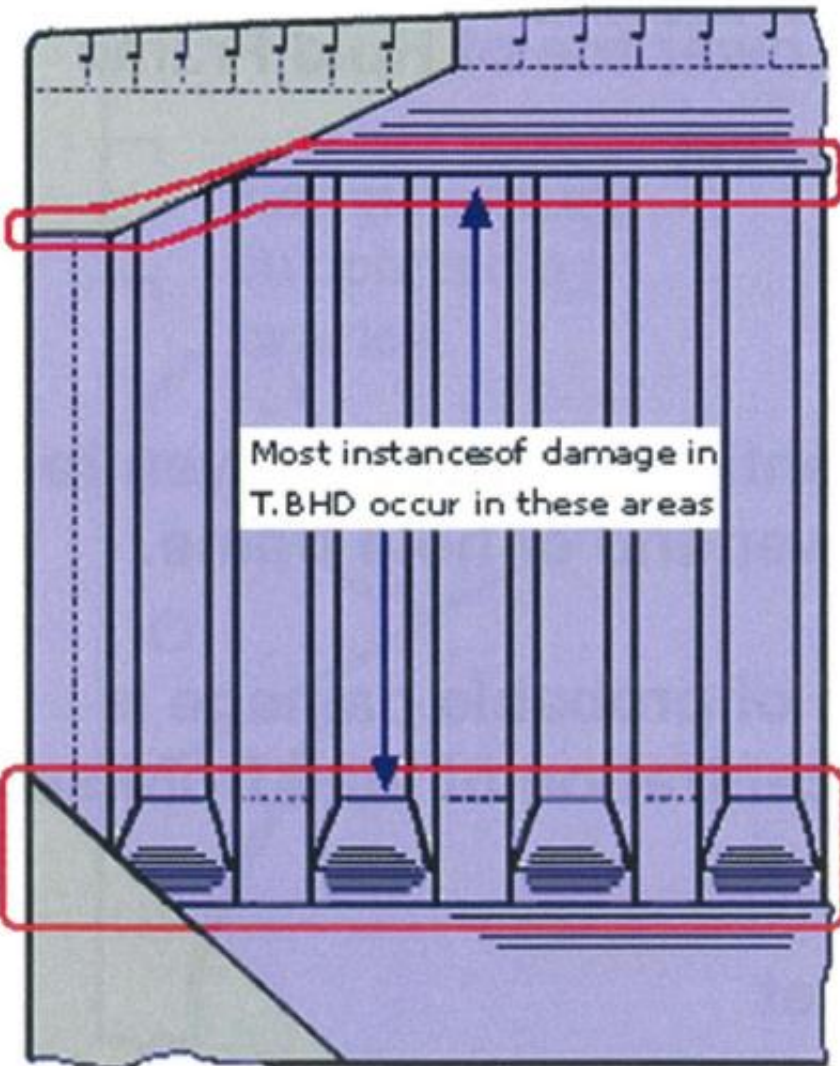
Upper & Lower part of T.BHD

Special attention should be given to the upper & lower part of T.BHD at the connection to the upper stool and lower stool.

Cracks are caused by high cyclic stress due to cargo or ballast in cargo hold.
