ICS Class

2A: Hull Structure

In compliance with the IMO resolution MSC.349(92) and MEPC.237(65), RO Code, Appendix 2.

MODULE 2A-Hull Structure (Content)

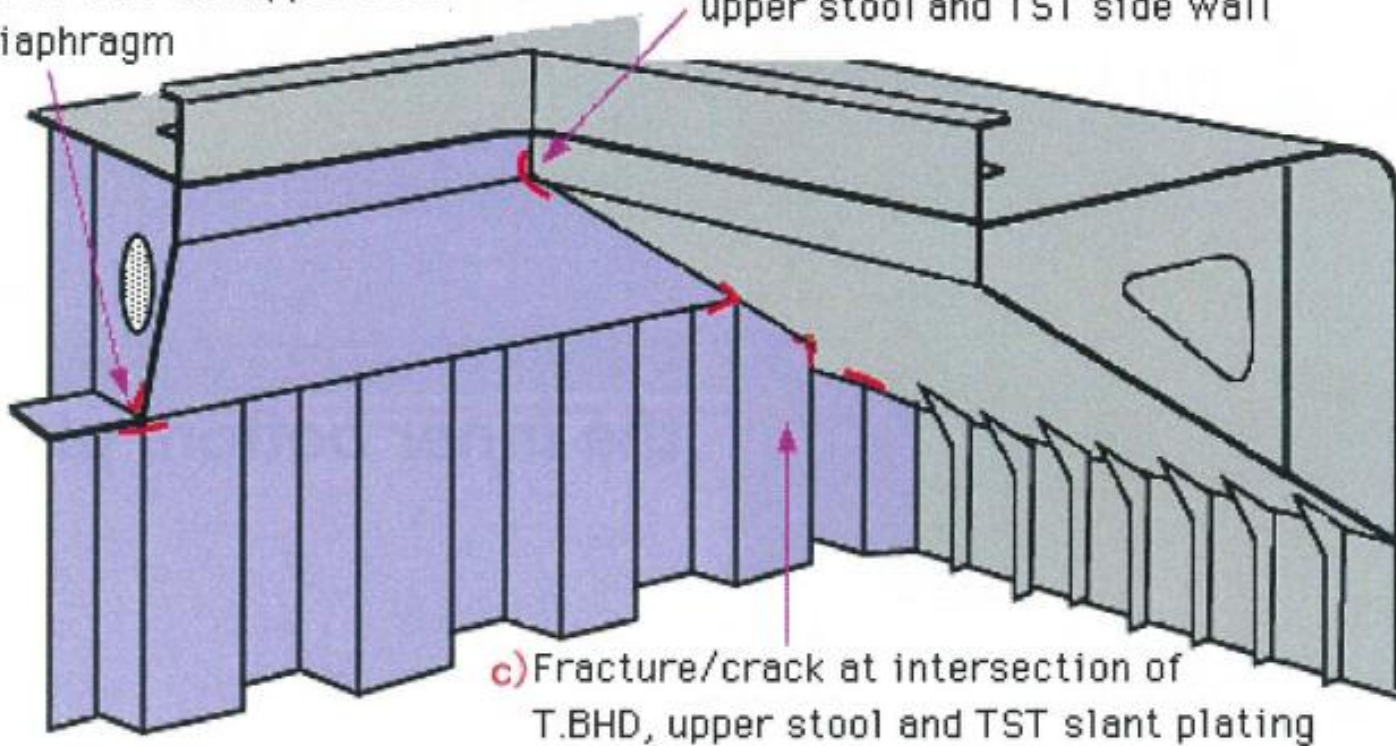
Typical fracture/crack in upper area of T.BHD
(including intersection of upper stool and TST)

b) Fracture/crack at intersection
of T. BHD and upper stool
diaphragm

a) Fracture/crack at intersection of
upper stool and TST side wall

c) Fracture/crack at intersection of
T.BHD, upper stool and TST slant plating

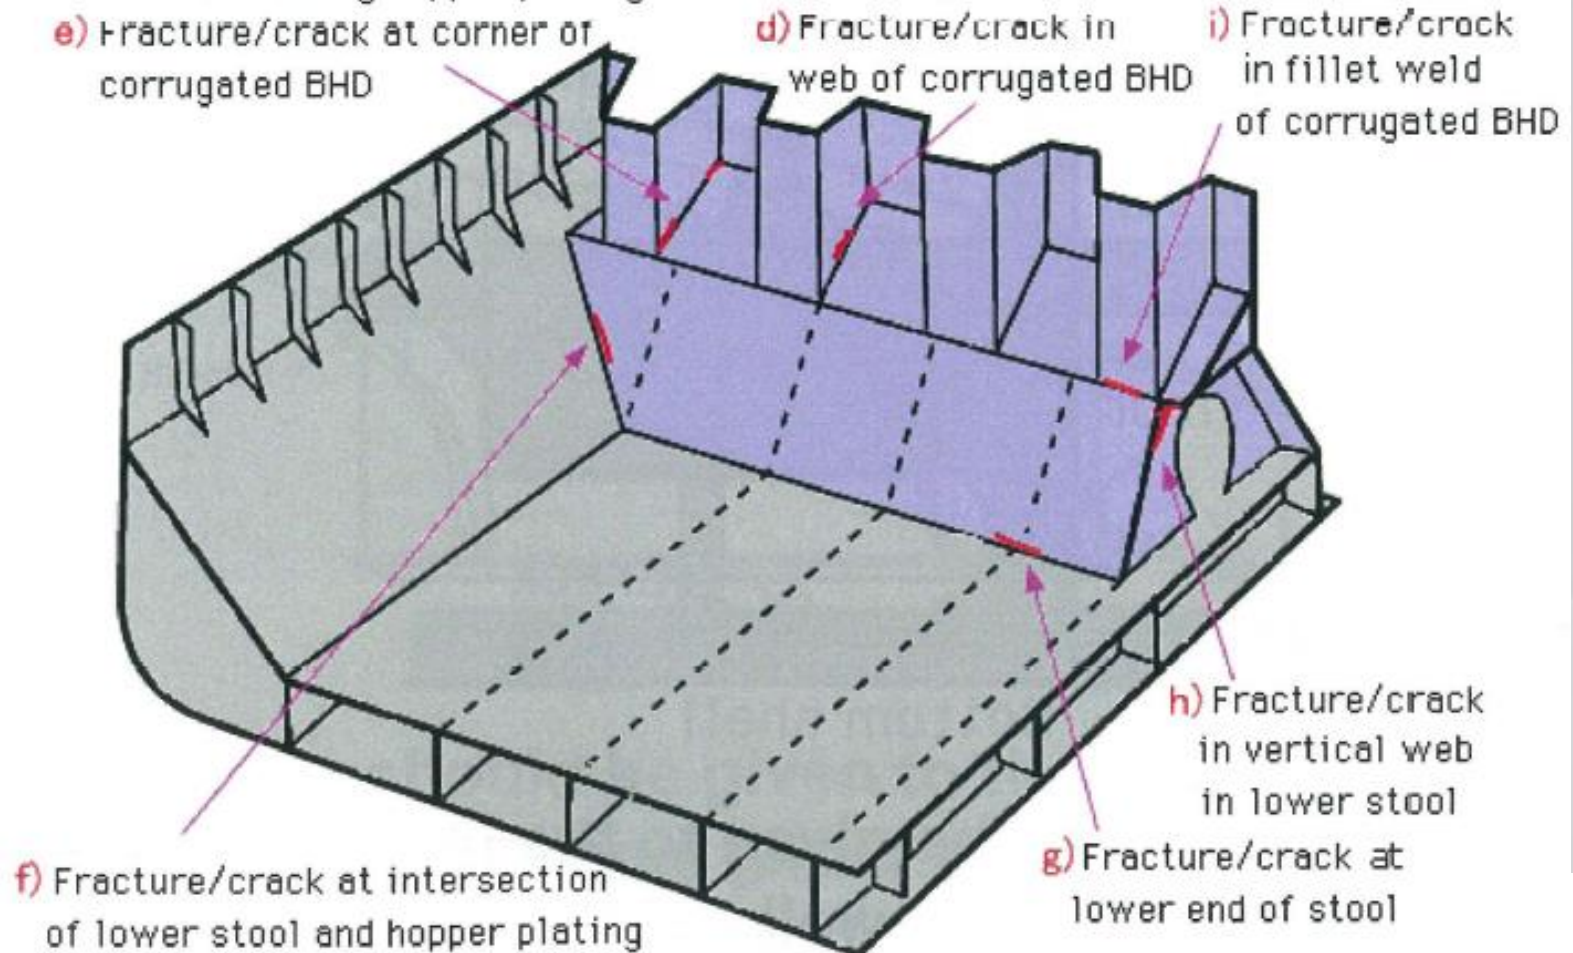
Typical fracture/crack in lower area of T.BHD

(including hopper plating and lower stool)

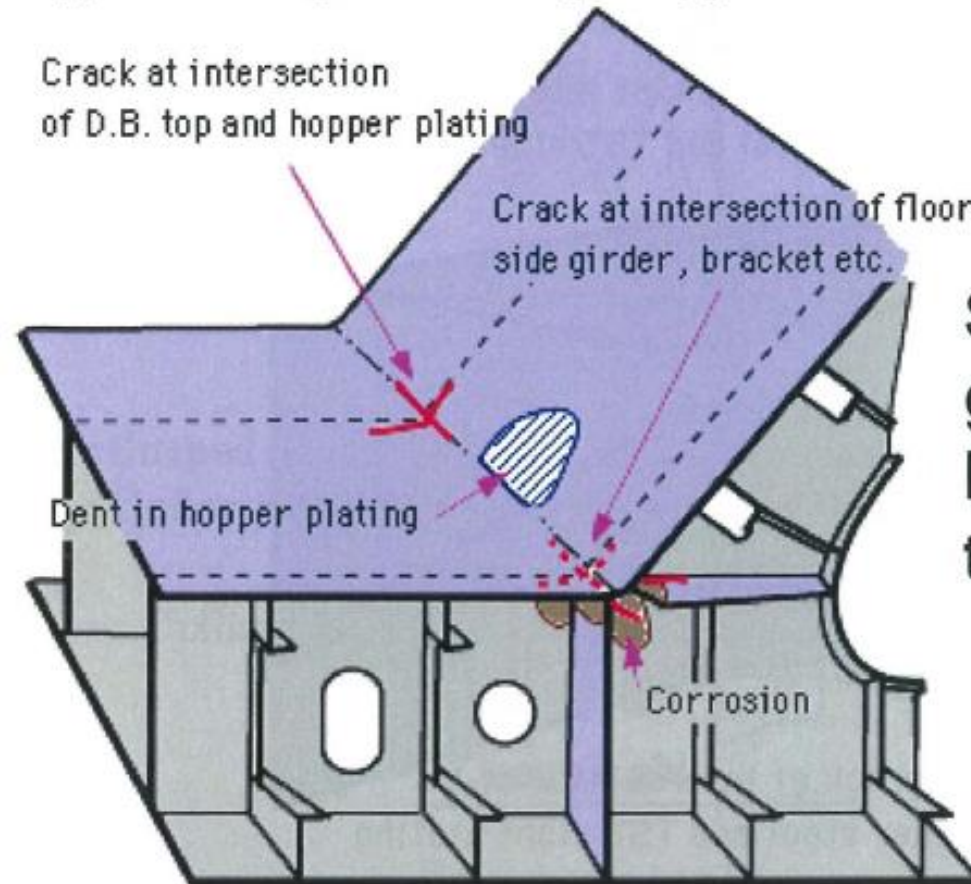
Hopper Plate of Bilge Hopper Tank

Typical damage to the bilge hopper structure

Crack at intersection
of D.B. top and hopper plating

Crack at intersection of floor,
side girder, bracket etc.

Special attention should be given to the connection between the hopper plate and the inner bottom plate.

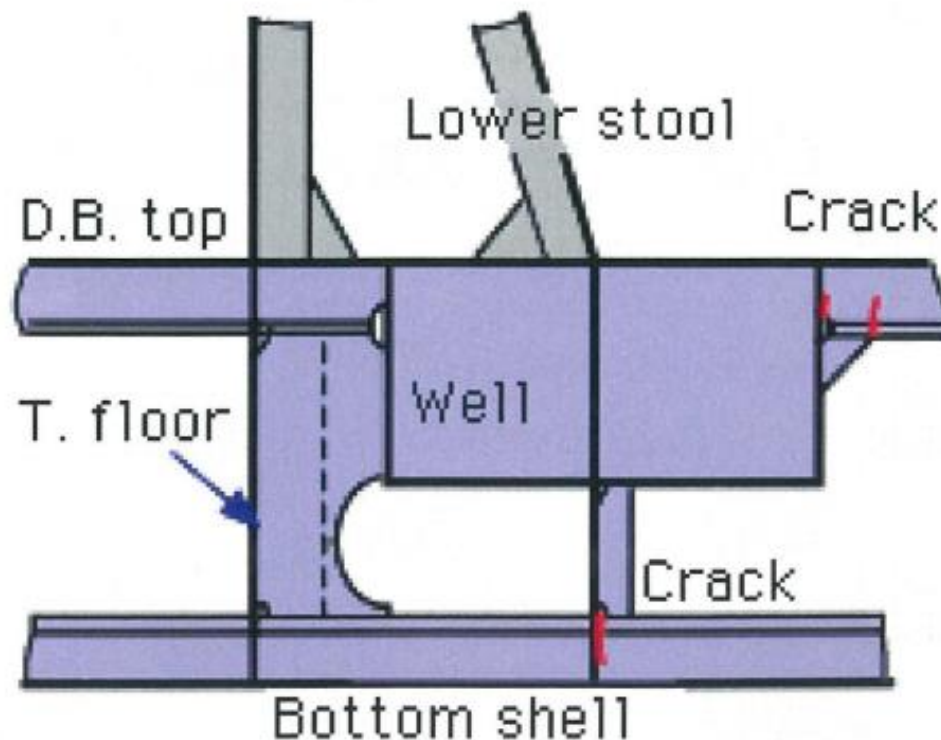
Inner bottom longl. & bottom longl.

Special attention should be given to the inner bottom longl. & bottom longl. near the bilge well.

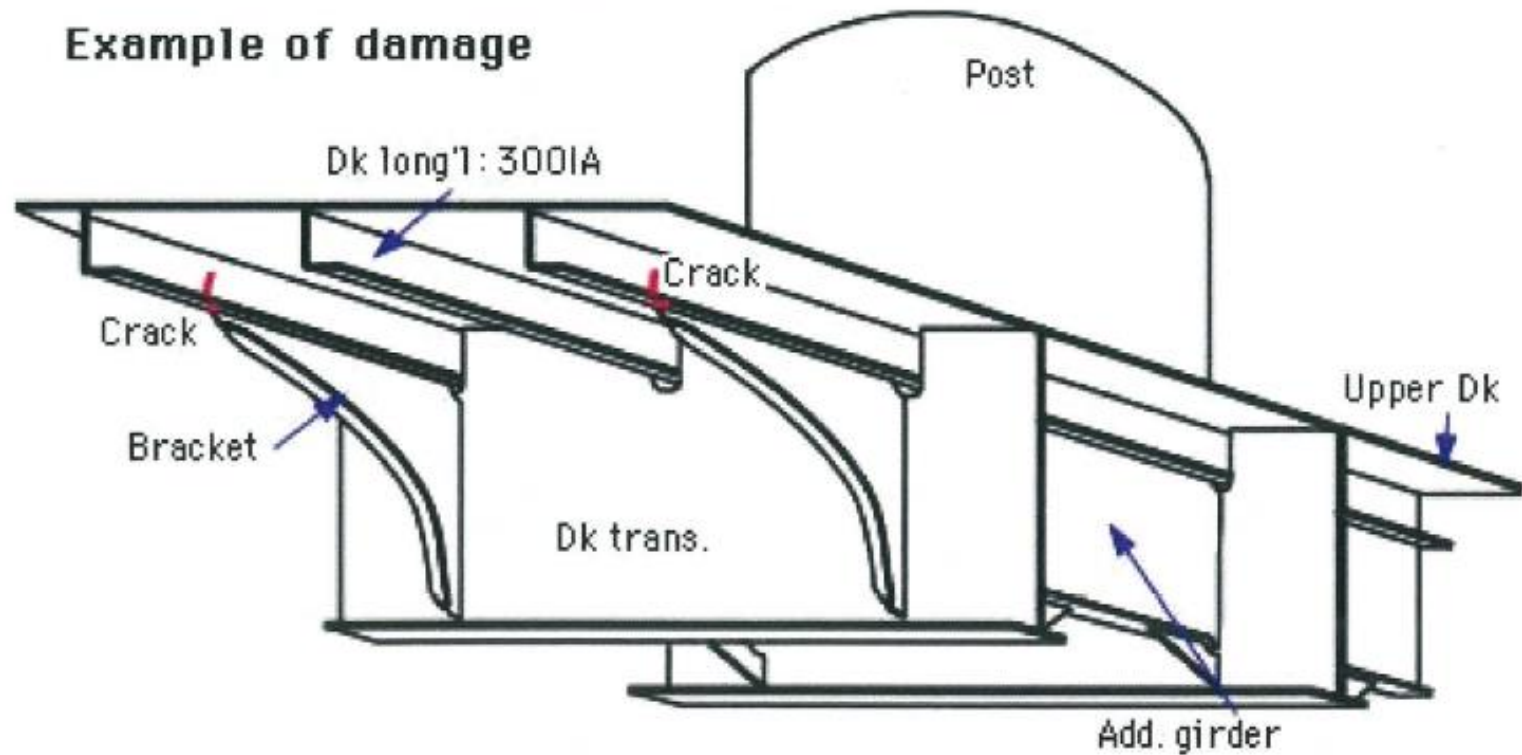
Deck Longitudinal

Example of damage

Special attention should be given to the deck longl. at the connection to the additional girder under the deck machinery.

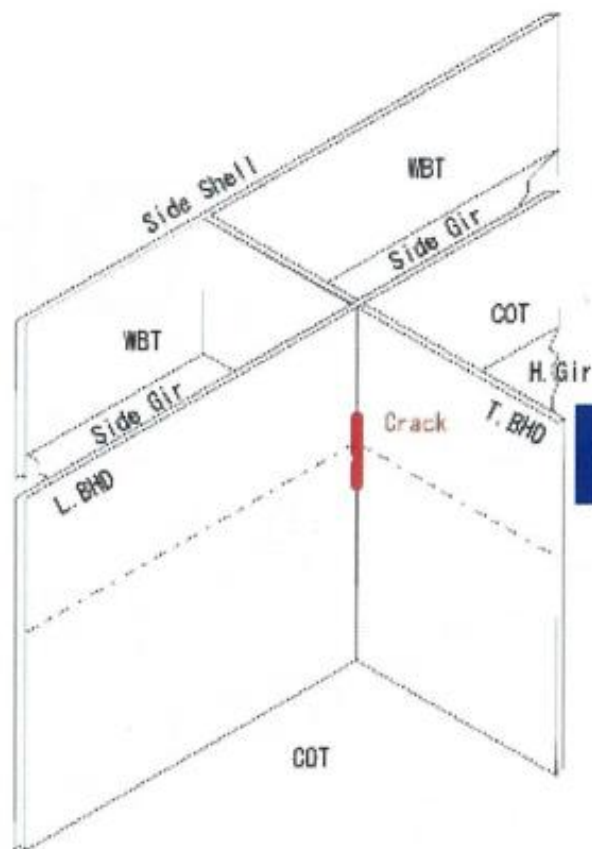
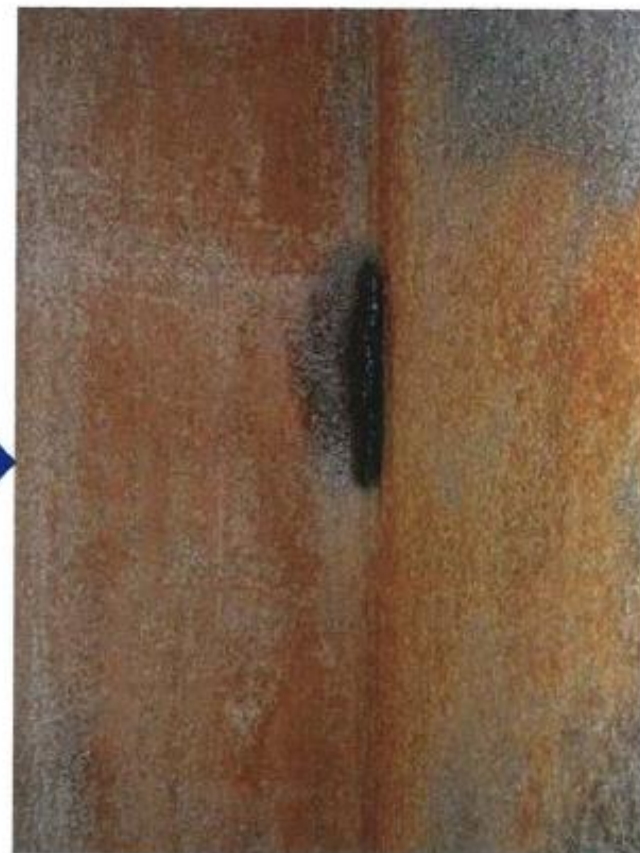
~ T.BHD in Cargo Tank ~ Connection between T.BHD and L.BHD

Special attention should be given to the connection between T.BHD and outside L.BHD at the horizontal girder level.

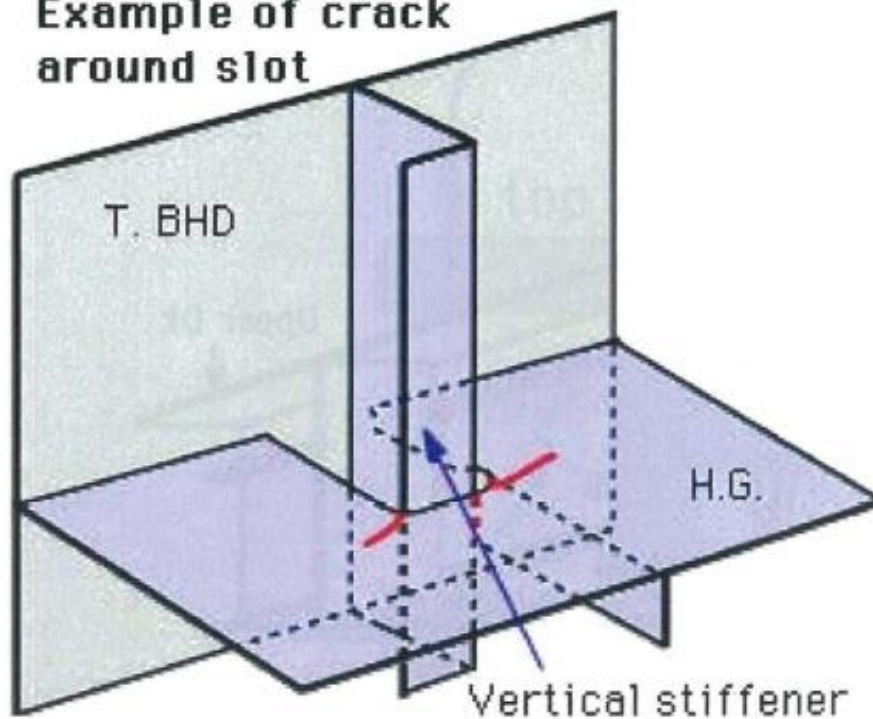
Horizontal Girder Slots

Example of crack around slot

Special attention should be given to the slot on horizontal girders for vertical stiffener penetration.

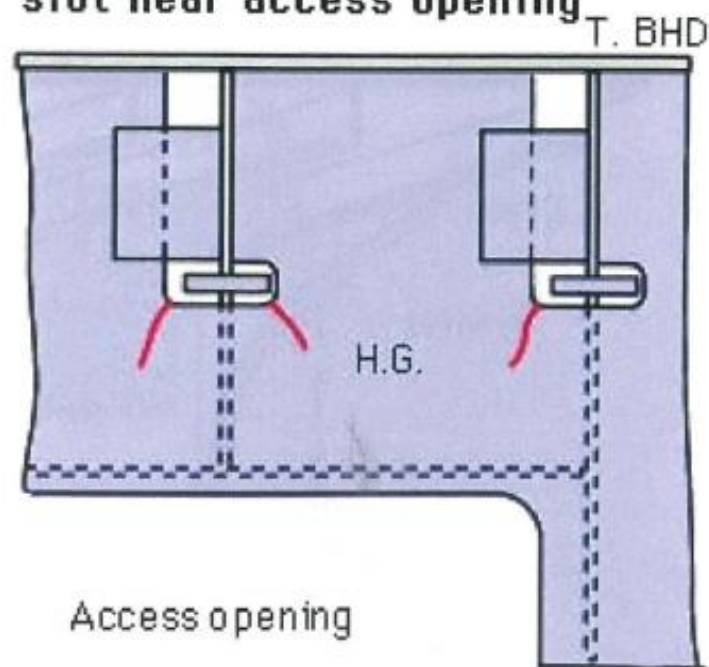
Example of crack around slot near access opening

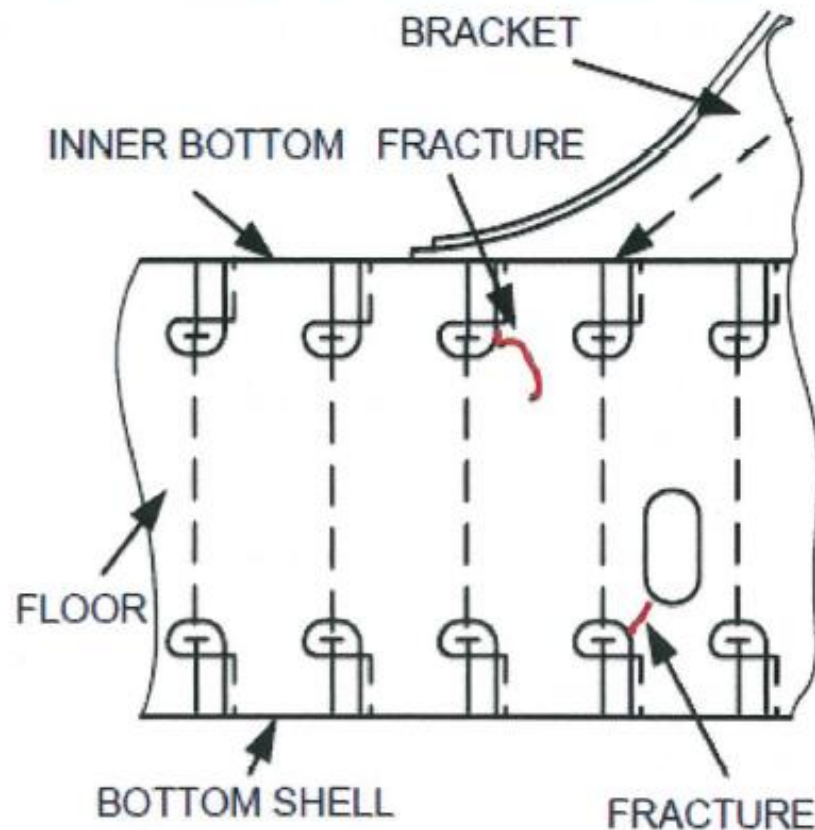
Floor of the Double Bottom Tank

Special attention should be given slot of Floor under Bracket associated to L.BHD.

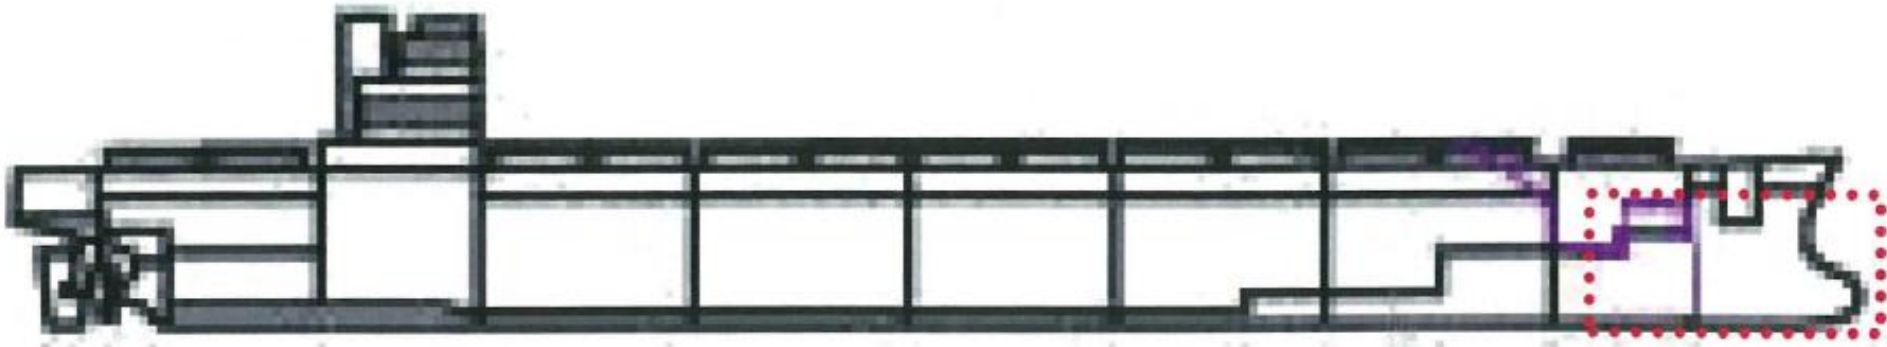
Shell Plates with internal structural members

Special attention should be given to buckling damage at the shell plate internal structural members due to bow flare slamming damage.

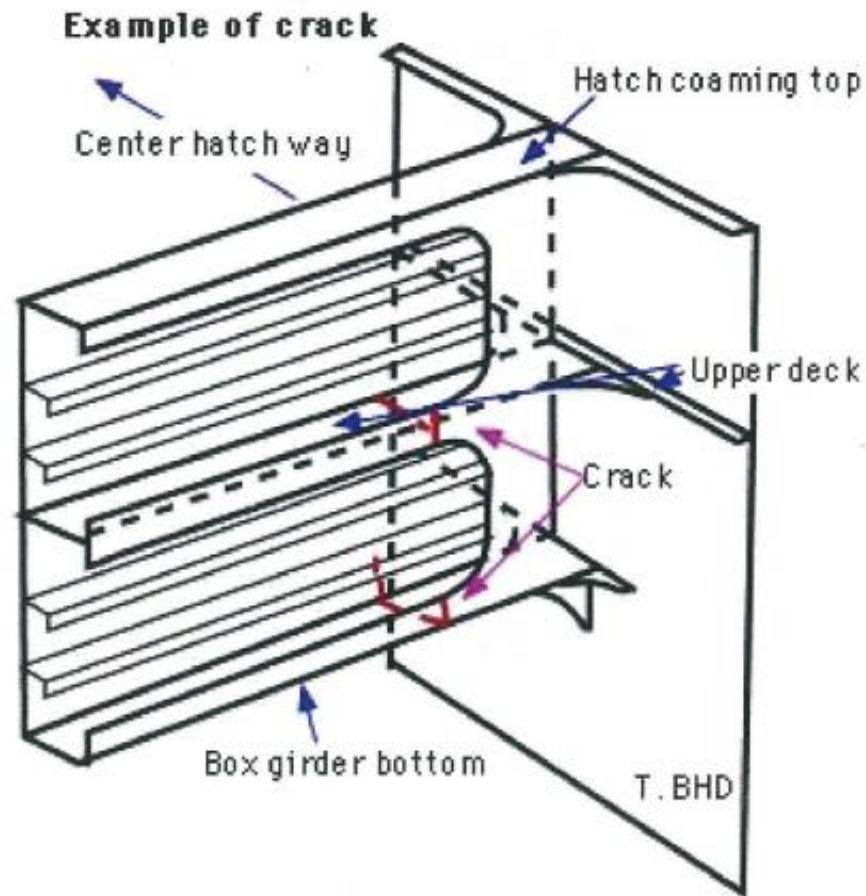
~ Deck Area ~ **Deck Box Girder**

Special attention should be given to the deck box girder.

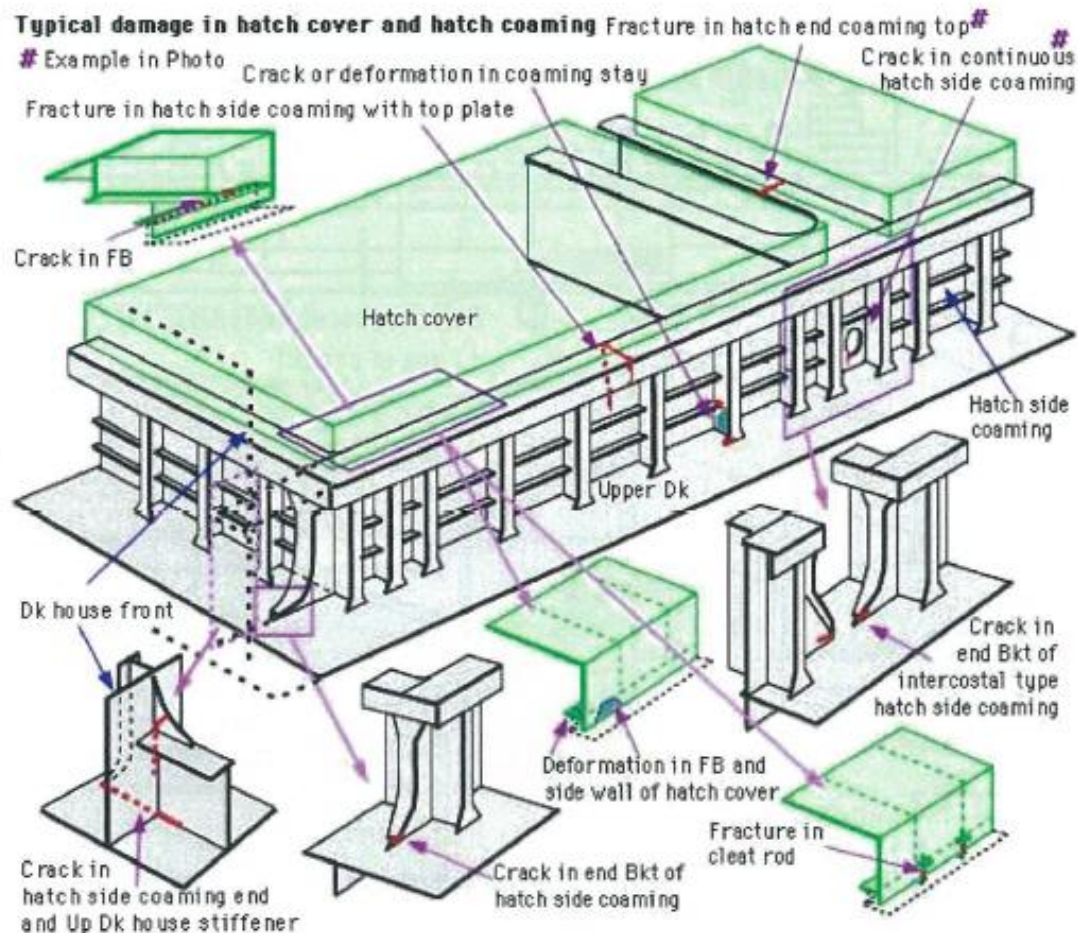
Special attention should be given to hard spots of hatch covers and hatch coamings

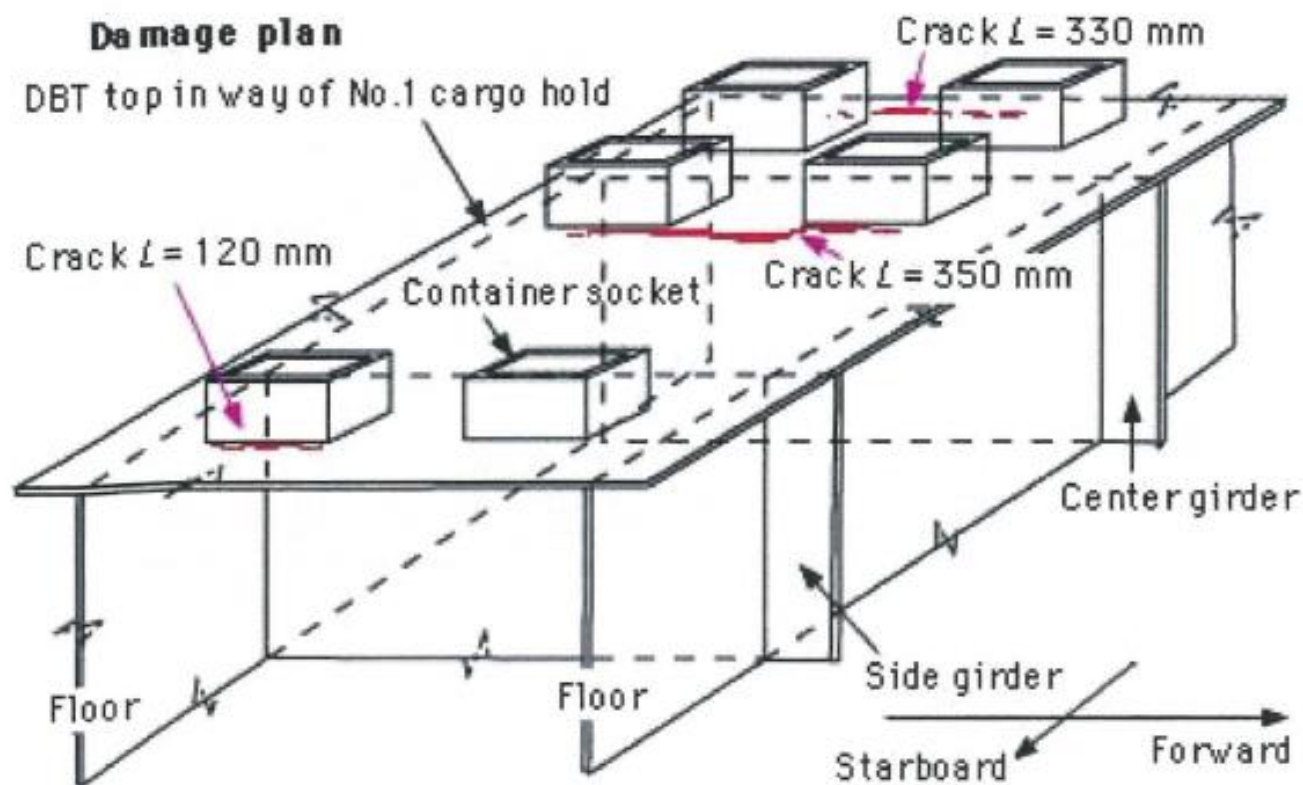
Area Around Container Socket on Inner Bottom Plate

Special attention should be given to the inner bottom plate around the container sockets

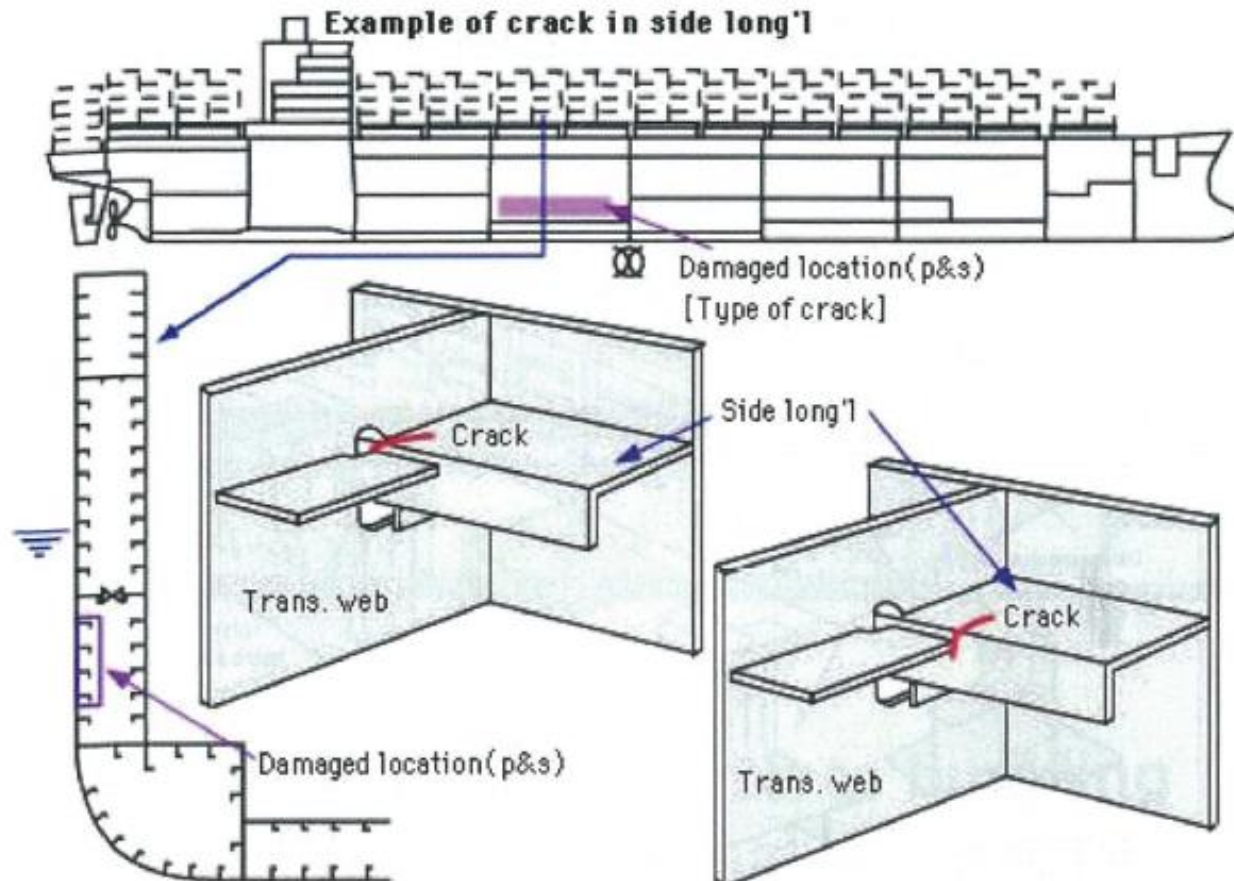
Side Longl. in Side WBT

Special attention should be given to the side longl. in the side WBT of container carriers.

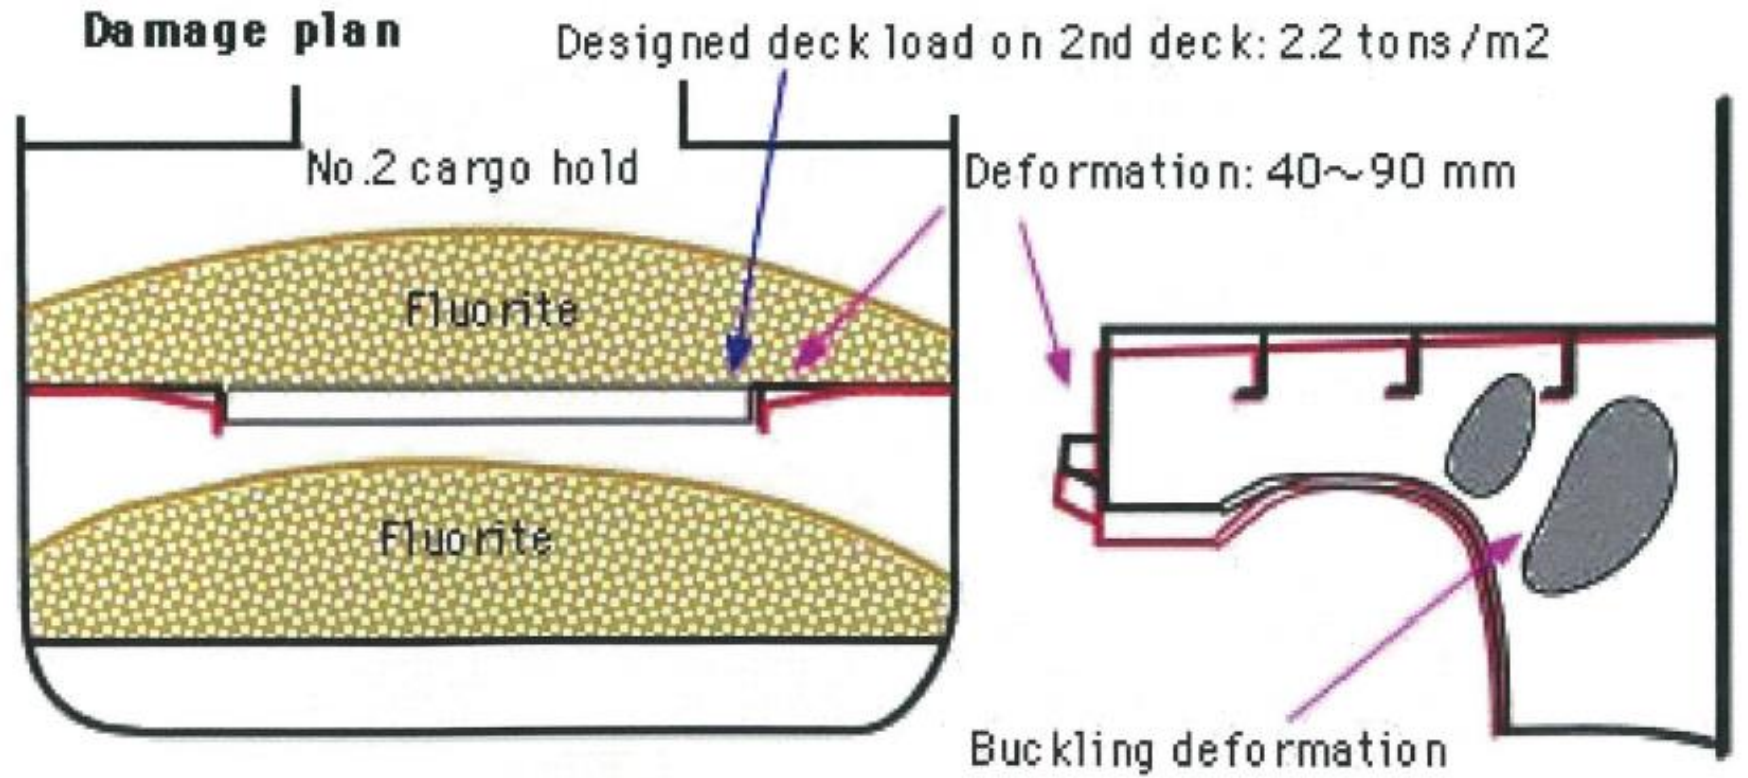
2nd Deck in Cargo Hold

Special attention should be given to 2nd deck of cargo holds.

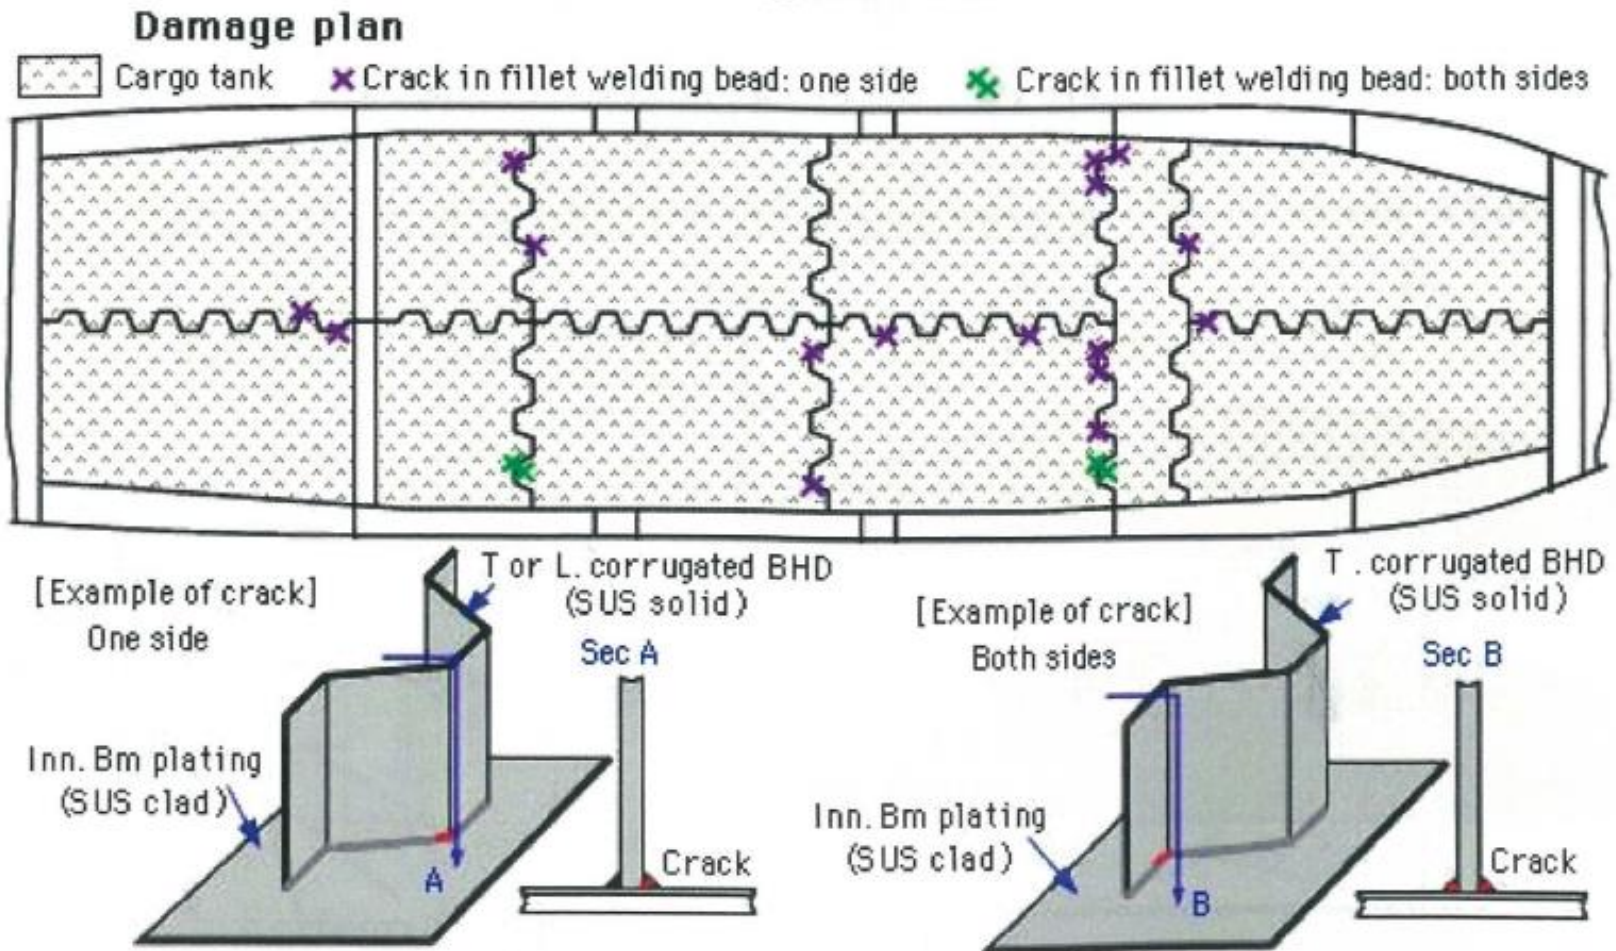
Special attention should be given to the connection between the Corr.BHD and the inner bottom plates.

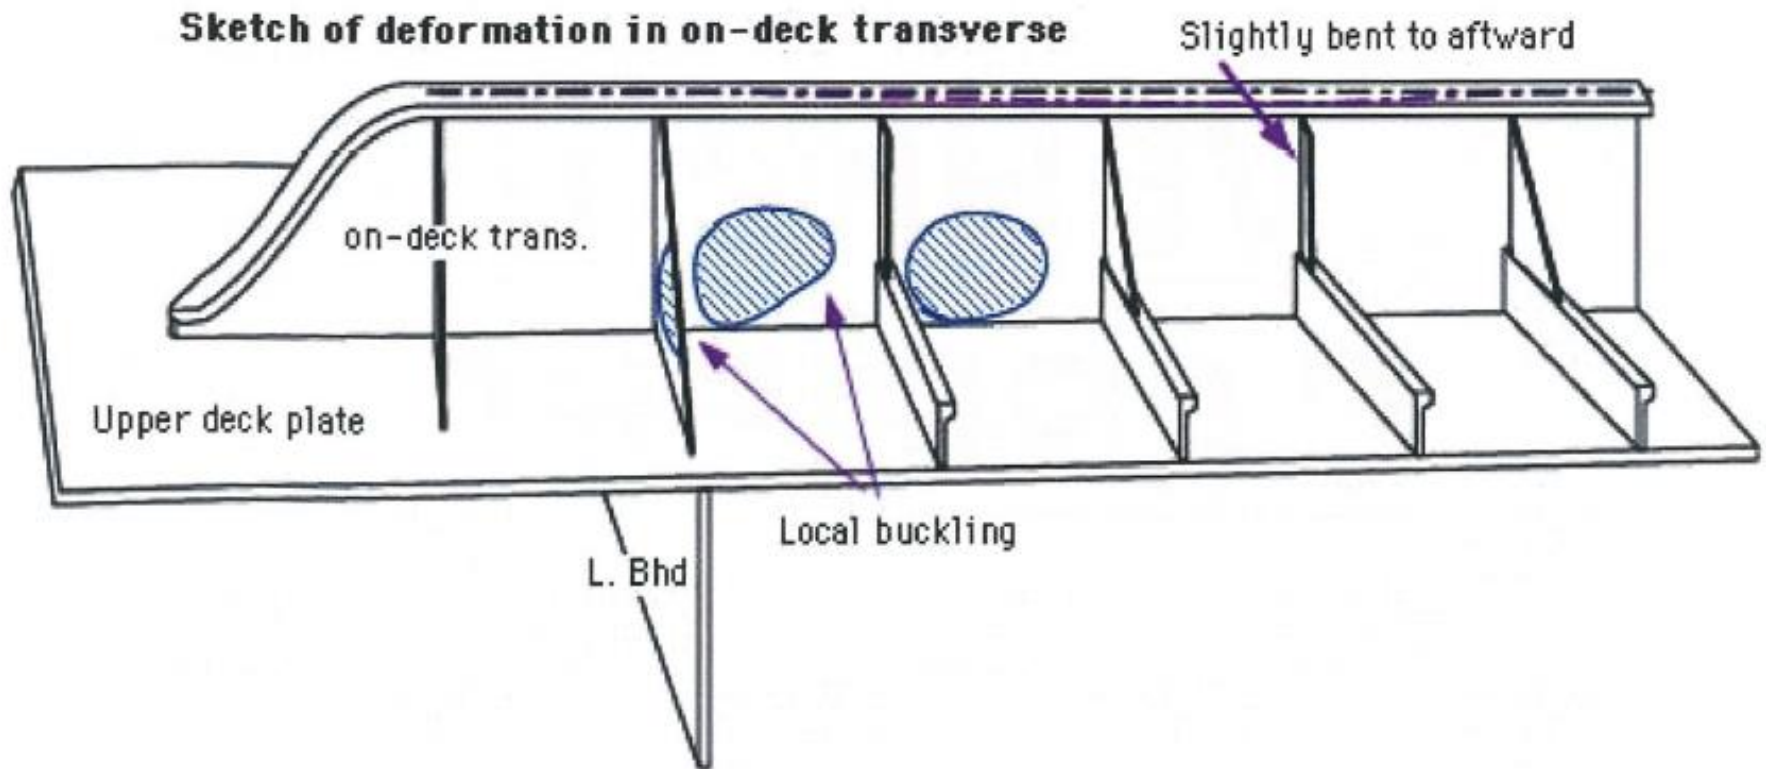
Special attention should be given to buckling in On-Deck Trans.

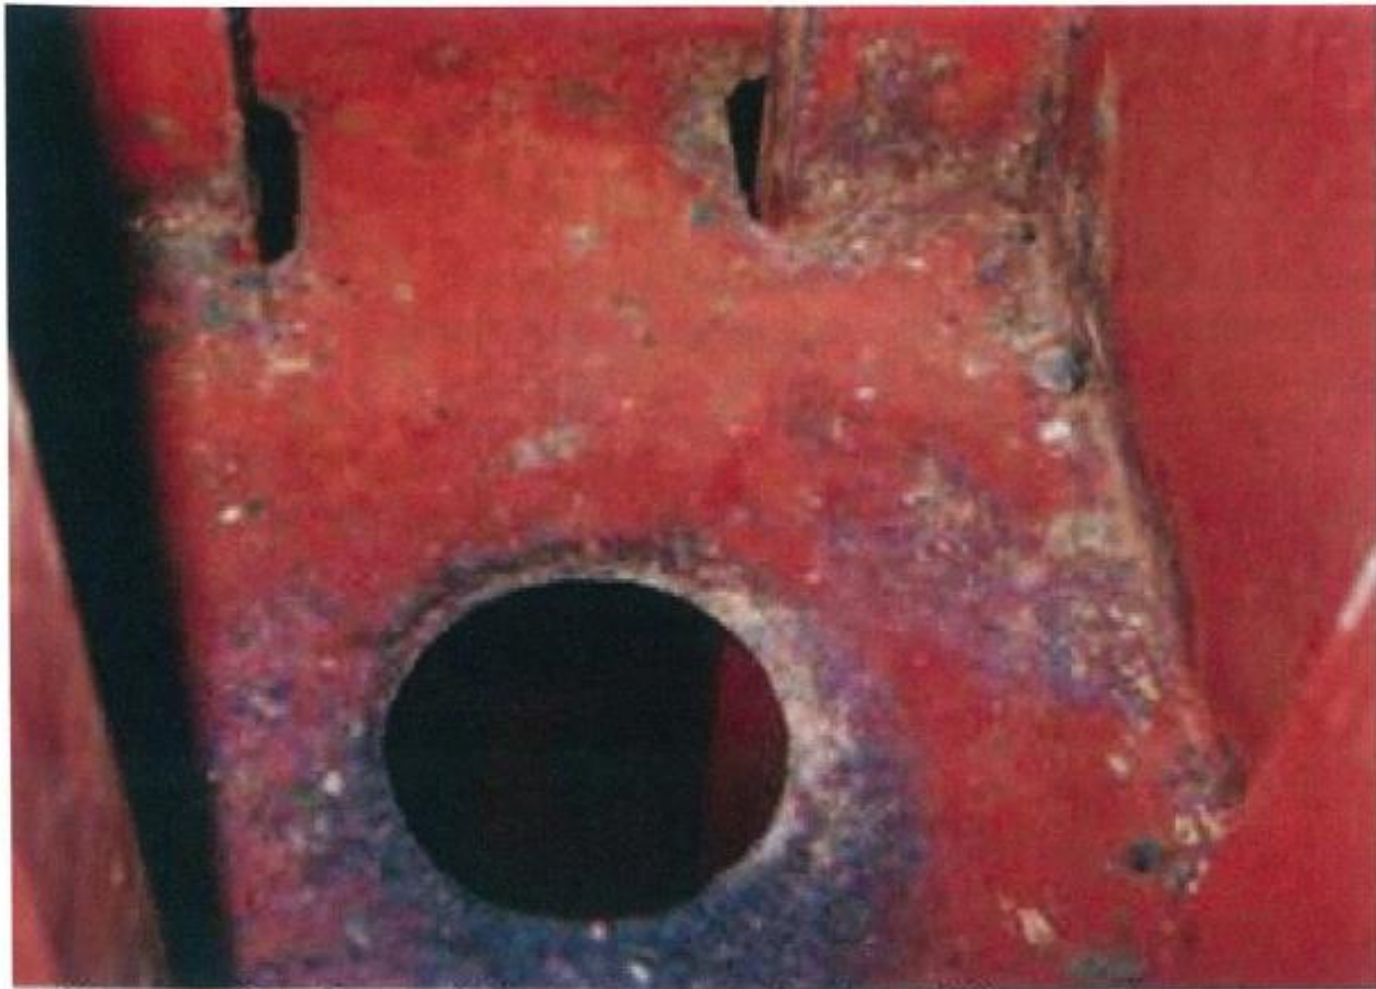
Special attention should be given to the cofferdam and access trunk adjacent to heated cargo tanks

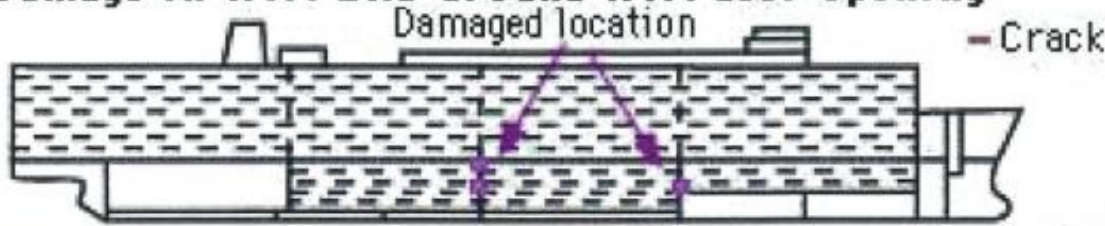
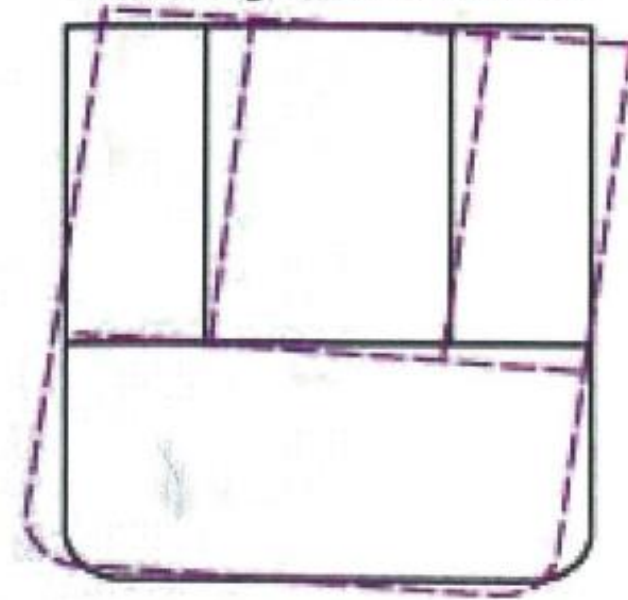
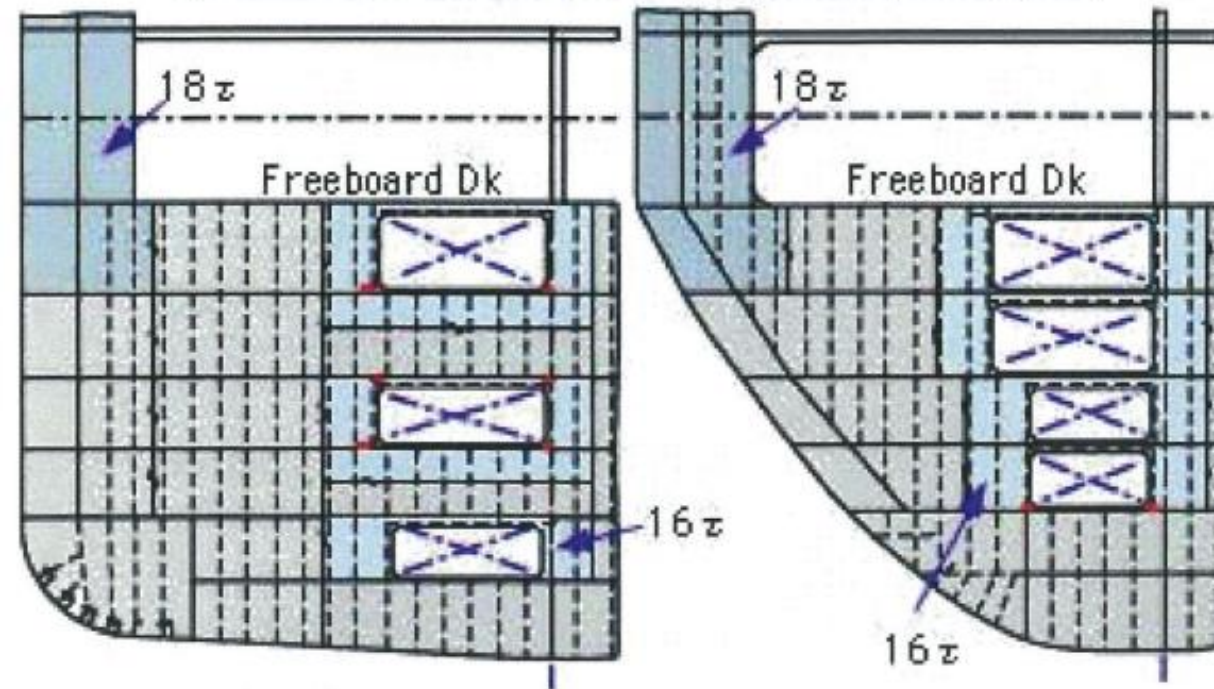
Damage in W.T. BHD around W.T. door opening

Racking deformation

Special attention should be given to water tight door openings in bulkhead due to racking deformation from rolling

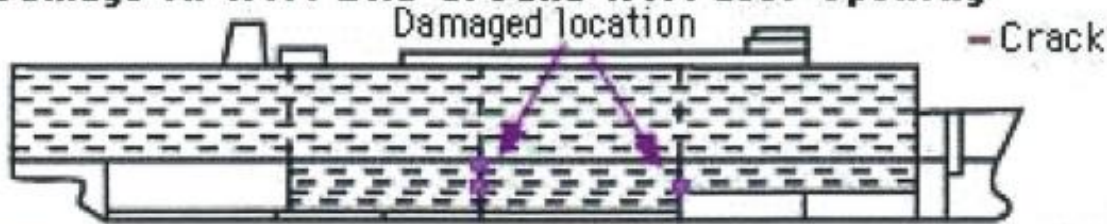
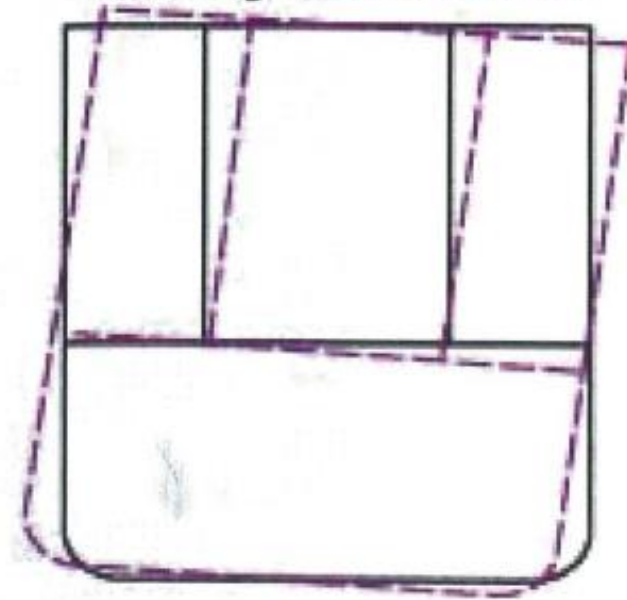
Damage in W.T. BHD around W.T. door opening

Racking deformation

Special attention should be given to water tight door openings in bulkhead due to racking deformation from rolling

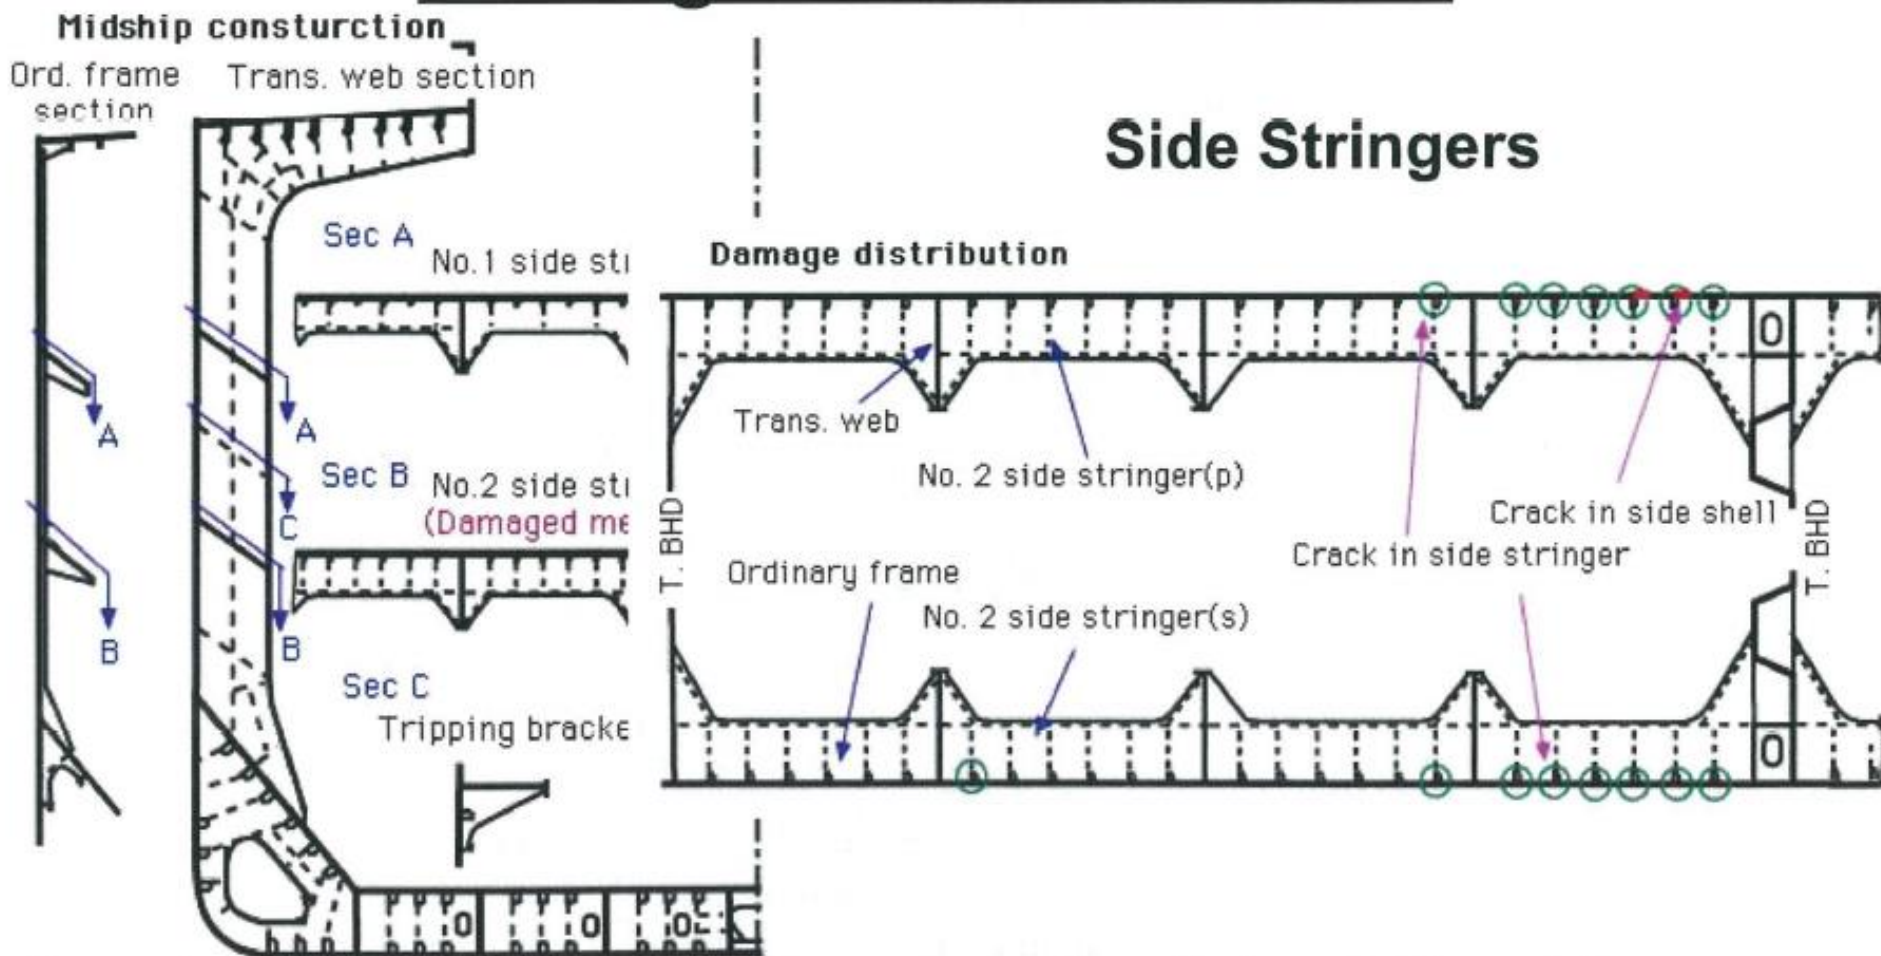
Special attention should be given to slots of the side stringers where they penetrate the hold frame.

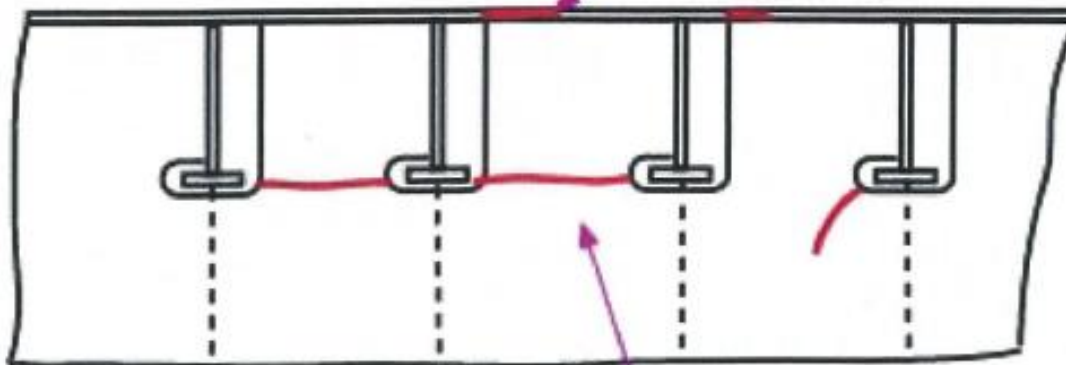
Cracks around the slot of side stringer

Example of crack on port side

Crack in side shell

$L = 400 \text{ mm}$
