ICS Class

2A: Hull Structure

In compliance with the IMO resolution MSC.349(92) and MEPC.237(65), RO Code, Appendix 2.

MODULE 2A-Hull Structure (Content)

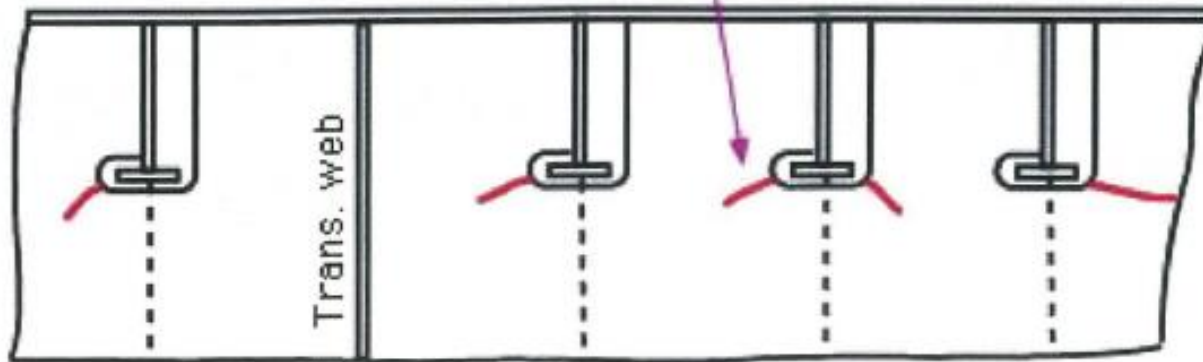
Crack in side stringer

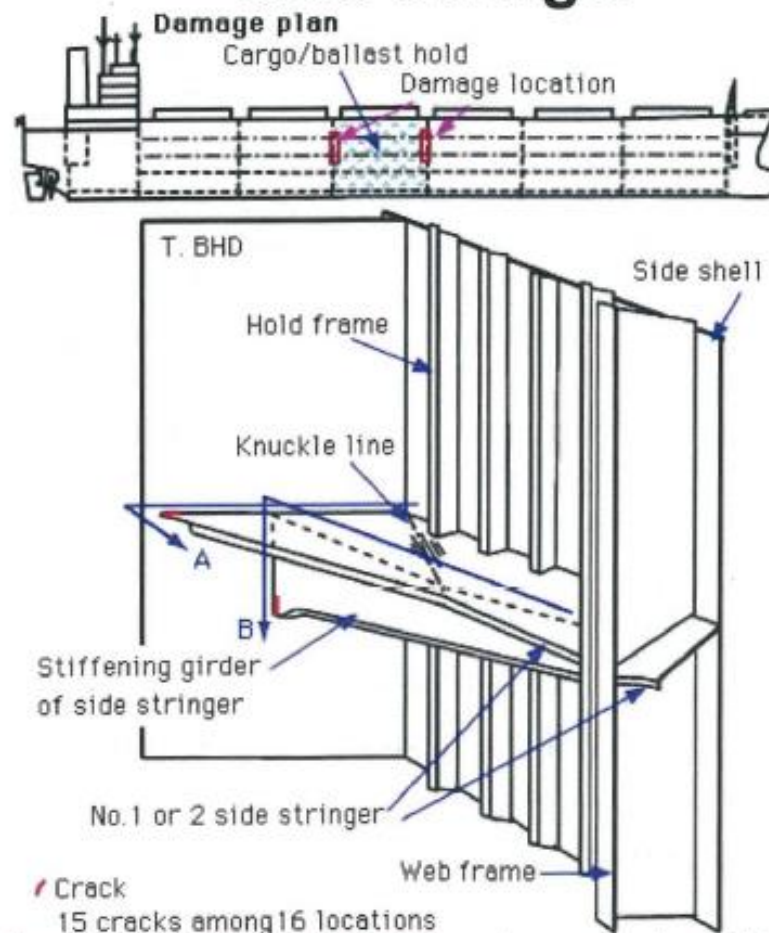
Side Stringer

Special attention should be given to the connection between the side stringer and T.BHD.

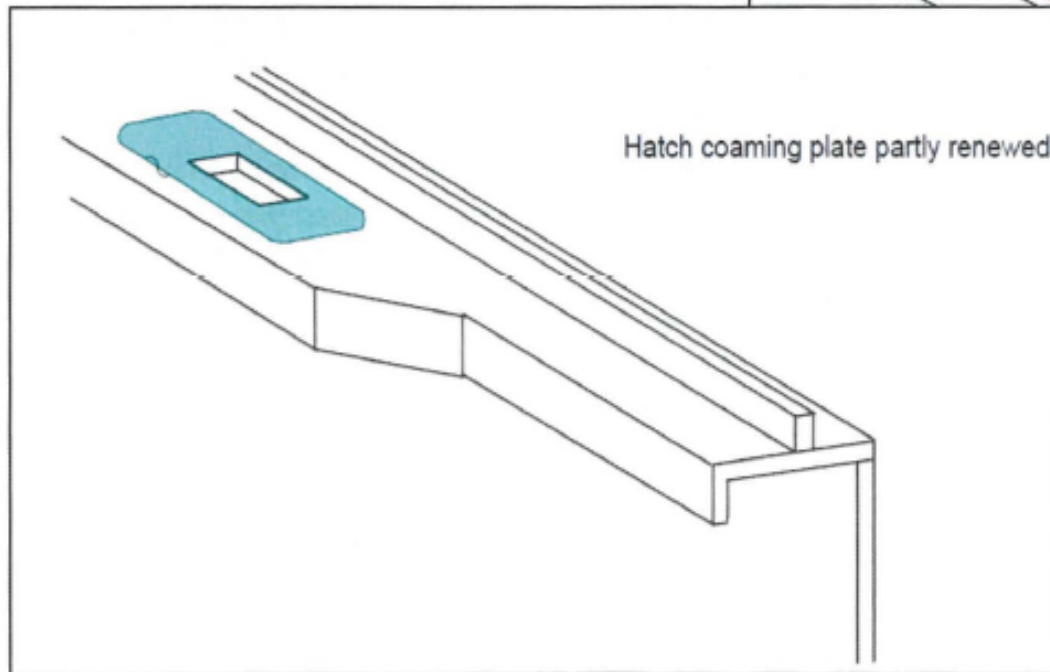
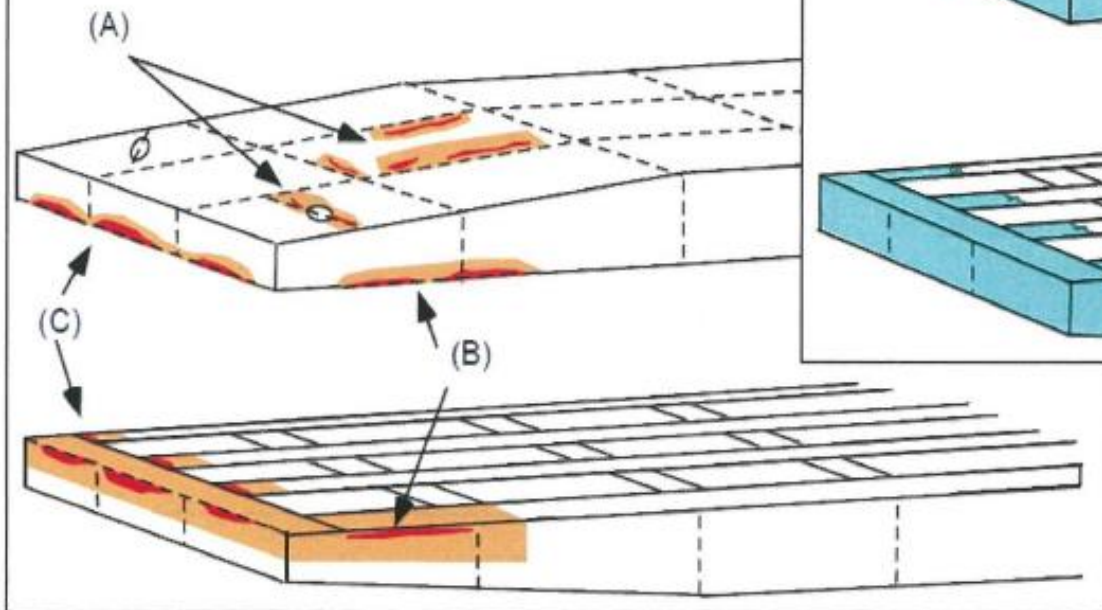
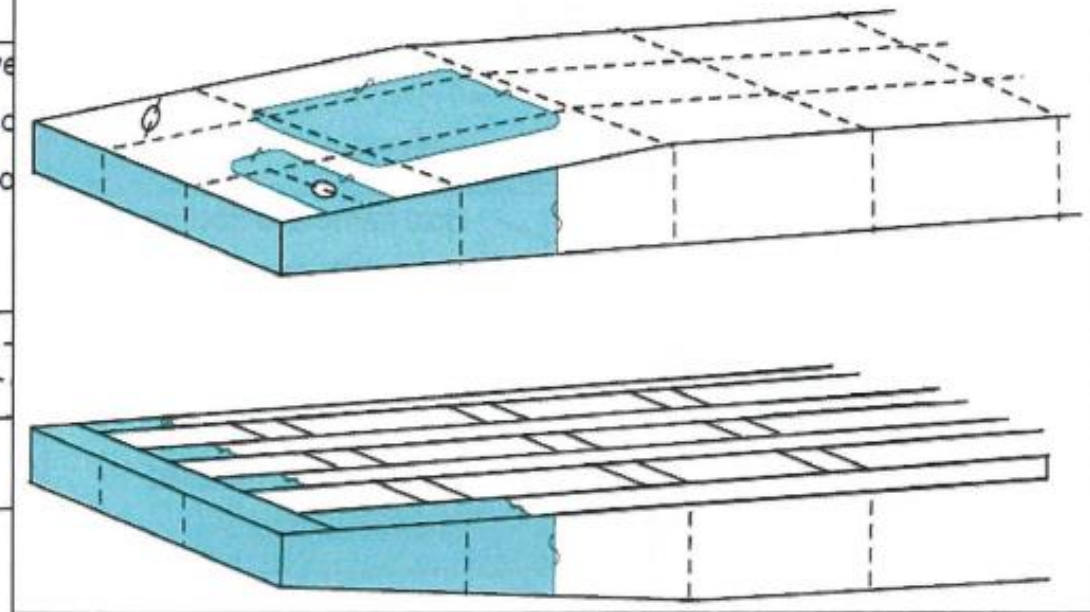
General Cargo Ship Upper Deck Regions

- (A) Corrosion and hole in top plate of pontoon hatch cover
- (B) Corrosion and hole in side plate / web plate of pontoon
- (C) Corrosion and hole in end plate / end face plate of pontoon

Holed / heavy corroded parts partly renewed

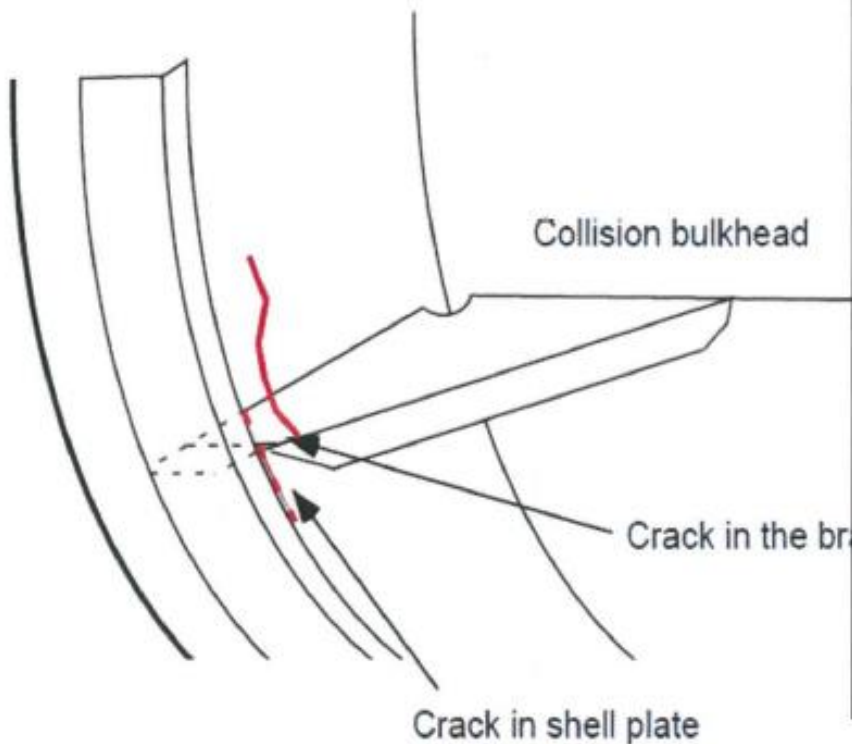
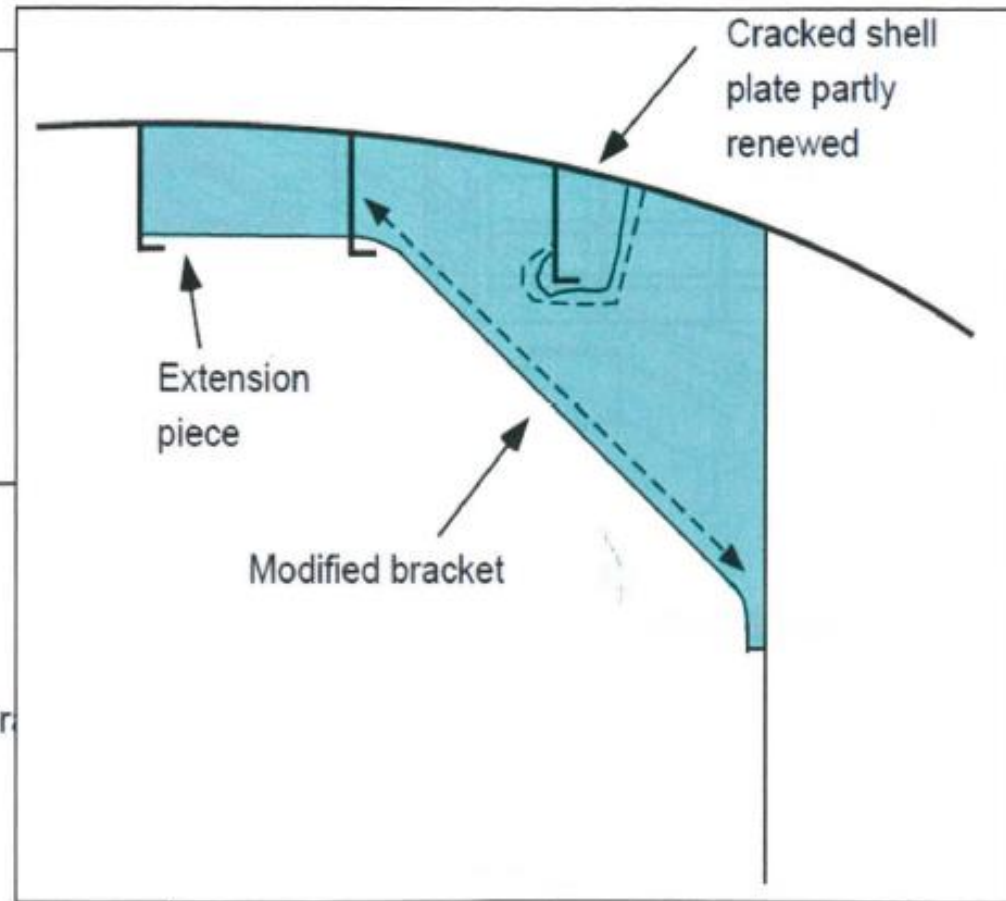
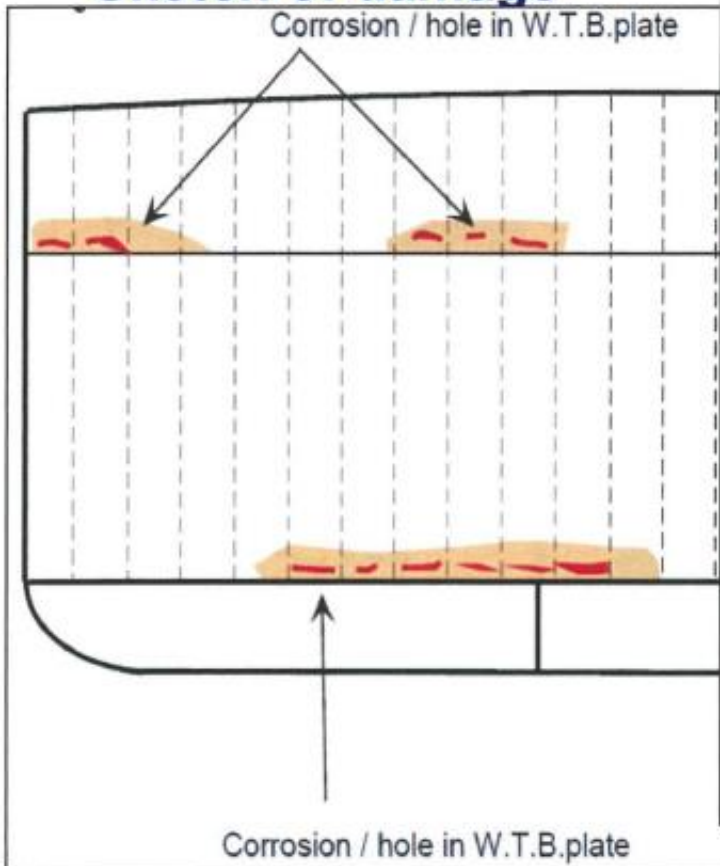
General Cargo Ship Cargo Hold Regions Sketch of repair

Corroded / holed part of W.T.B. plates partly renewed

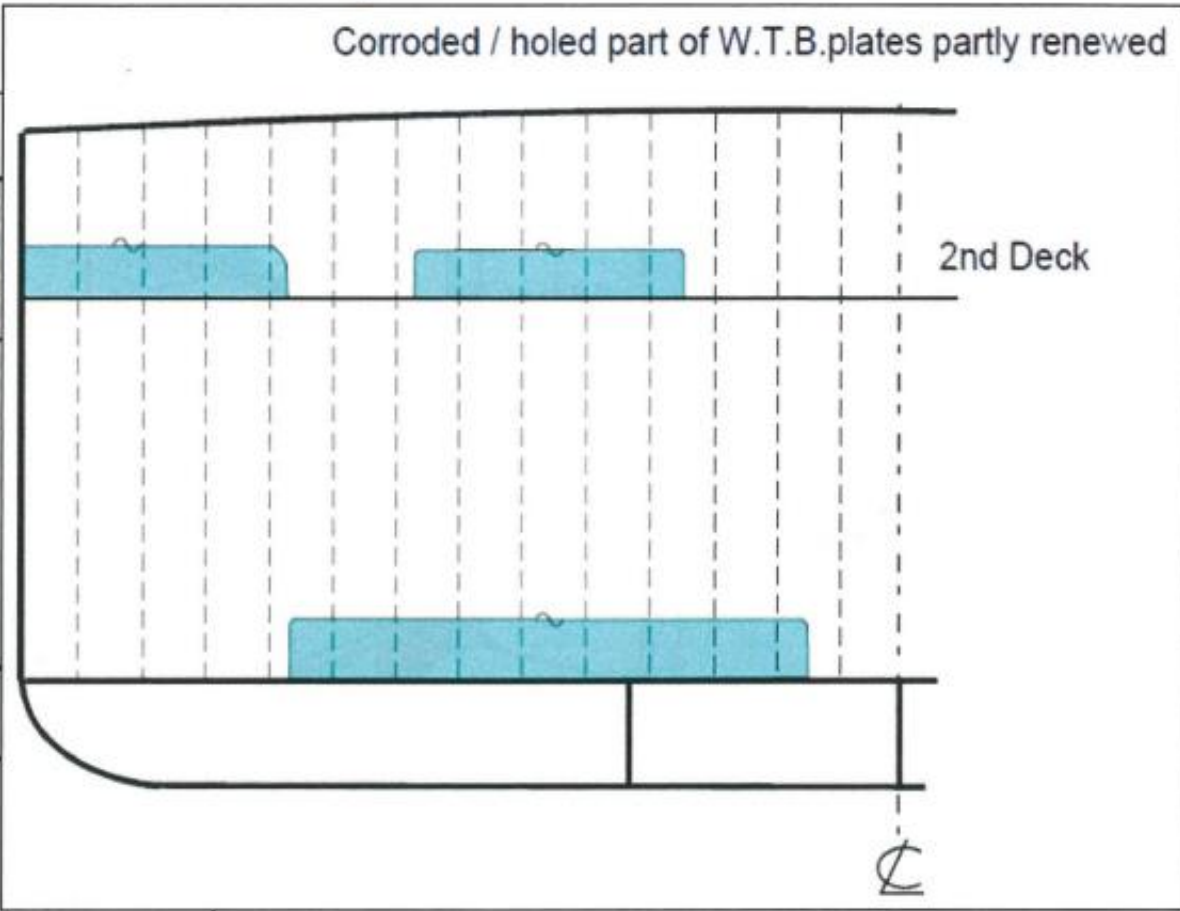
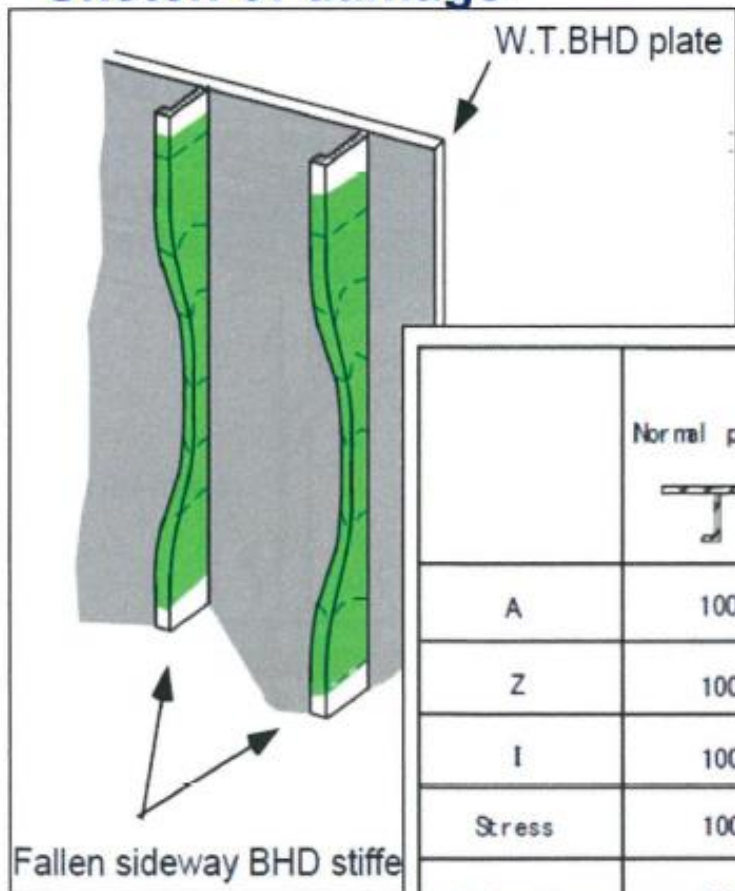
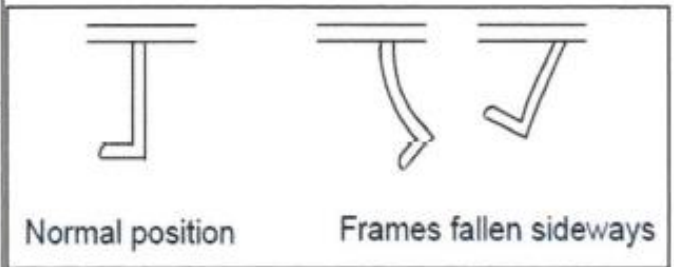
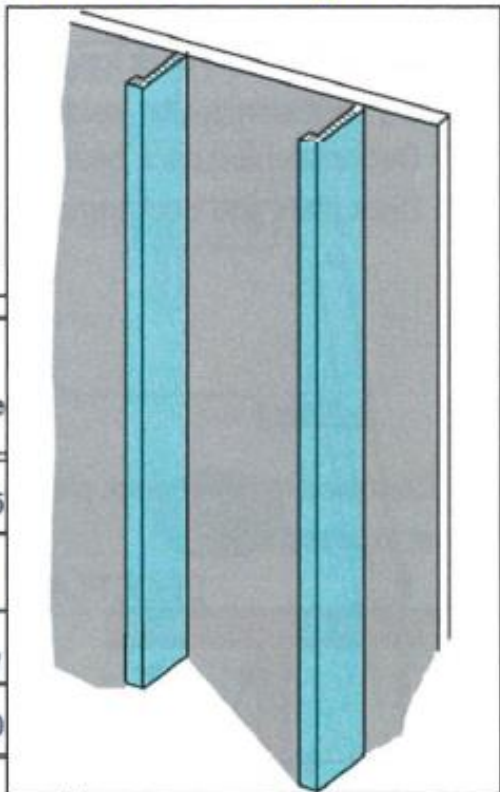
General Cargo Ship Cargo Hold Regions

Normal position	15 degrees	30 degrees	45 degree
A	100	100	100	100
Z	100	92.6	66.1	57.7
I	100	89.7	58.1	42.0
Stress	100	108	151	174
Deflection	100	111.4	170.0	238.0

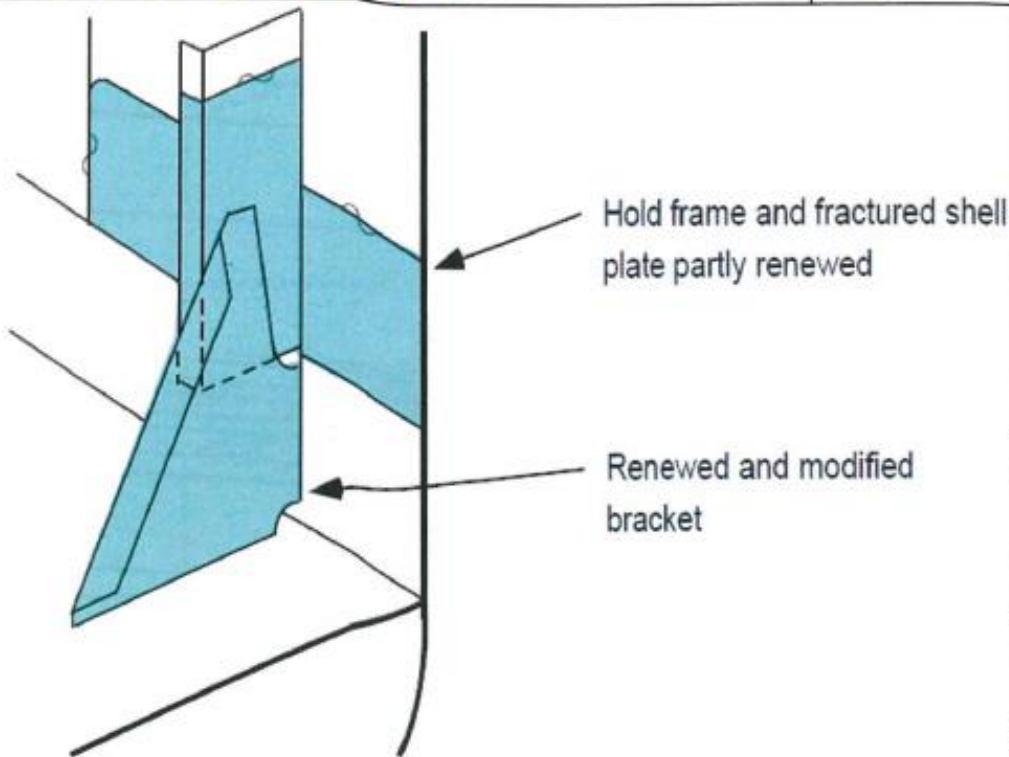
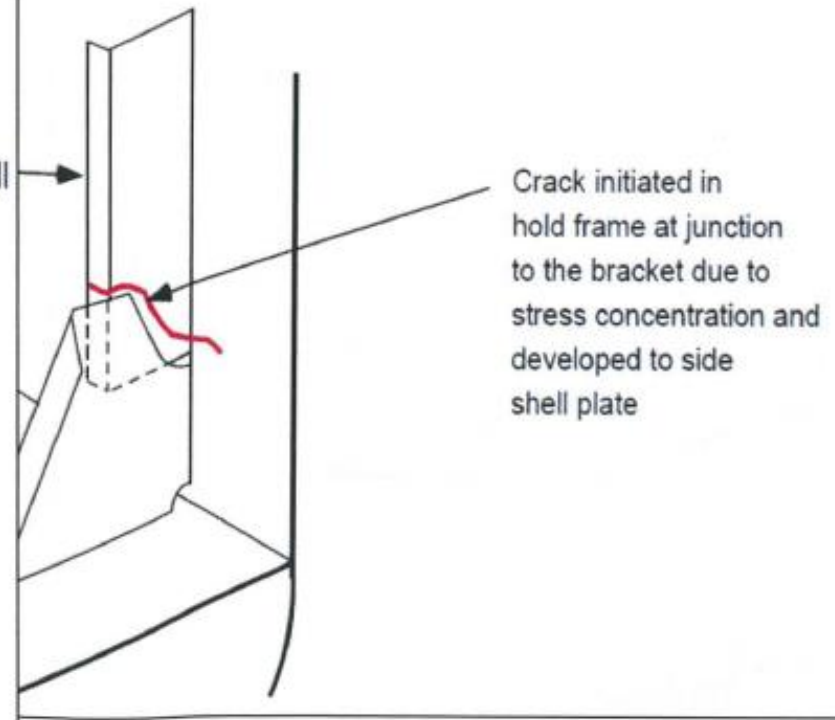
General Cargo Ship Cargo Hold Regions

Crack in shell plate resulted from fracture of hold frame at the connection of lower bracket.

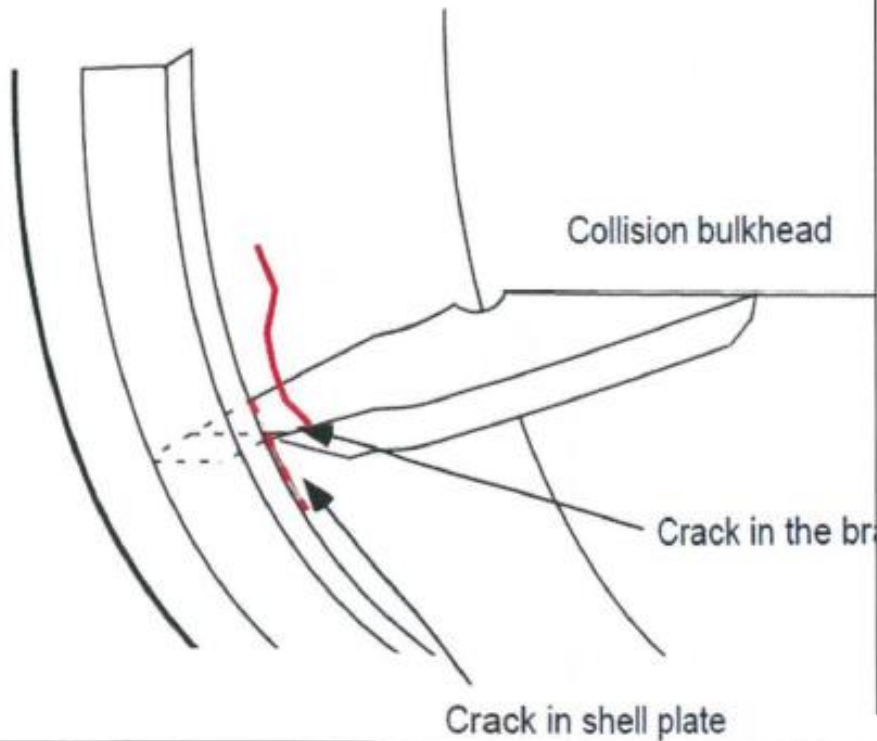
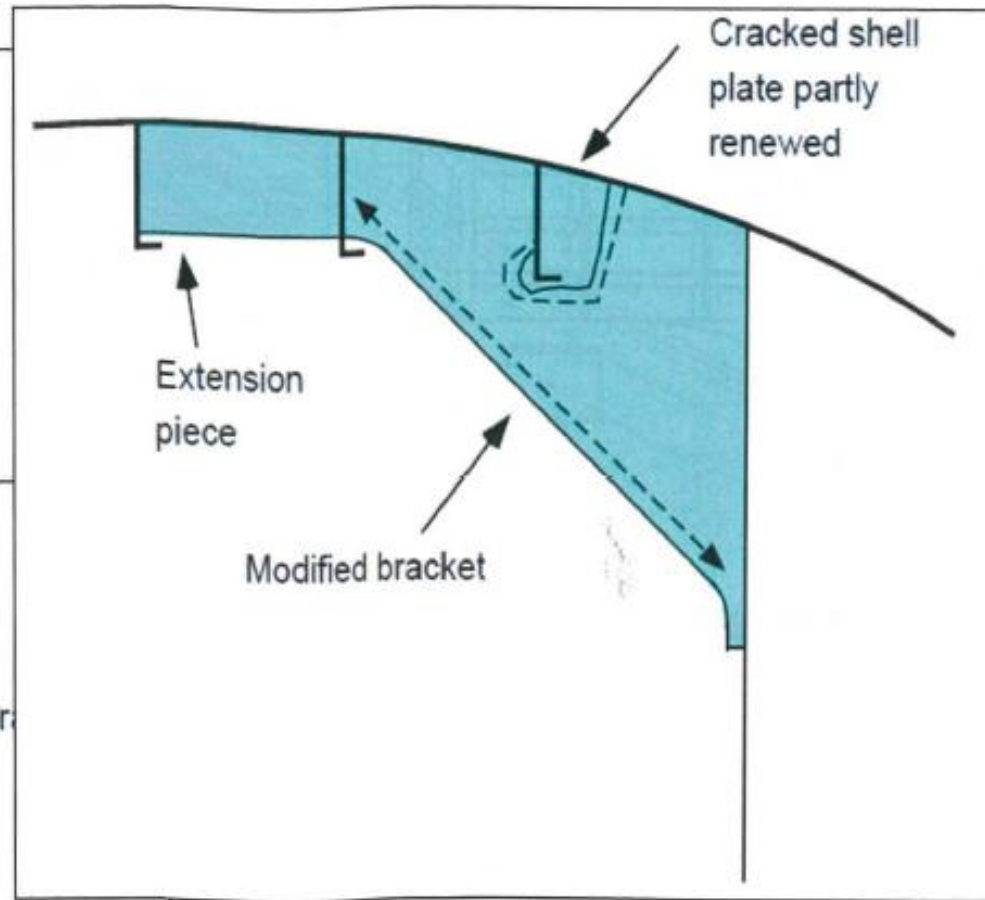
General Cargo Ship Cargo Hold Regions

Crack in shell plate resulted from crack in balancing bracket on the collision bulkhead.

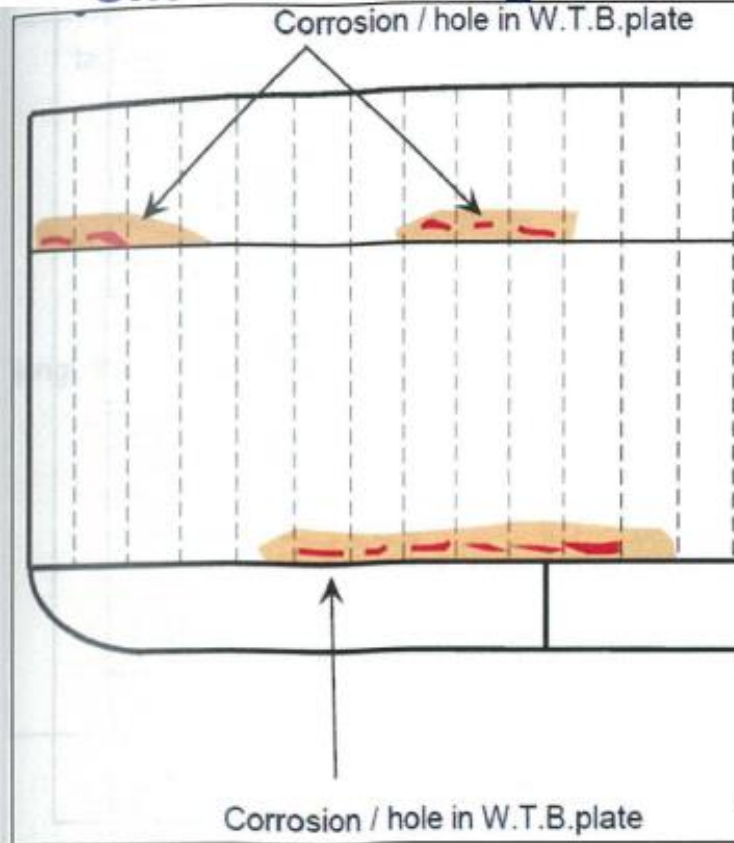
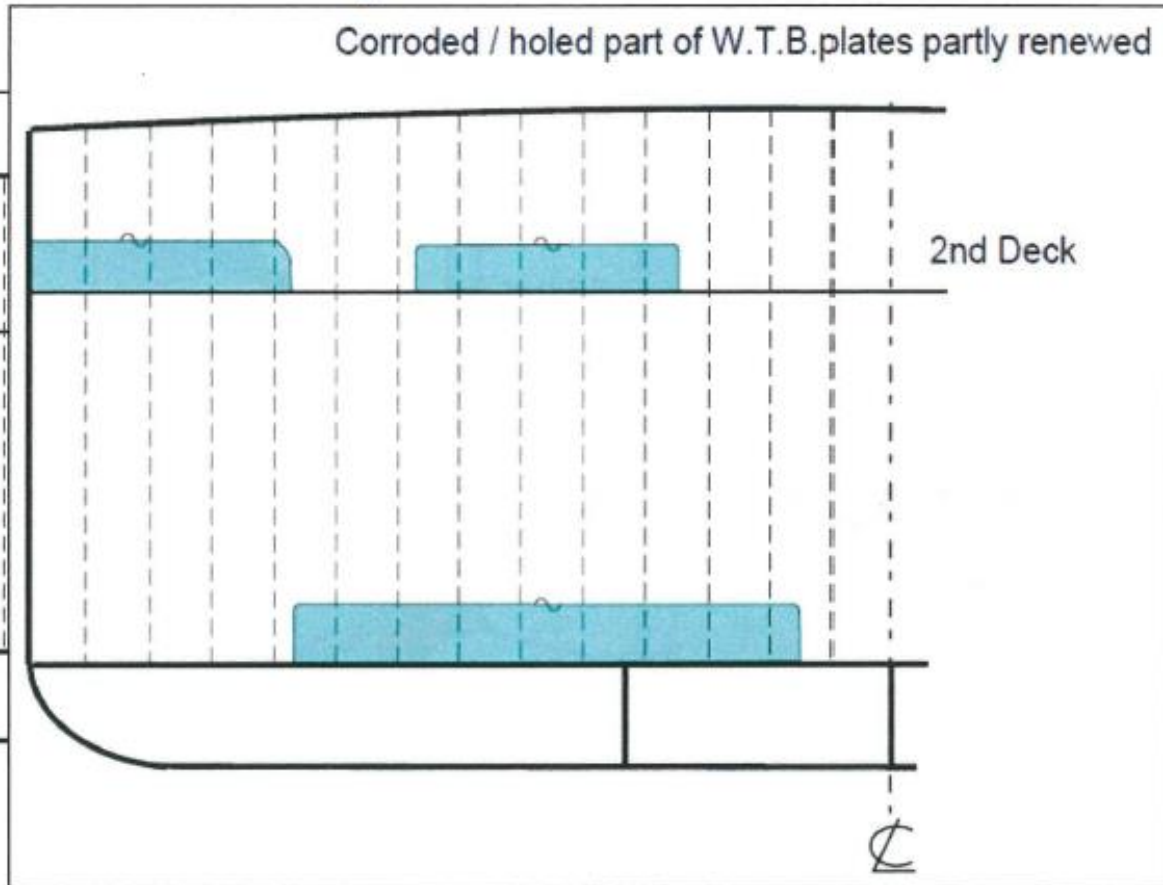
General Cargo Ship Cargo Hold Regions Sketch of repair

Corrosion / hole in W.T.B. plate

Corroded / holed part of W.T.B. plates partly renewed

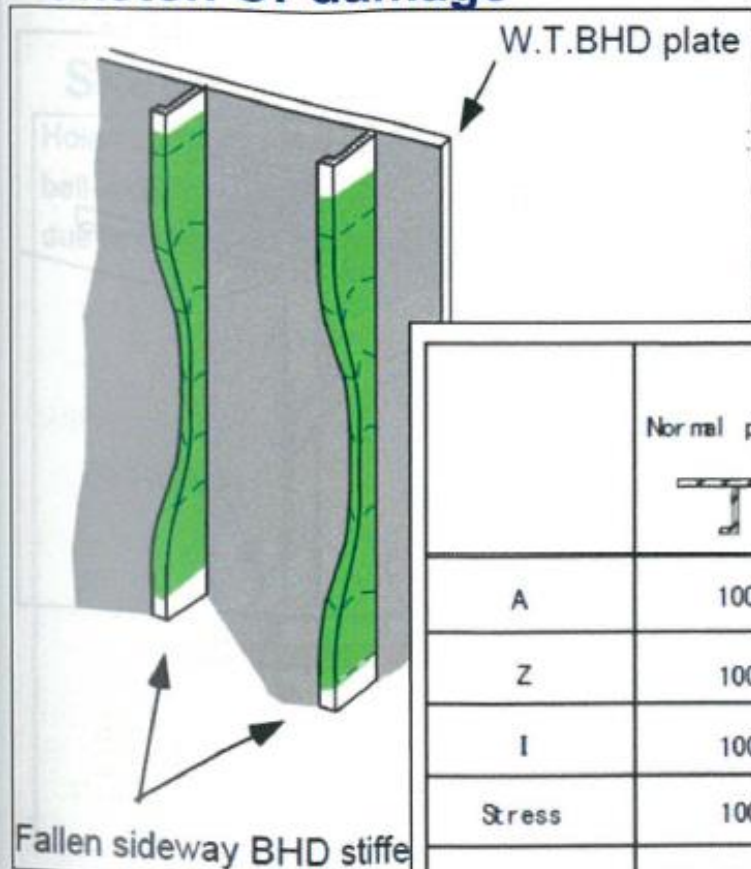
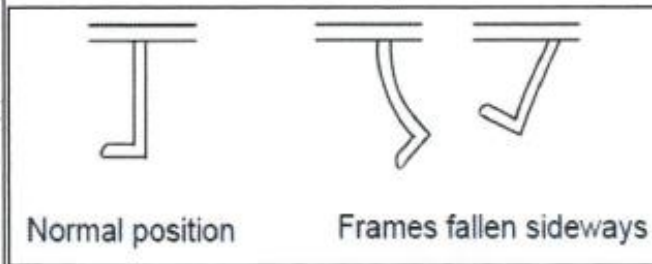
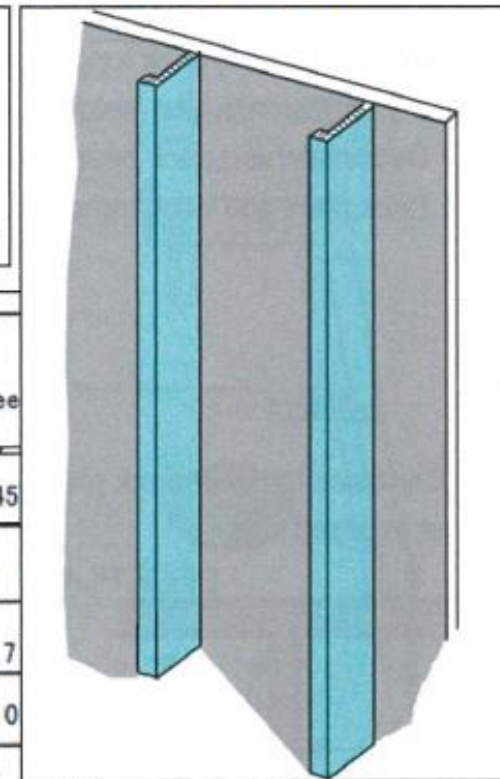
General Cargo Ship Cargo Hold Regions

Normal position	15 degrees	30 degrees	45 degree
A	100	100	100	100
Z	100	92.6	66.1	57.7
I	100	89.7	58.1	42.0
Stress	100	108	151	174
Deflection	100	111.4	170.0	238.0

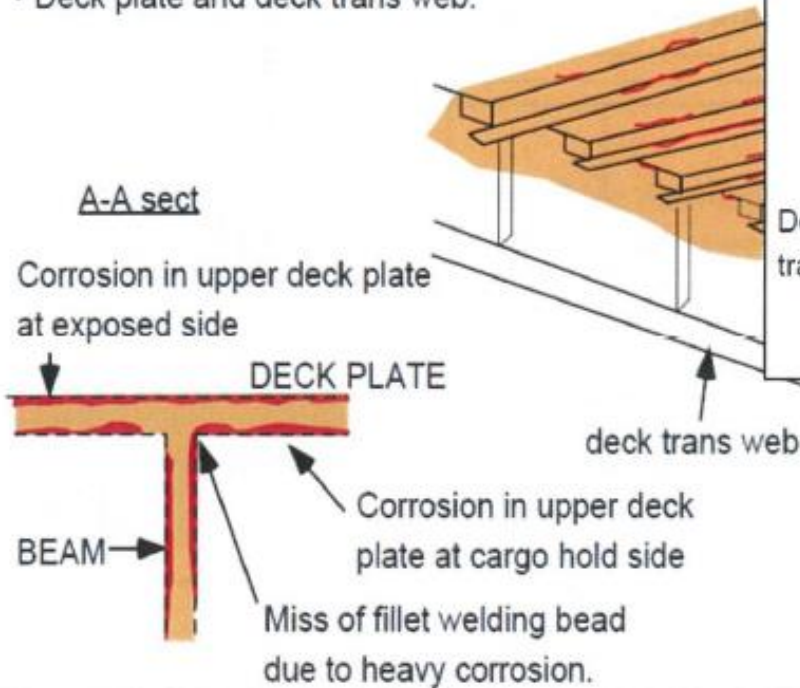
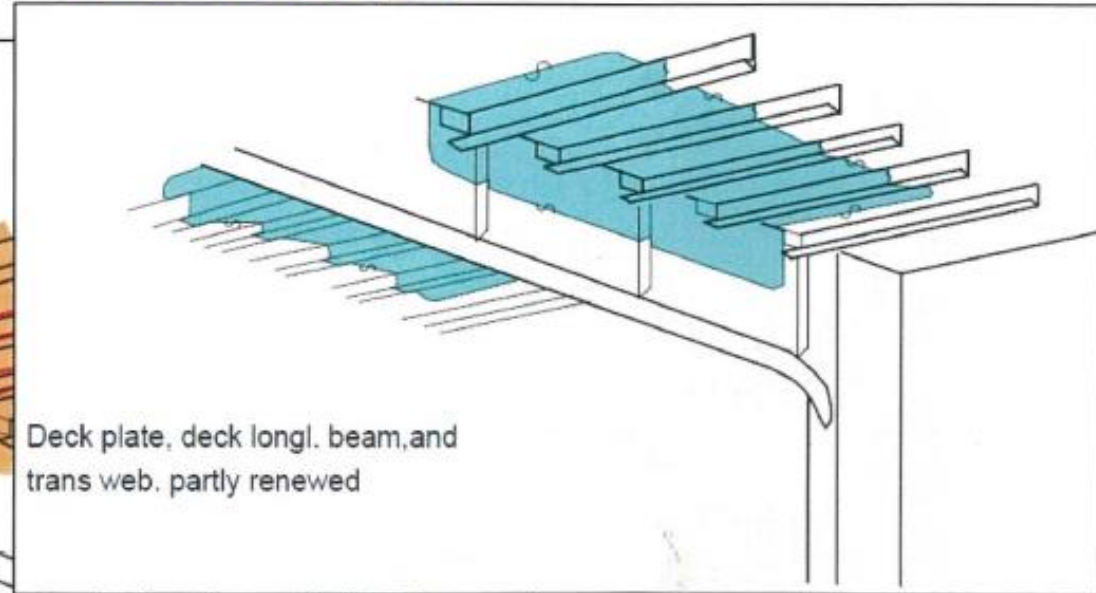
General Cargo Ship Cargo Hold Regions

- ① Heavy corrosion in deck longl. beam
- ② Heavy corrosion in fillet welding bead between
 - Deck plate and deck beam, and
 - Deck plate and deck trans web.

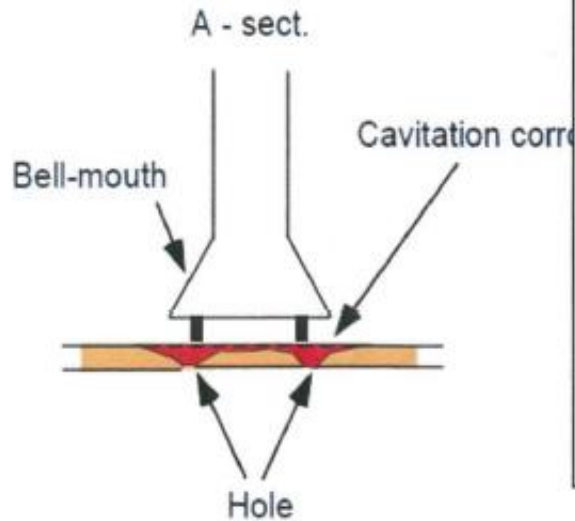
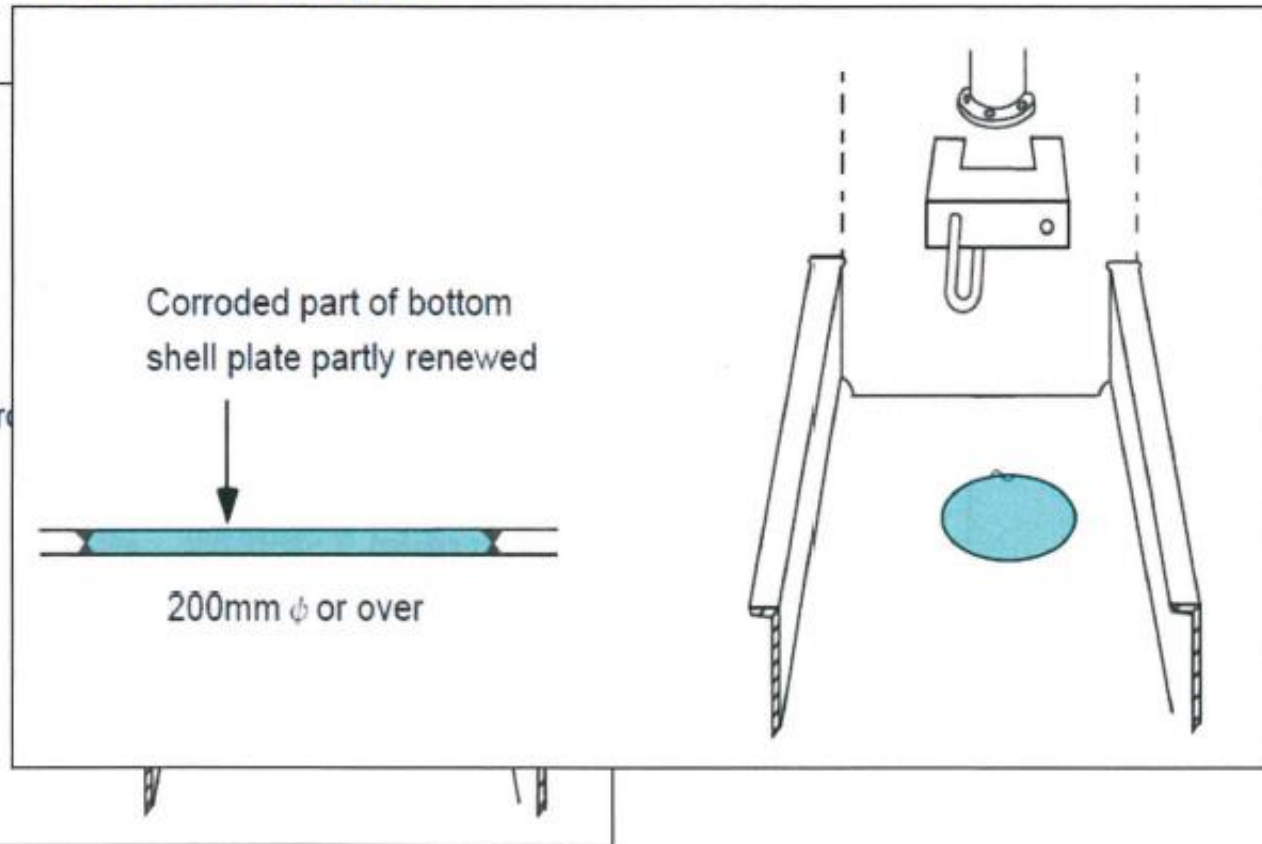
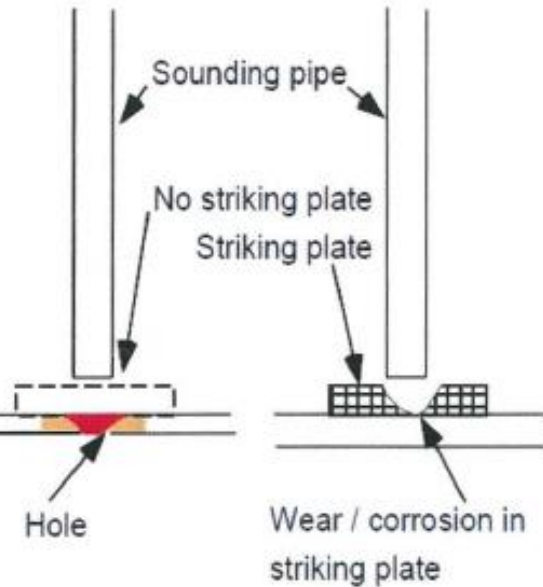
General Cargo Ship D.Bottom Tank Regions Sketch of repair

Holes in bottom shell plate underneath sounding pipe in water ballast tanks, bilge tanks and F.O.Tanks due to wear /wastage.

Note : Wear / corrosion in striking plate in FOT is due to sea water from sounding pipe.

Corrosion part of bottom shell plate partly renewed

Striking plate renewed

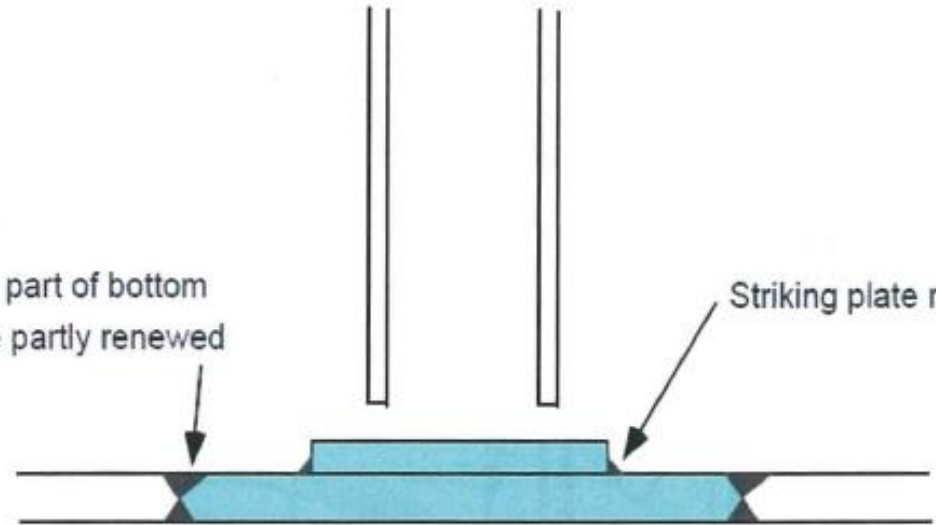
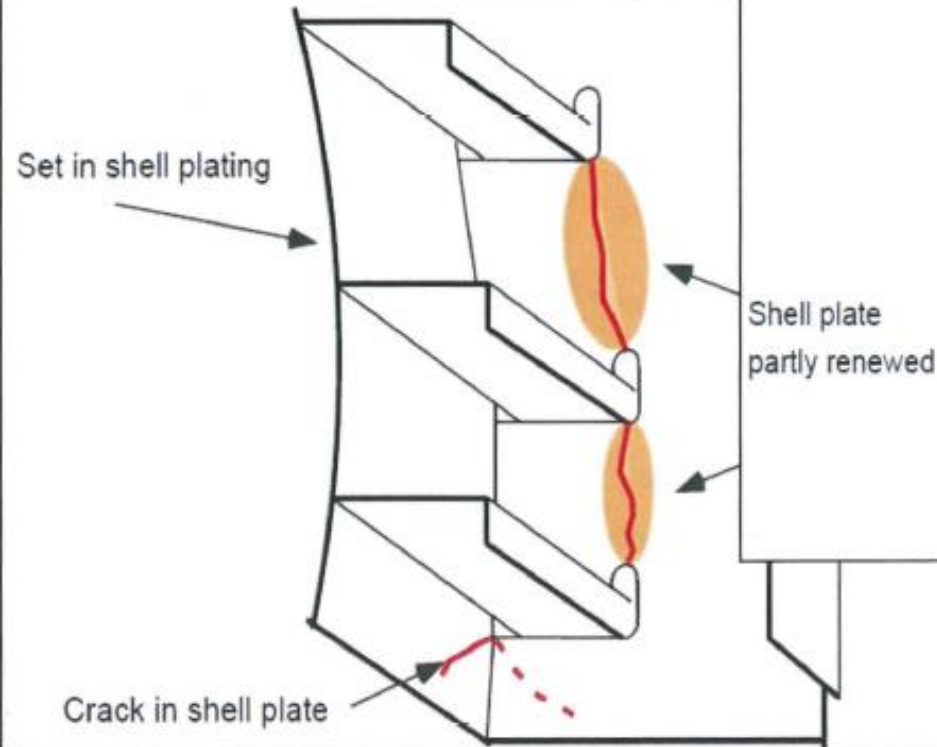
General Cargo Ship FPT Regions

Crack in side shell plate resulted in fracture of side transverse web and excessive corrosion in way of WB

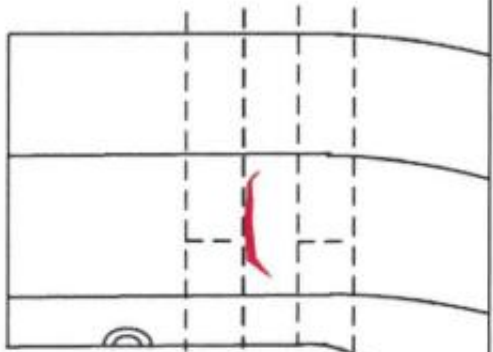
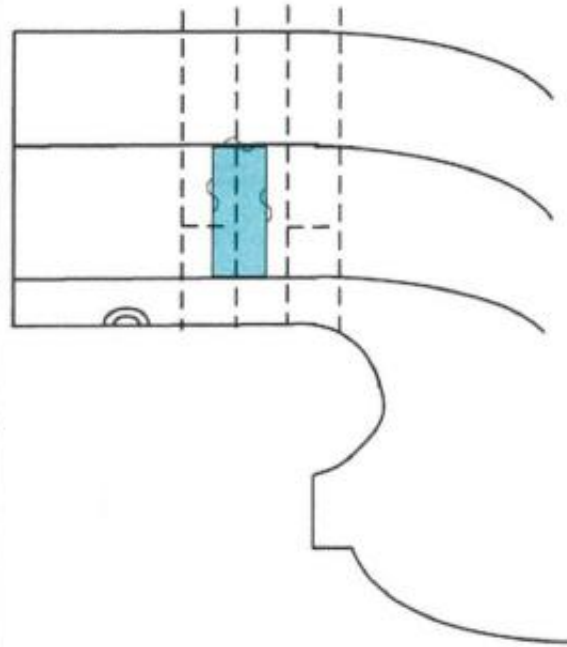
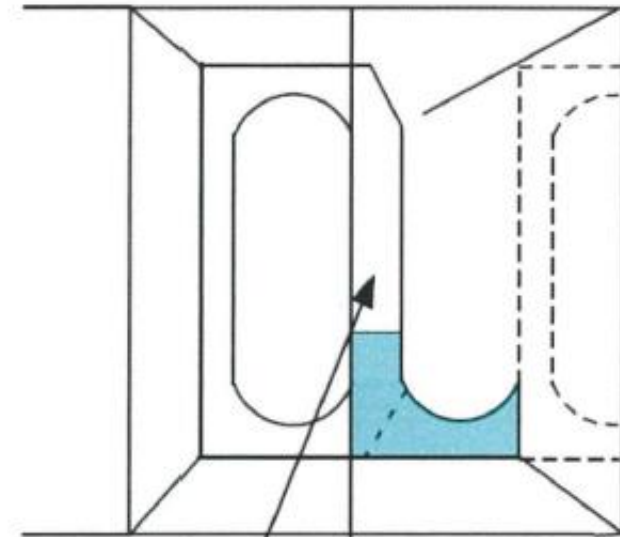
General Cargo Ship APT Regions

Crack in shell plate due to propeller excited vibration.

Crack in shell plate partly renewed

Modified shell stiffener fitted

Original stiffener

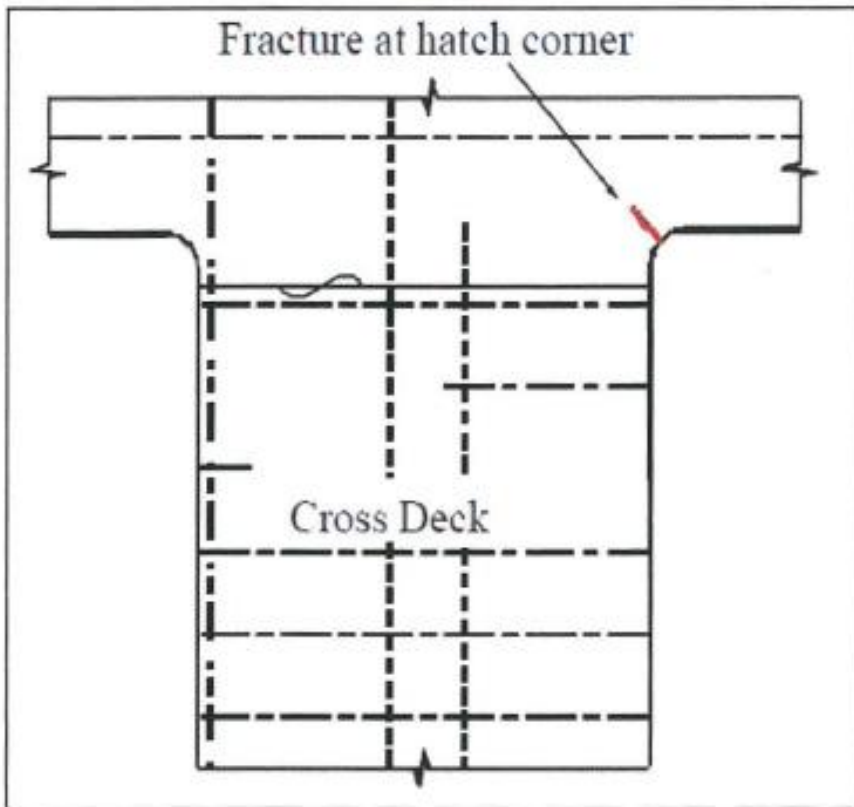
Sketch of damage

Deck Structure

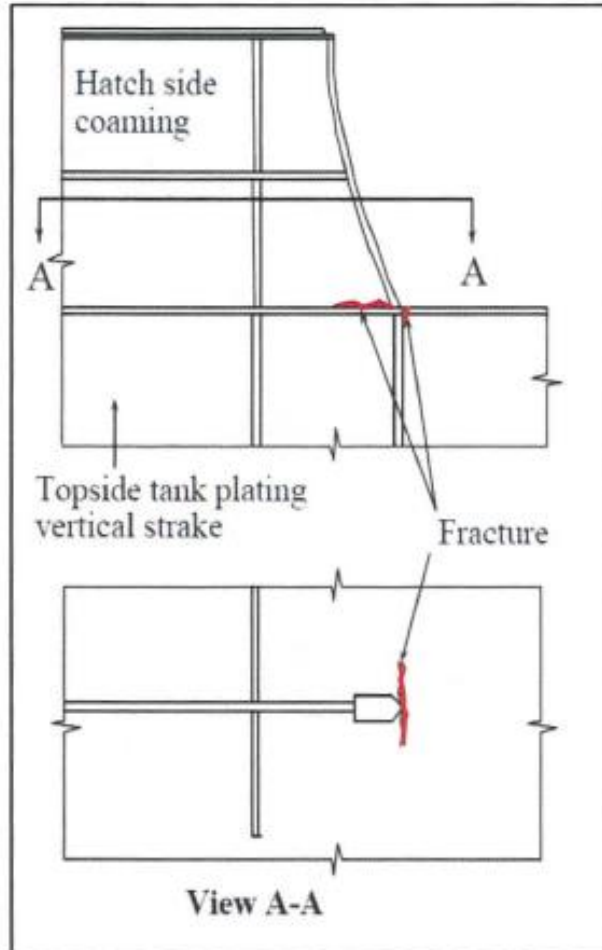
Sketch of damage

Deck Structure

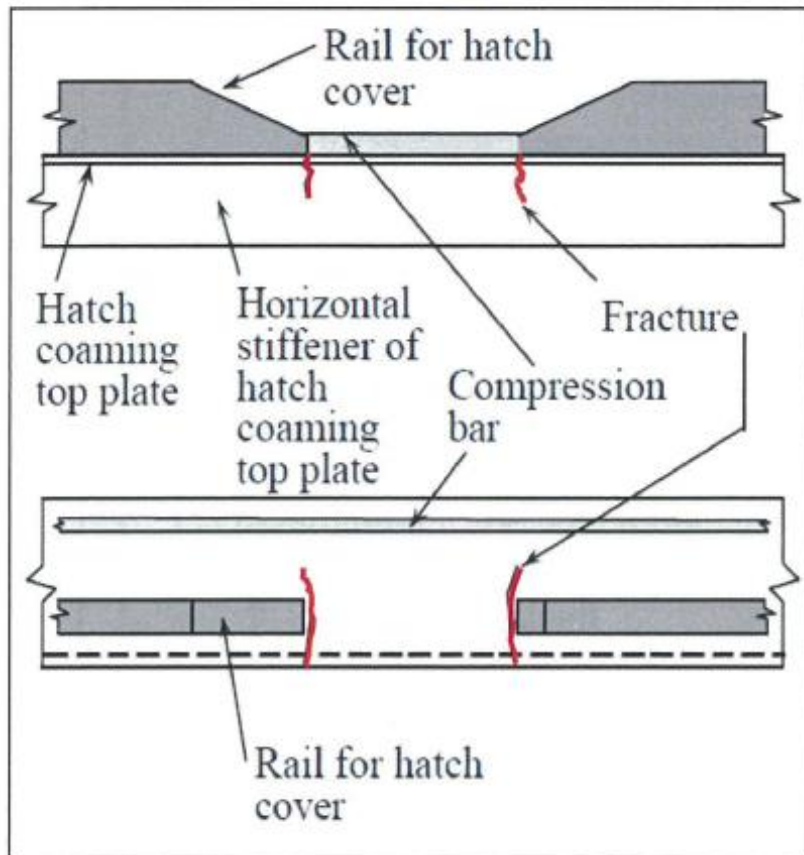
Sketch of damage

Deck Structure

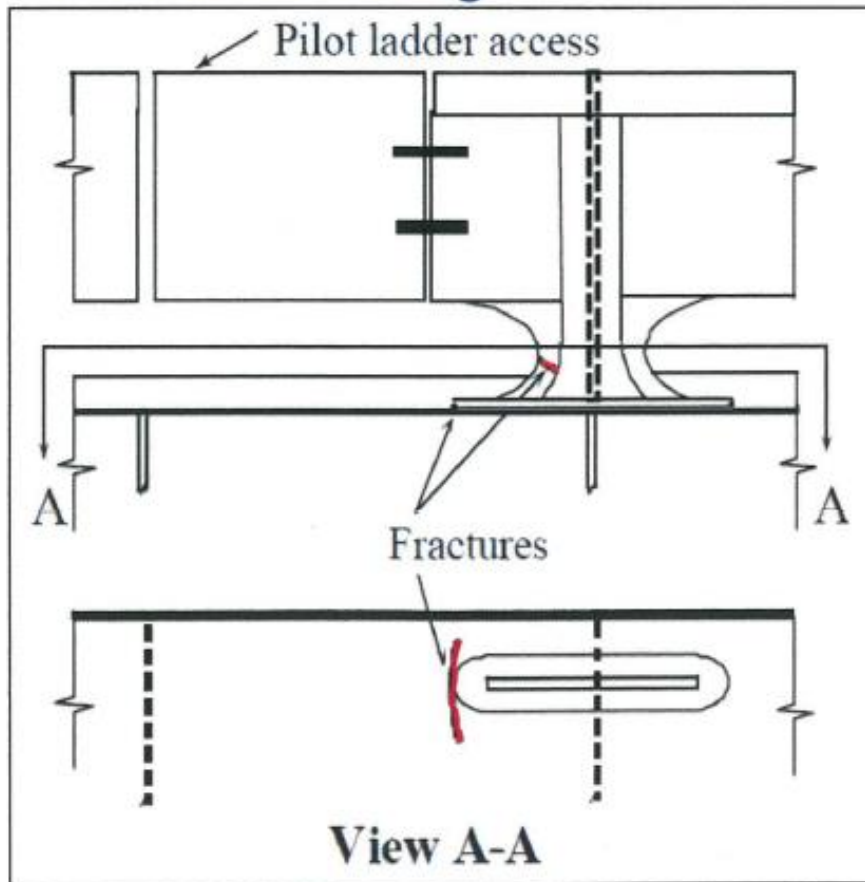
Sketch of damages

Example of Deck Structure

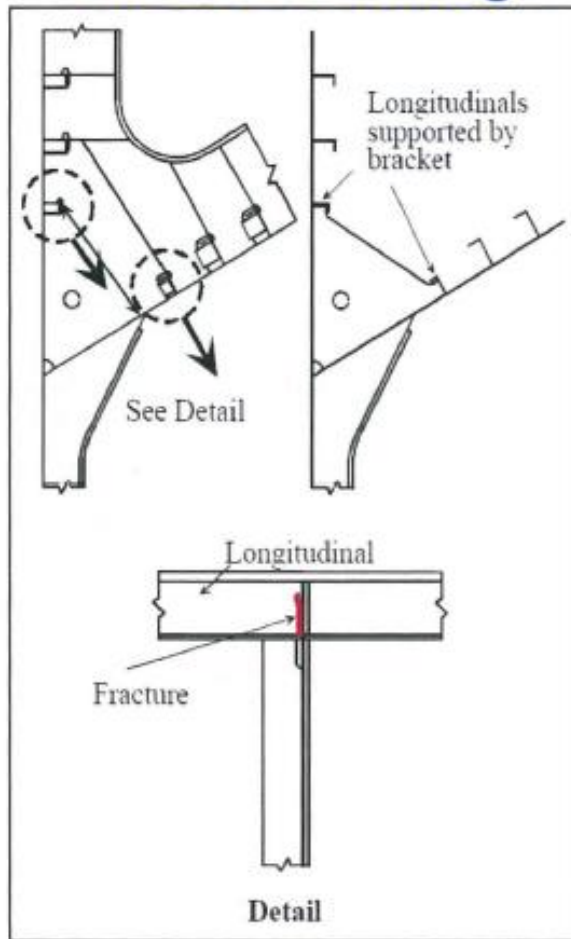
Sketch of damage

Topside Tank Structure

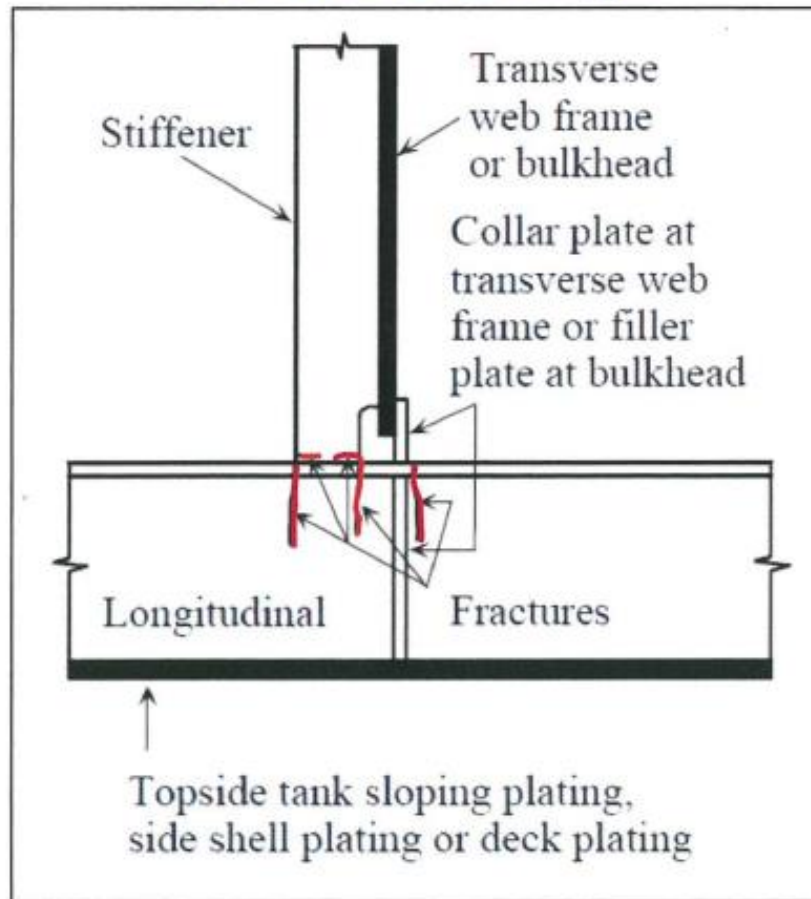
Sketch of damage

Topside Tank Structure
