ICS Class

2A: Hull Structure

In compliance with the IMO resolution MSC.349(92) and MEPC.237(65), RO Code, Appendix 2.

MODULE 2A-Hull Structure (Content)

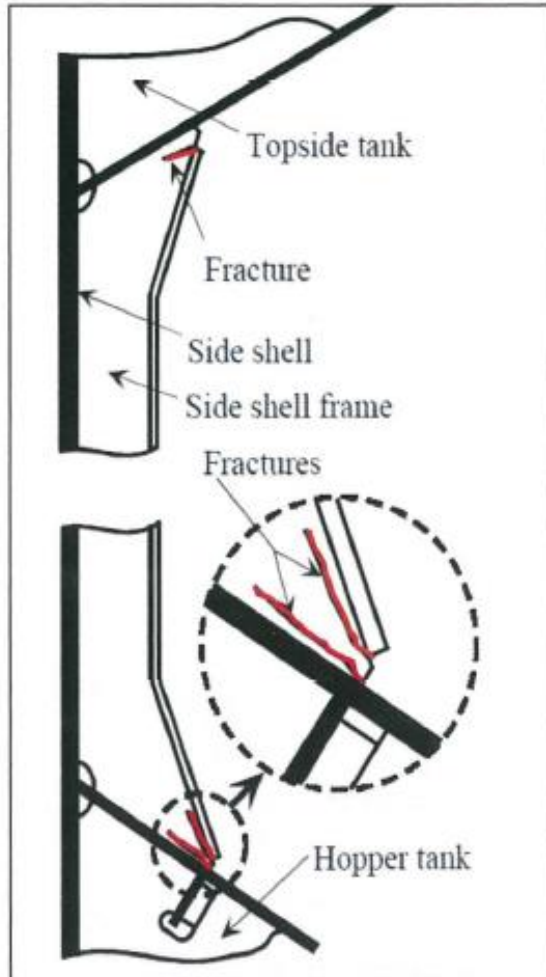
Sketch of damage

Cargo Hold Side Structure

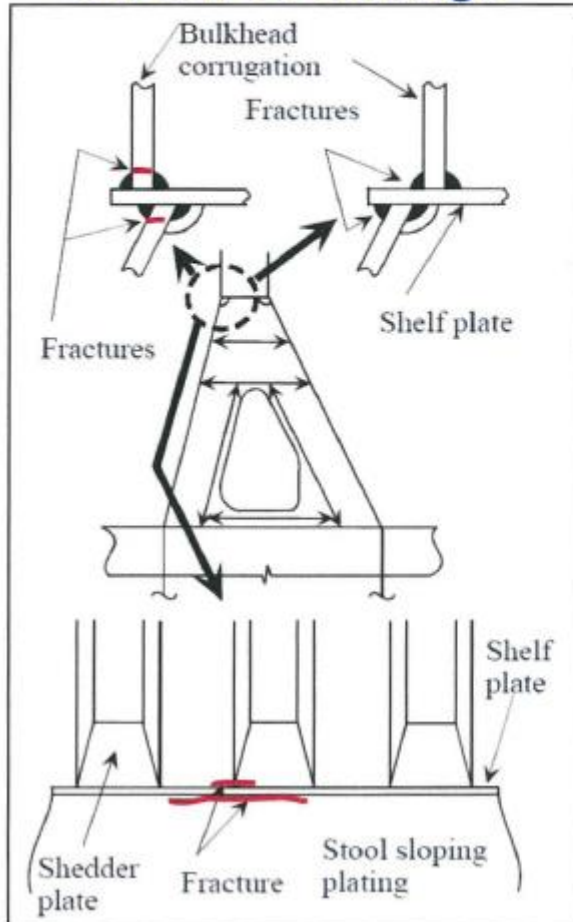
Sketch of damage

Transverse Bulkhead

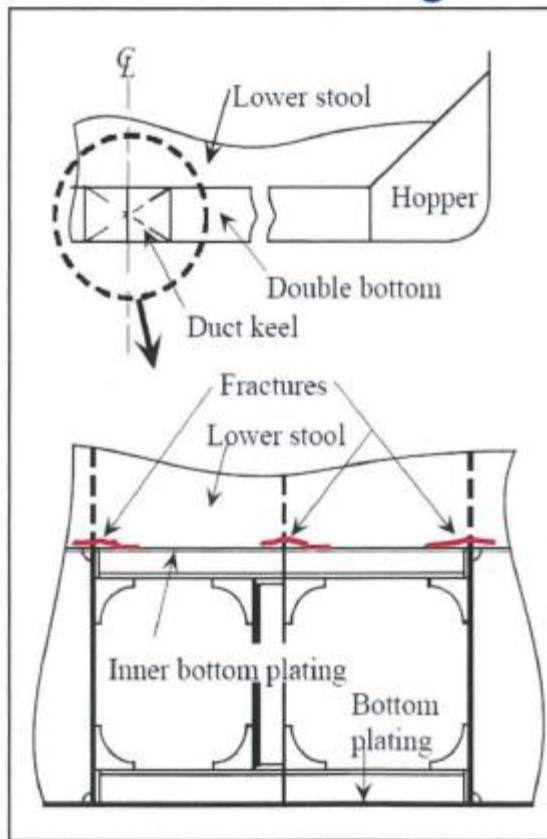
Sketch of damage

Transverse Bulkhead

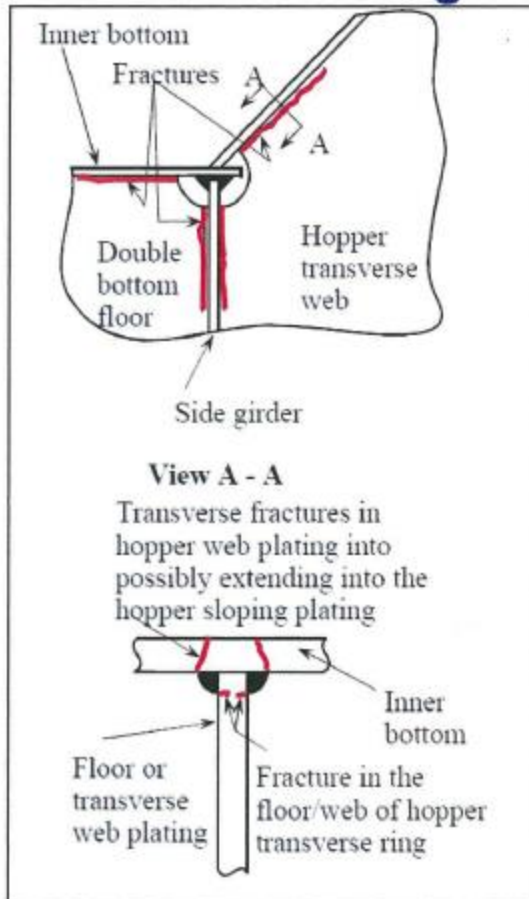
Sketch of damage

Double Bottom Tank

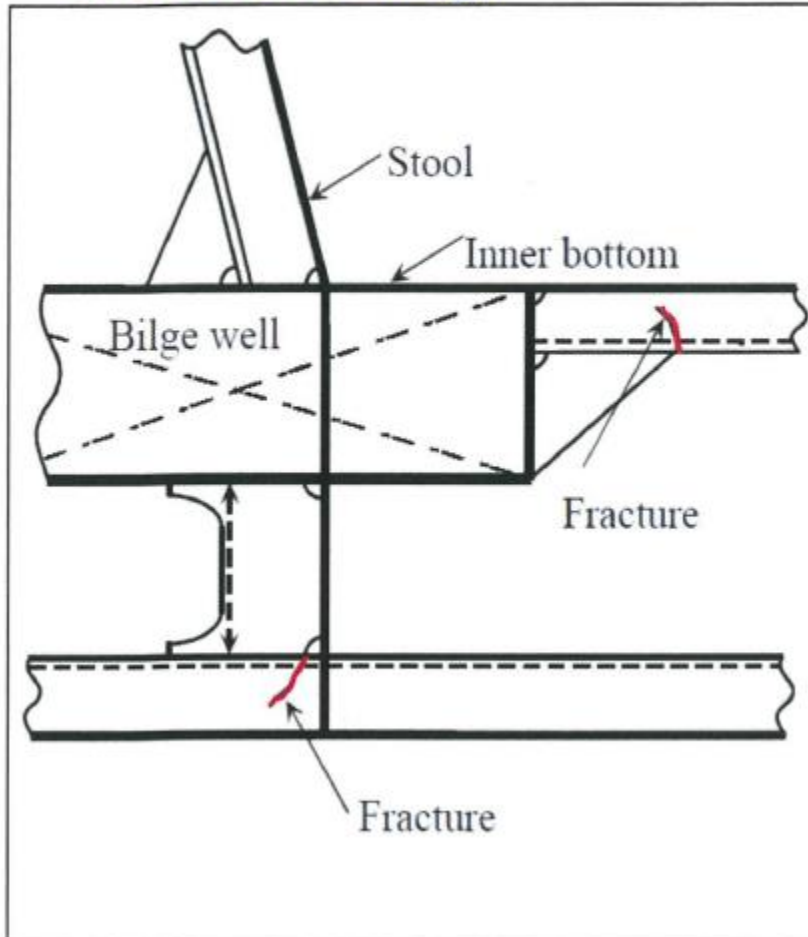
Sketch of damage

Double Bottom Tank

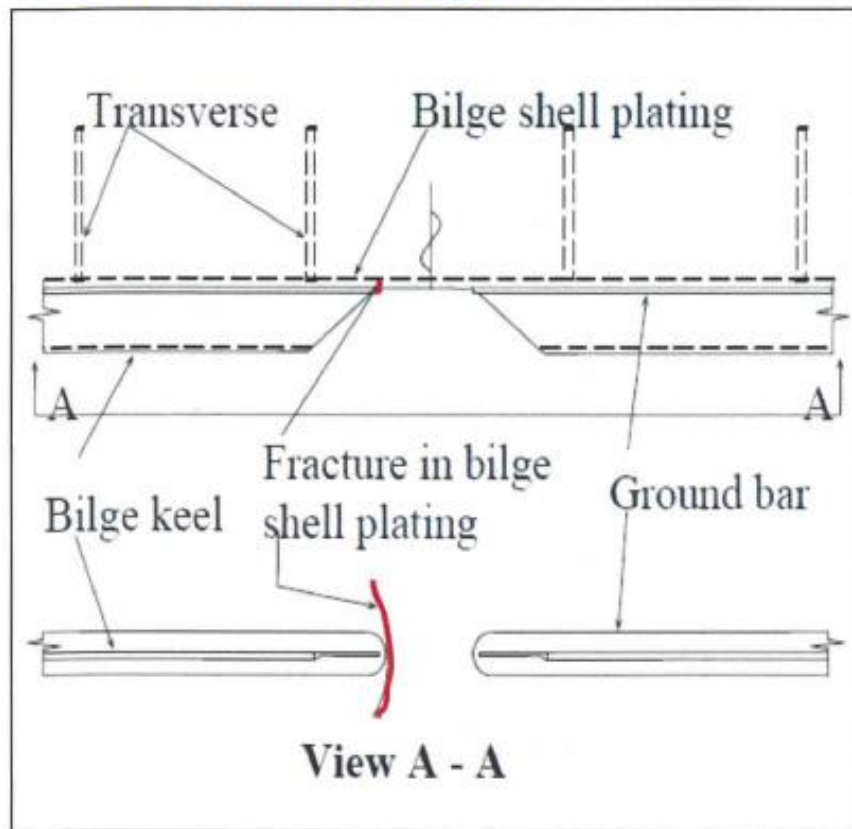
Sketch of damages

Bottom Shell Plate

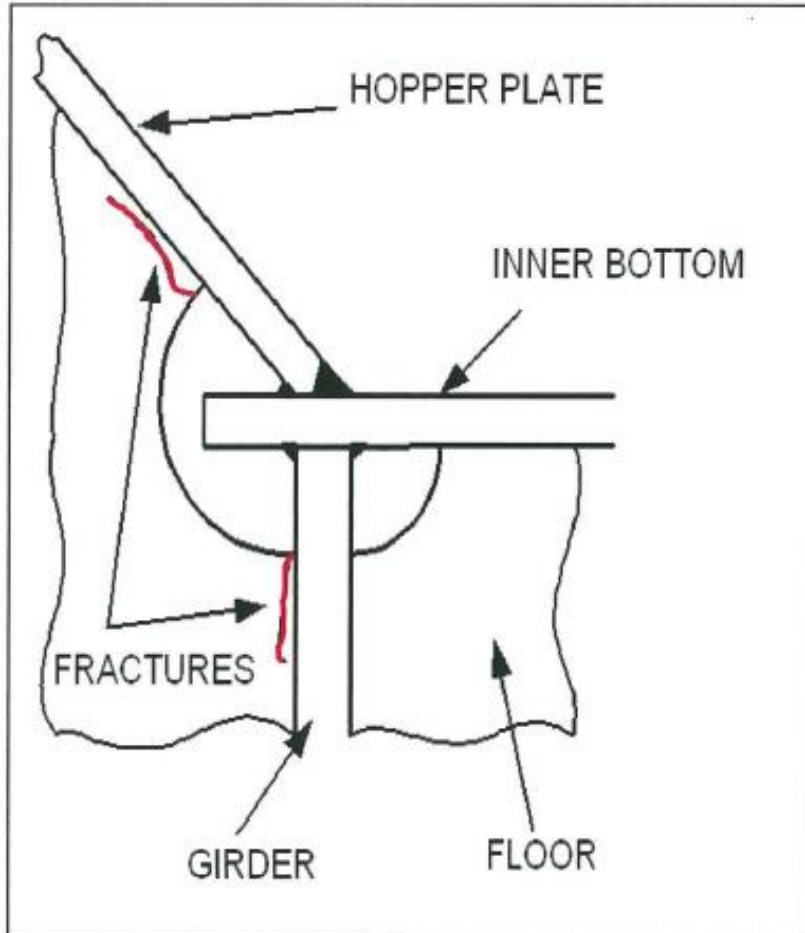
Sketch of damage

Hopper and Double Bottom Ballast Tank

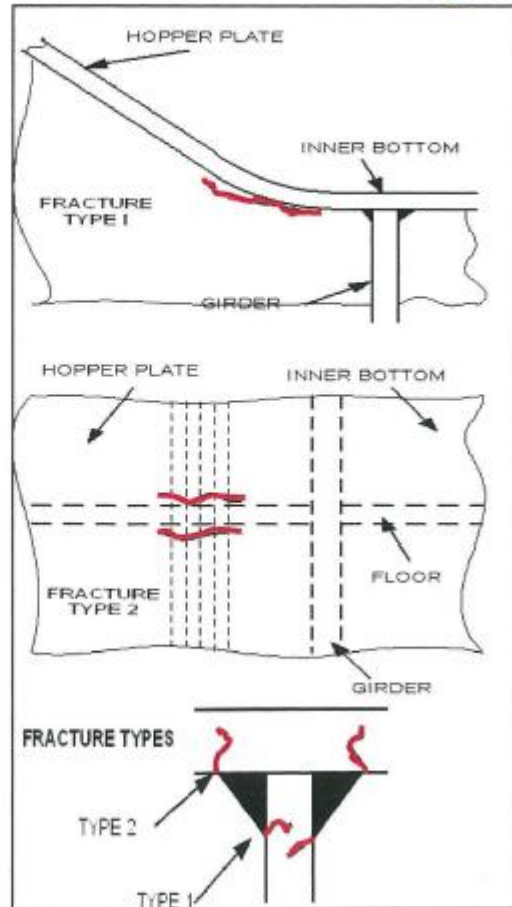
Sketch of damages

Example of Hopper and Double Bottom Ballast Tank

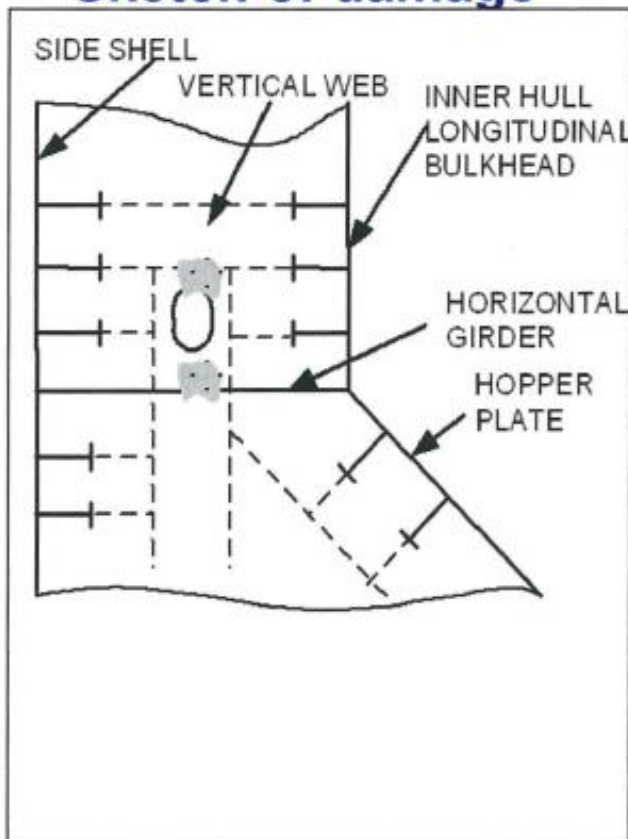
Sketch of damage

Wing Ballast Tank

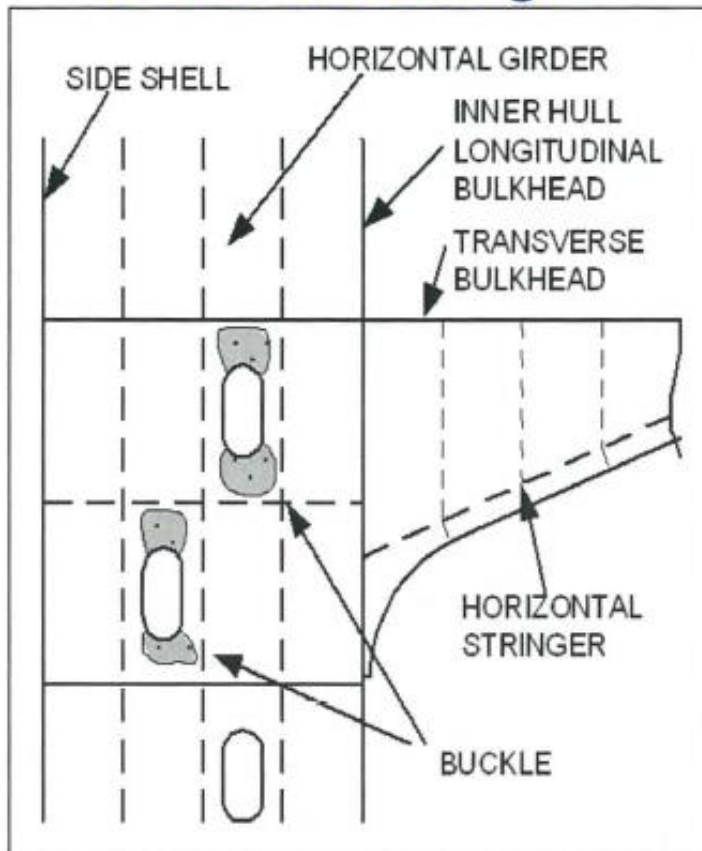
Sketch of damage

Wing Ballast Tank

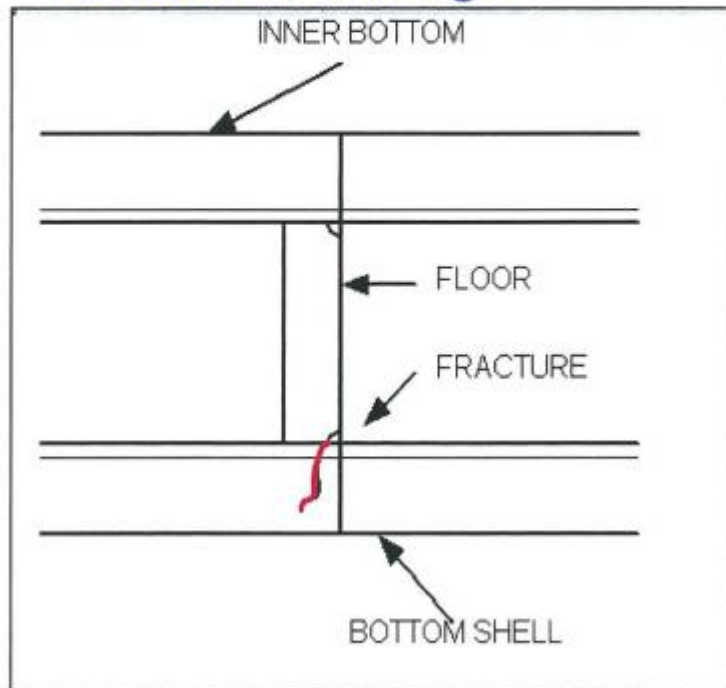
Sketch of damage

Bottom Ballast Tank

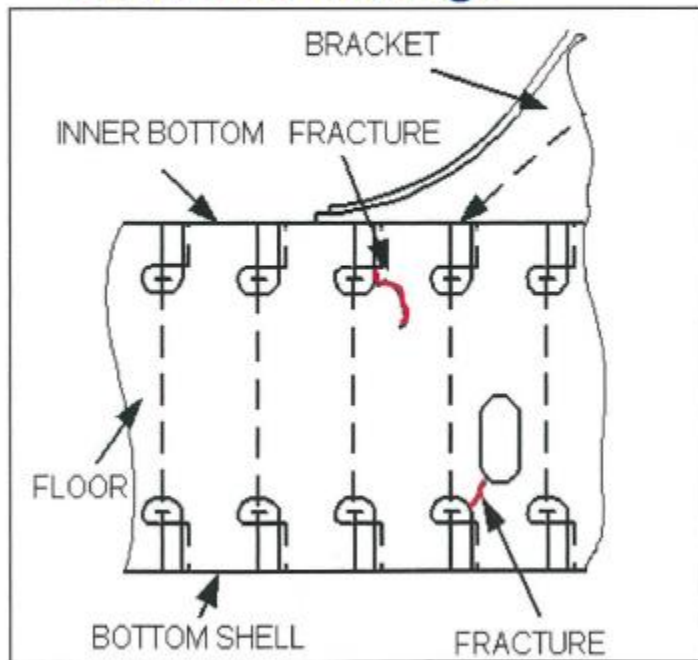
Sketch of damage

Bottom Ballast Tank

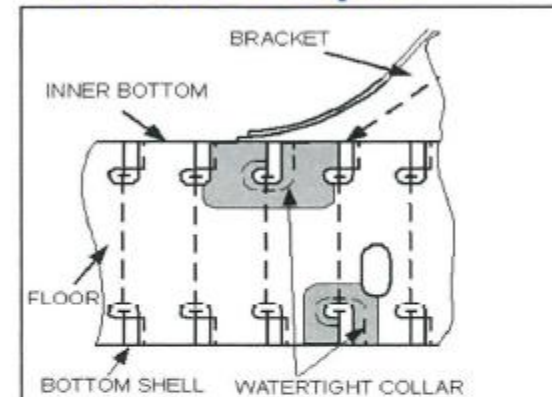
Sketch of repair

Above for relatively small fractures.

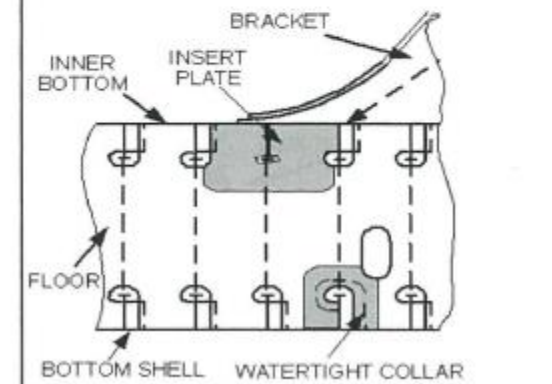
Above method for larger fractures.

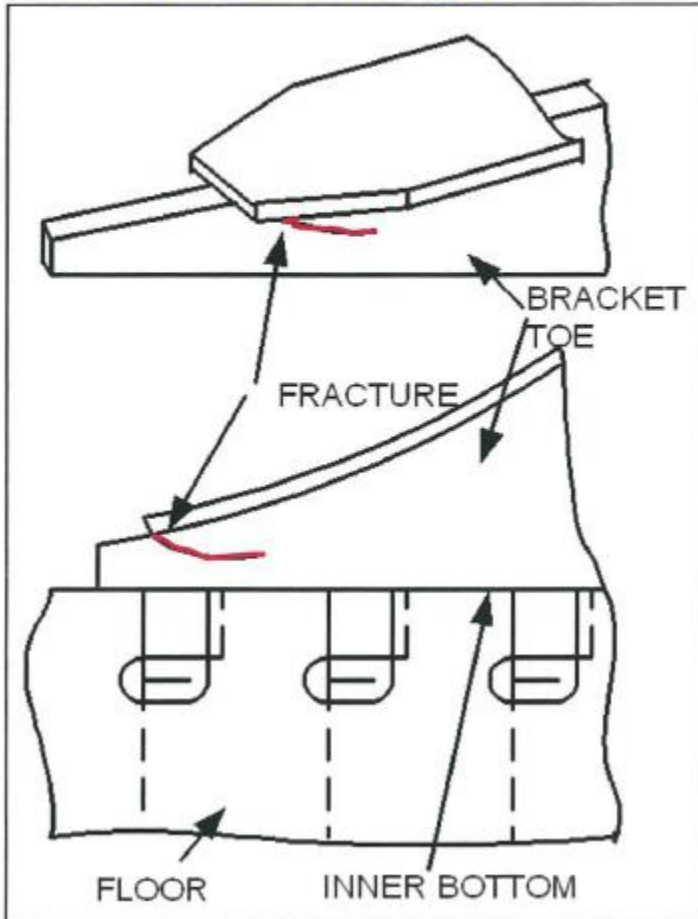
Sketch of damages

Web Frames in Cargo Tank

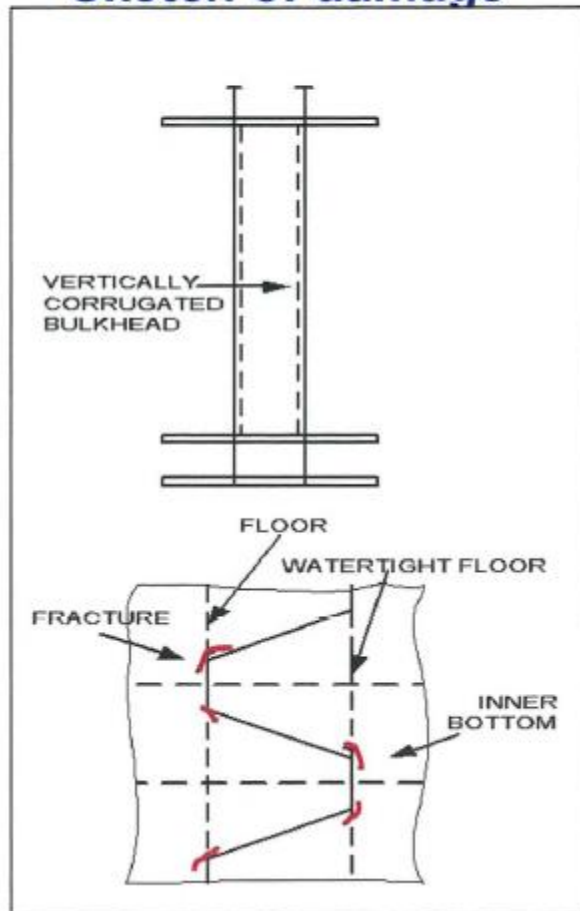
Sketch of damage

Transverse Bulkhead

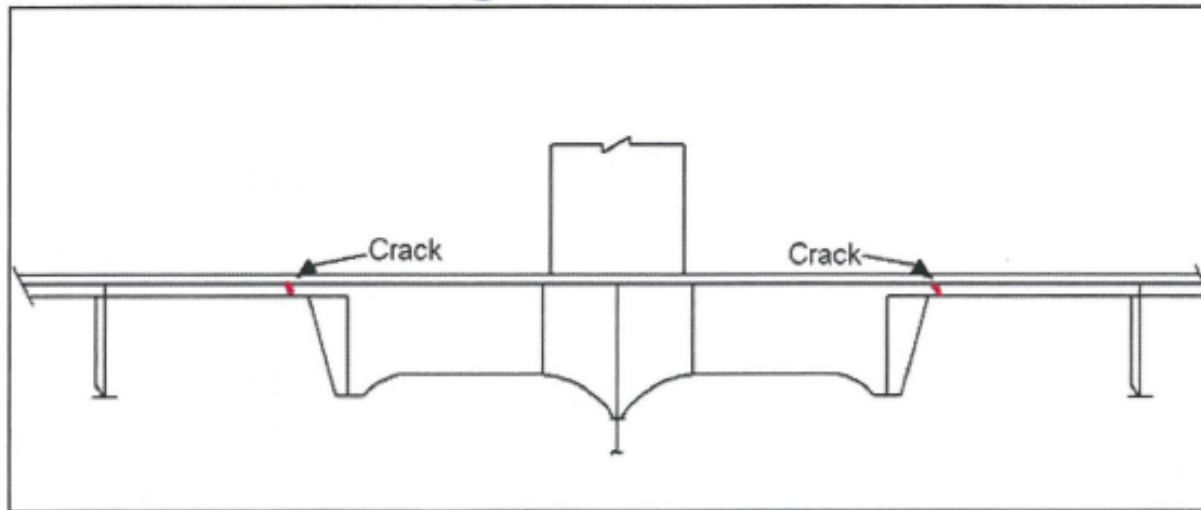
Sketch of damage

Deck Plating on the Crane Pedestal Support

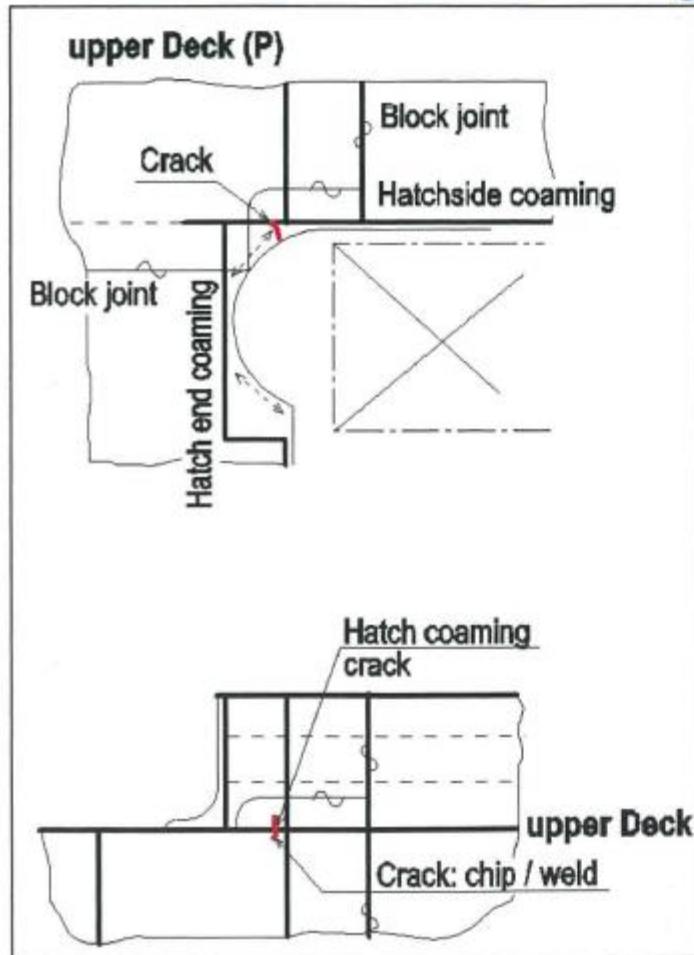
Sketch of damage

Upper Deck

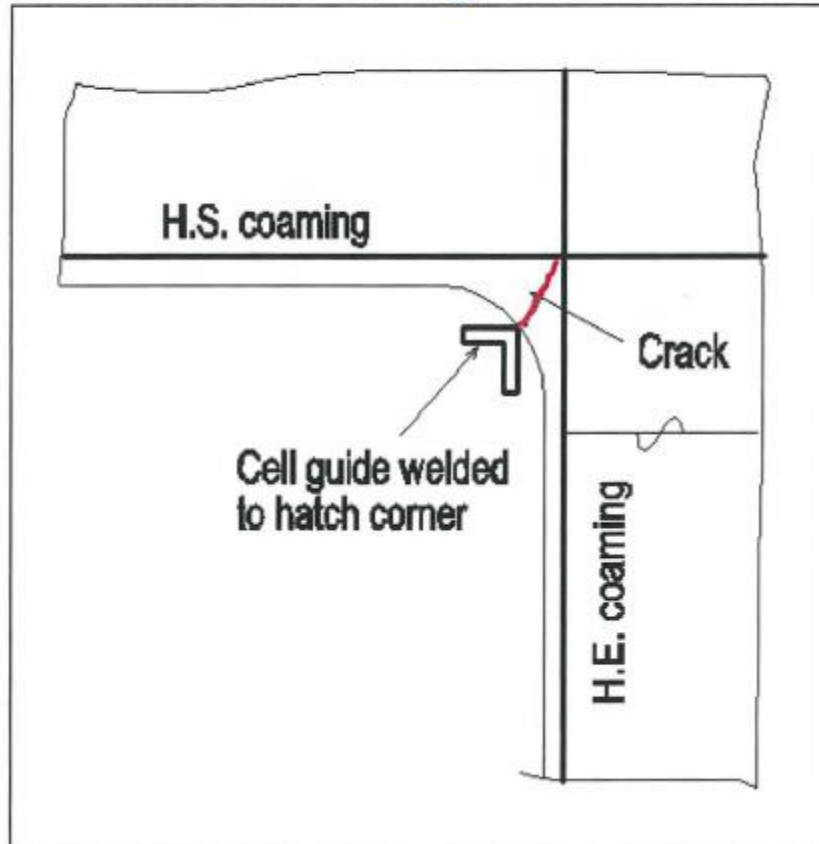
Sketch of damage

Upper Deck

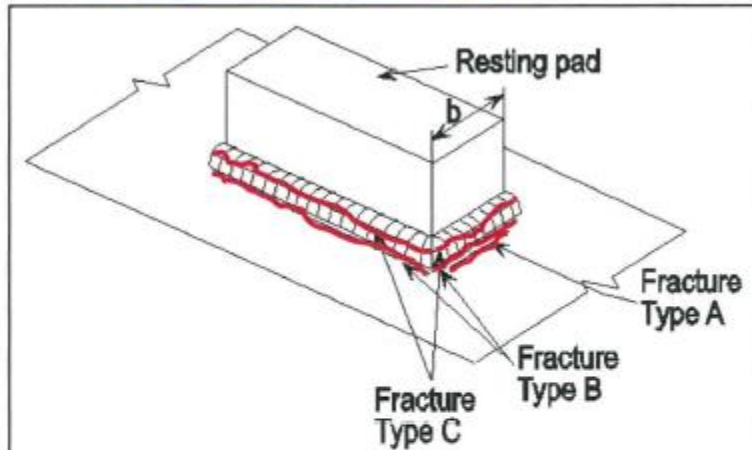
Sketch of damage

Upper Deck

Fracture Type A:

Starting in way of the undercut or HAZ of the transverse fillet weld and propagating in the top plating.

Fracture Type B:

Fracture Type C:

Starting and propagating in fillet weld

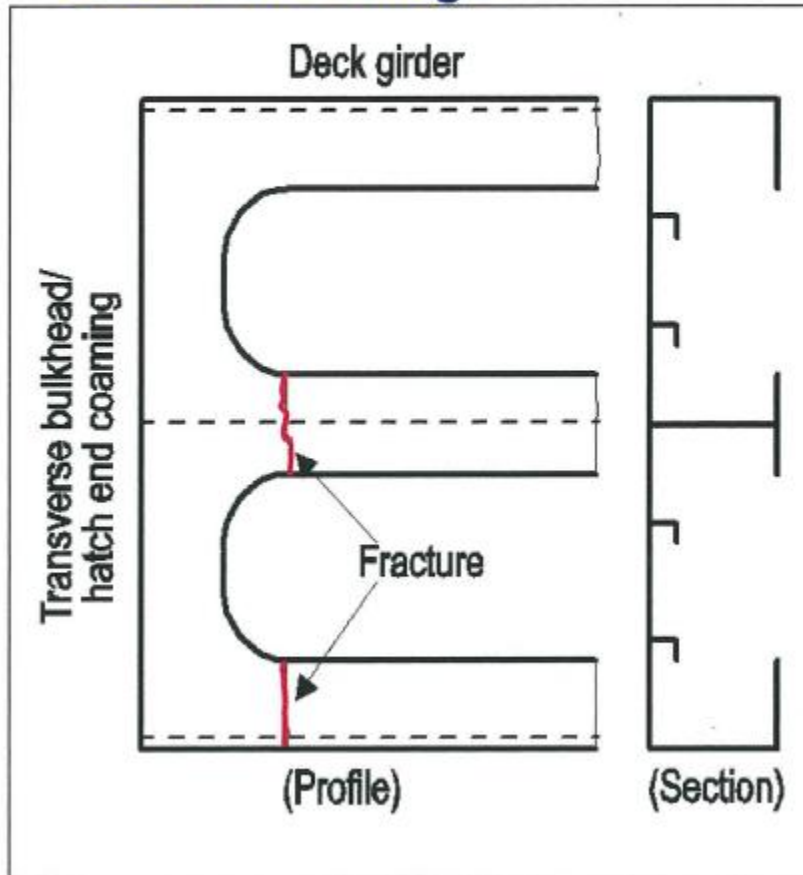
Sketch of damage

Upper Deck

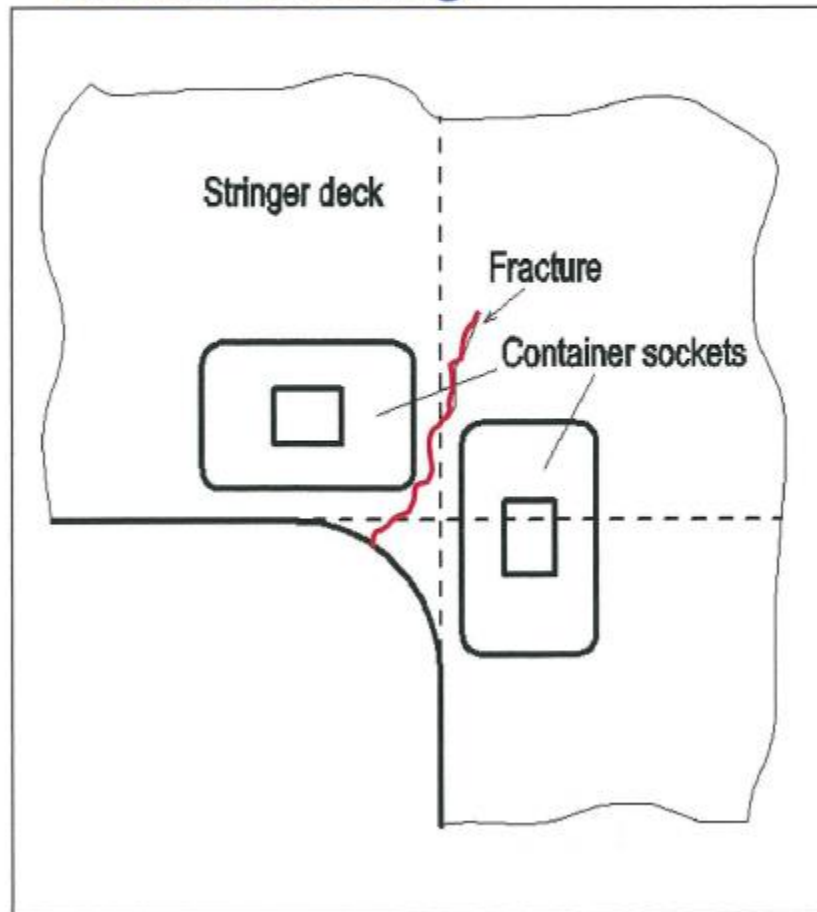
Sketch of damage

Upper Deck

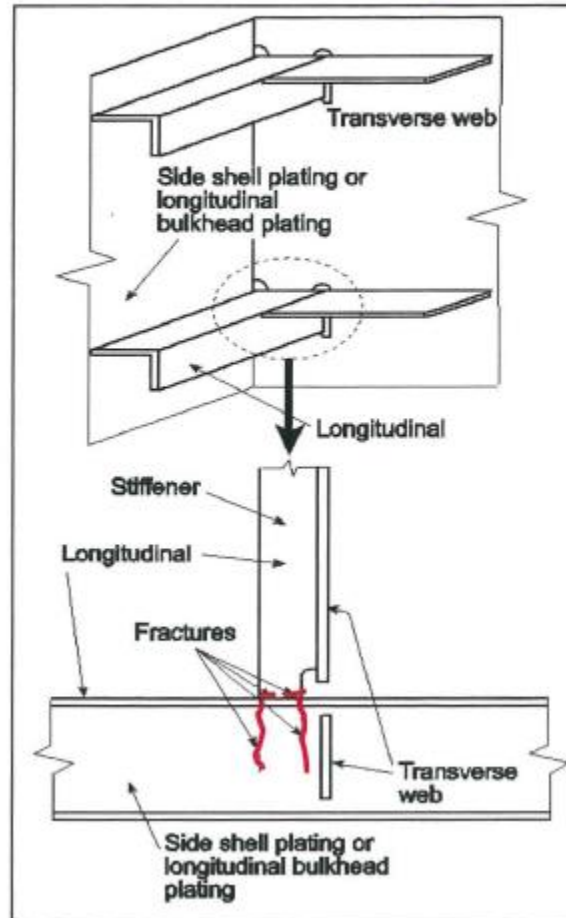
Sketch of damages

Example of Side Structure

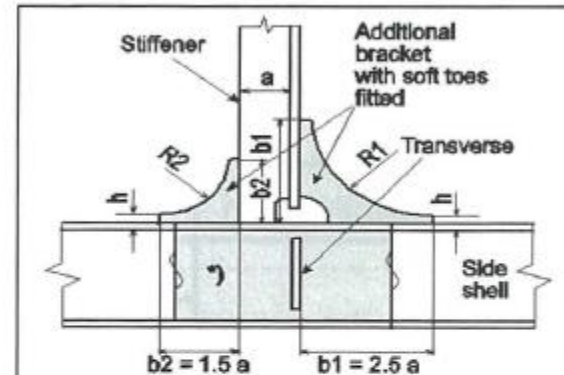
Sketch of repair

- *) Where required, the longitudinal to be cropped and part renewed
1. For a slope at toes max. 1:3, $R1 = (b1 - h) \times 1.6$ and $R2 = (b2 - h) \times 1.6$
 2. Soft toe bracket to be welded first to longitudinal
 3. Scallop in bracket to be as small as possible recommended max. 35 mm
 4. If toes of brackets are ground smooth, full penetration welds in way to be provided
 5. Maximum length to thickness ratio = 50:1 for unstiffened bracket edge
 6. Toe height, h, to be as small as possible (10-15 mm)

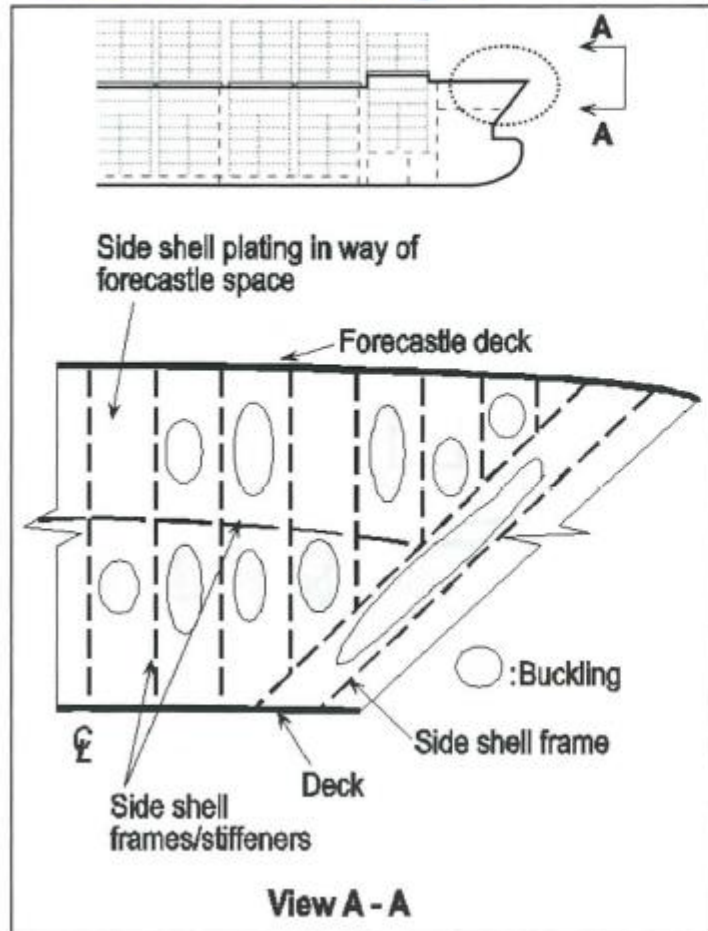
Sketch of damages

Example of Fore End Structure

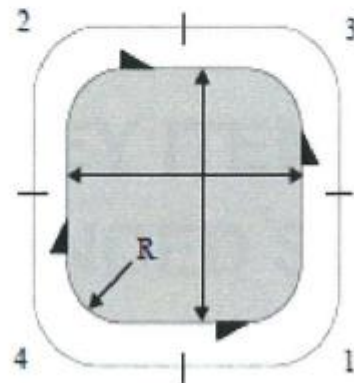
Renewal of Plates

- Size insert: Min. 300 x 300 mm
- Welding sequence:

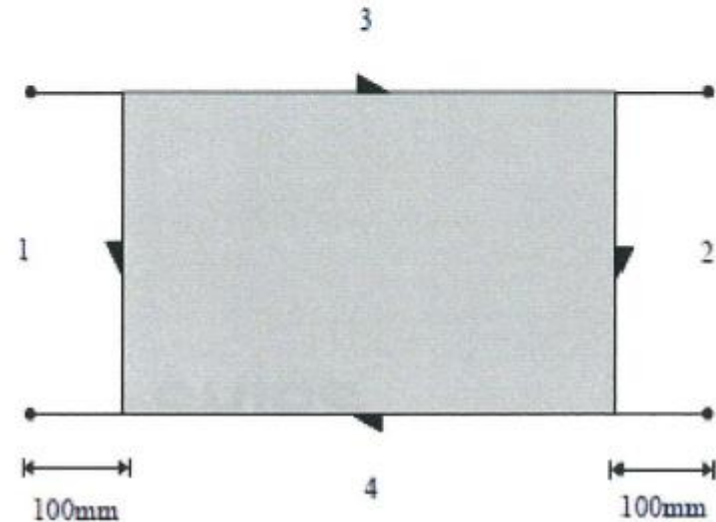
$R = 5 \times \text{plate thickness}$
min. 100mm
