ICS Class

2B: Machinery Systems In compliance with the IMO resolution MSC.349(92) and MEPC.237(65), RO Code, Appendix 2.

The following Module 2B: Machinery Systems is based on several Example Cases of Machinery Damages. This has the purpose and objective to give a clear example on the survey check points.

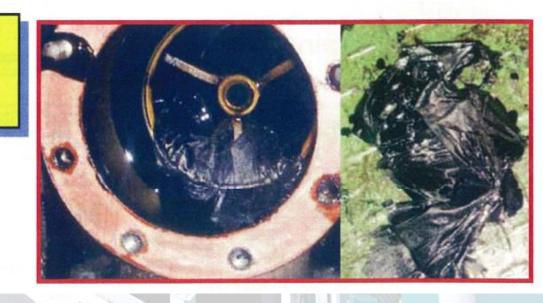
A waste cloth was stuck in the check valve on the suction of No.2 L.O. Pump.

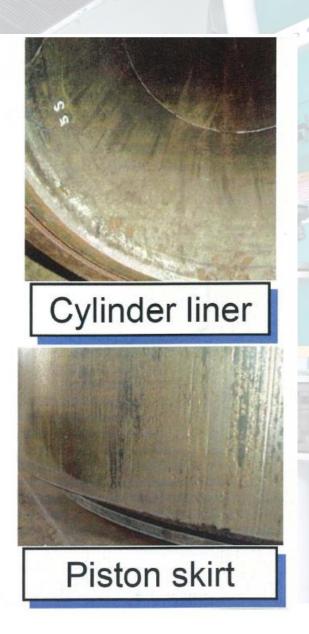
Piston Ring

- 1. Abnormal wear (vertical scratching) on sliding surface
- 2. Uneven wear at each rings
- 3. Spherical particles (alumina and silica) in scratches on sliding surface
- 4. No Abnormalities in material composition and hardness

Scores occur to cylinder liner inside wall(Aggressive wear)

Abnormal wear and brakeage of piston ring

Engine damage occurred due to insufficient elimination of alumina and silica at F.O. purifiers.

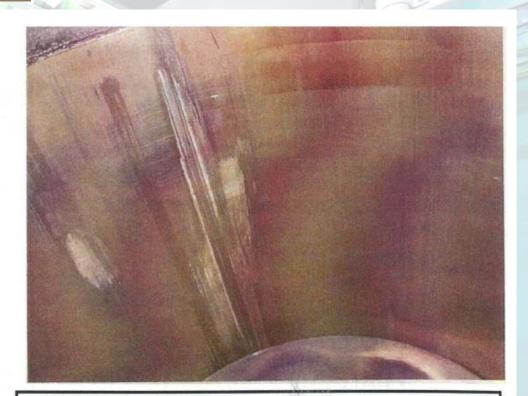
Deep cut of No.B-5 Cylinder Liner

Fitting bolts on upper holding plate were loosened

Insufficient tightening of the fitting bolts on the upper holding plate was suspected after the overhauls

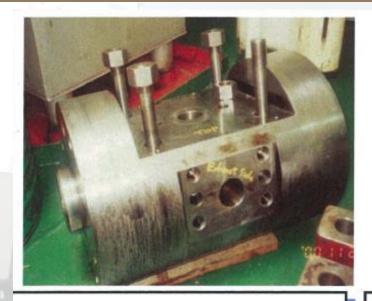
No.4 Crosshead Pin & Bearing: Burn out

The fretting was occurred after loosening the tightening bolts for the bearing

- The contacting surface was worn out
- The clearance of the crosshead pin bearing exceeded the limit

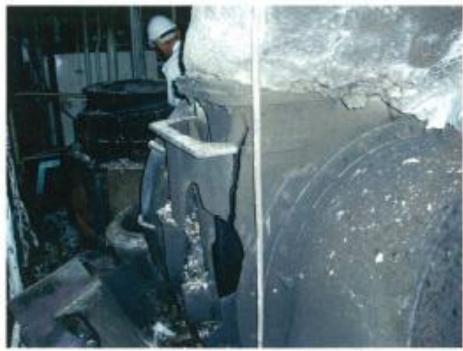
Turbocharger

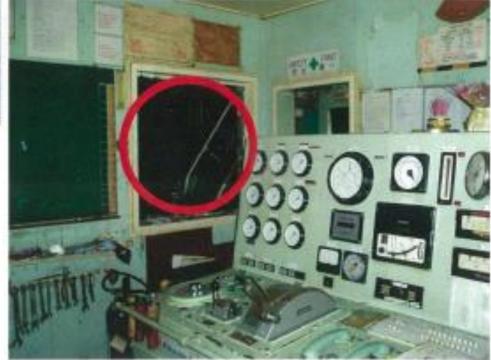
Broken Engine Control Room Window

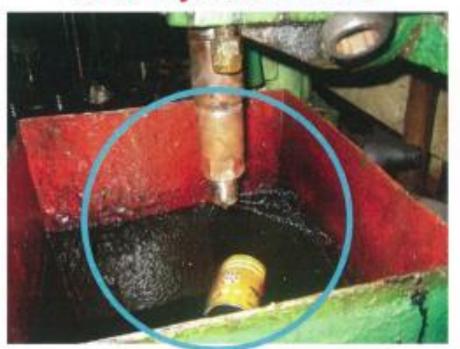
No.5 Injection Valve

Unbalanced atomizing of No.2, 5 and 6 FO injection valve

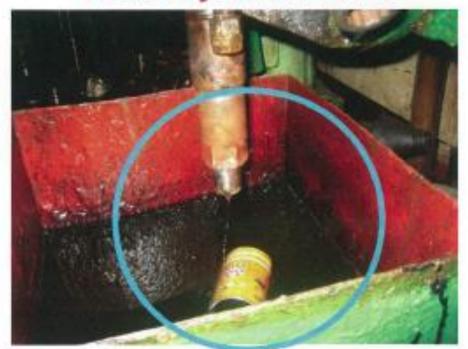
No.6 Injection Valve

Poor maintenance of M/E and failure to comply with manufacturer's instructions

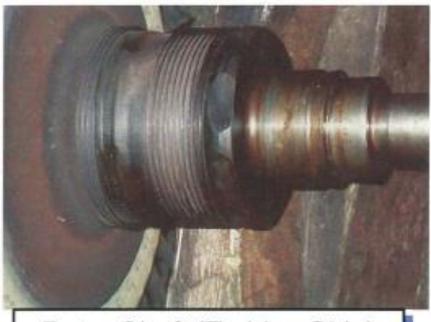
Rotor Shaft (Turbine Side)

Breakage of drive shaft due to drive gear wear

Rotor shaft bearing burn out

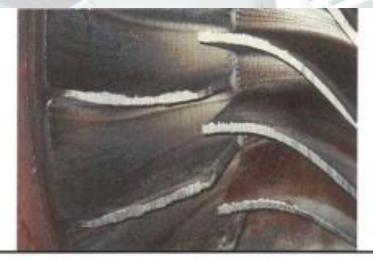
Blower Impeller (Reduction of 5 mm in thickness)

The damage occurred due to contact of blower impeller to casing.

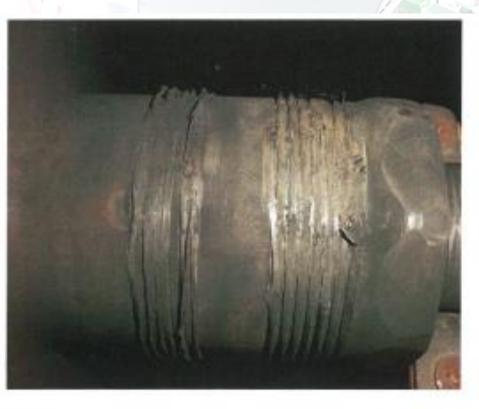
Rotor Shaft

Insufficient cooling due to poor maintenance

- → Harmful effect for L.O.
- → Burn out of bearing

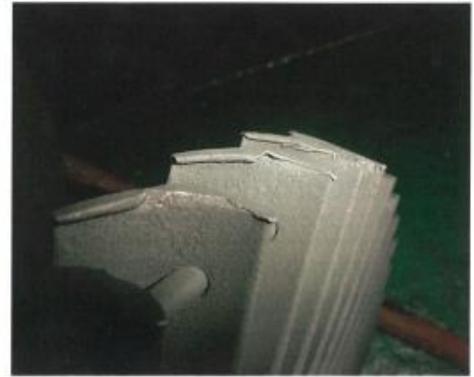
Turbine Blades

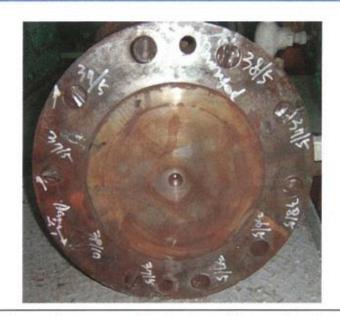
All coupling bolts between the crank and intermediate shafts were broken.

Fore flange of intermediate shaft

Torque fluctuation of torsional vibration would be principal reason of this damage

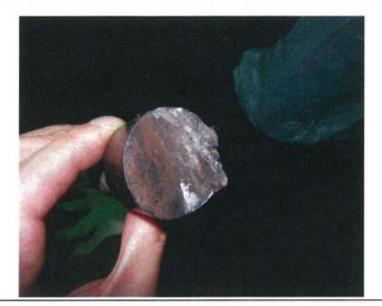
Section of bolt breakage (Crack is occurred at circumferential direction)

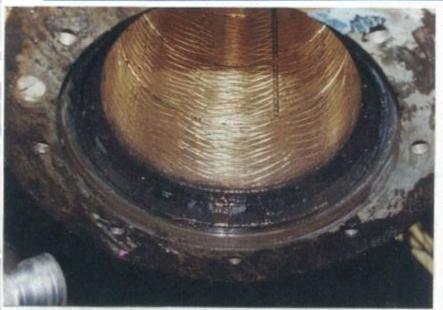
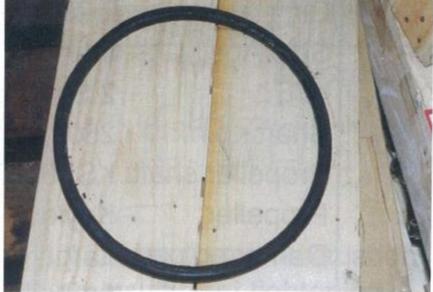
Condition of damage

Boss of propeller: Black on contact surface of O ring due to entering of sea water

O ring: Wholly weak contact and unequal contact (especially inside)

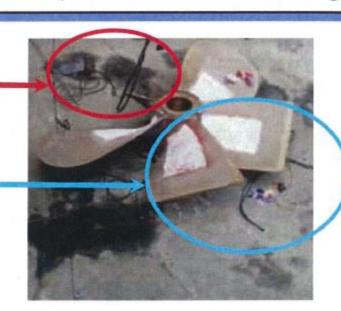
Damaged Condition

Horizontal vibration occurred during full speed ahead running

Cut blade "C" and "D" to prevent vibration

Reduced speed operation

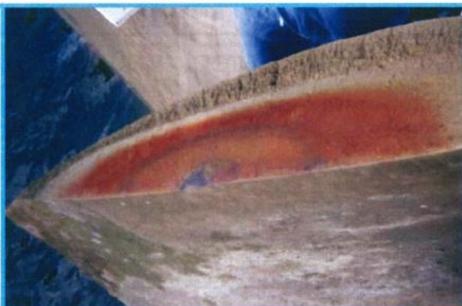
Fracture Surface of Blade "A"

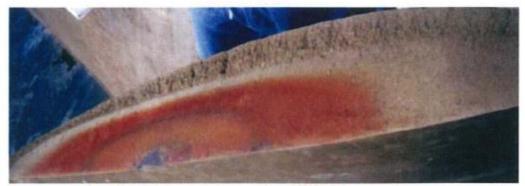
Condition of Blade "A"

Crack Starting Point = 0.35R

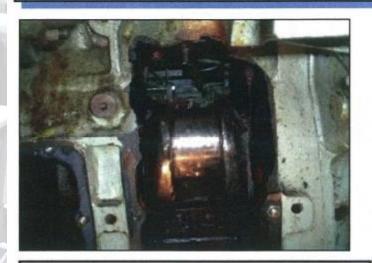
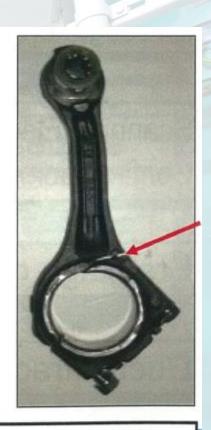
Breakage of No.6 Piston Rod of No.2 G/E Occurred

Breakage of Piston Rod

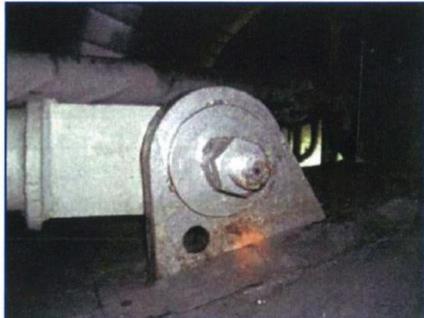
Boiler Side

Welding of the bolts for prevention of loosening by the ship's crew

Welded Stay

- Damaged part, where the tube plate is welded with the shell plate at inside of water drum, is highly stressed area.
- It is possible that cracks are initiated due to welding defects.

Thermal expansion is not absorbed efficiently by the boiler stays due to the welding of the bolts to prevent loosening.

- 1. PT or MT to be carried out for surface crack detection.
- 2. Stop holes to be drilled at the both ends of crack.
- 3. Edge preparation
- 4. Welding by qualified welder
- PWHT(Post Weld Heat Treatment) to be carried out, if necessary.
- PT or MT to be carried out for surface crack detection.
- 7. RT or UT to be carried out for detection of inner defects.
- 8. Hydrostatic test to be carried out.
- *1 PT: Penetration Testing
- *2 MT: Magnetic Particle Testing
- *3 RT: Radiography Testing
- *4 UT: Ultrasonic Testing

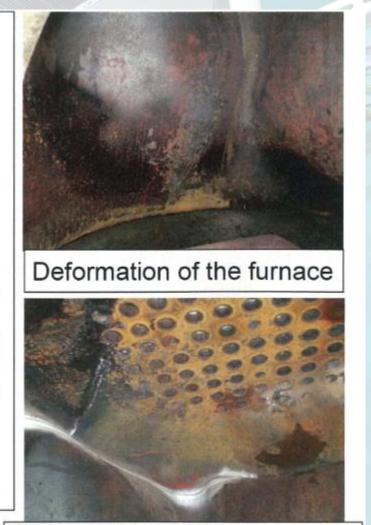
Deformation of the tube plates

After departure, crew found water leakage in furnace of boiler.

- (1)Leakage of water from smoke tube lower part
- (2)Deformation of lower tube plate
- (3)Deformation of furnace
- (4)Accumulation of scale in water side
- (5)Malfunction of feed water control system
- (6)Malfunction of low low water level burner cut system
- (7)Blockage of feed water nozzle

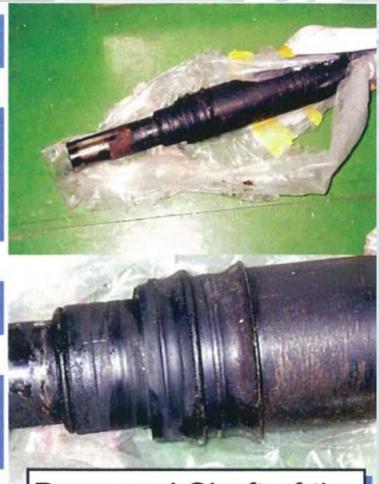
Driving shaft ball bearings were damaged due to L.O. shortage and shaft vibration occurred

Damaged Shaft of the Homogenizer

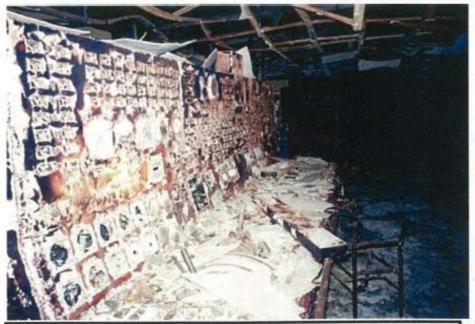
E/R burnt down and fire was extinguished 10 hours later. Three crew members died.

Inside of Engine Control Room

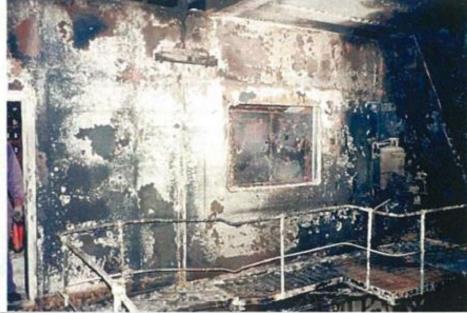
Outside of Engine Control Room

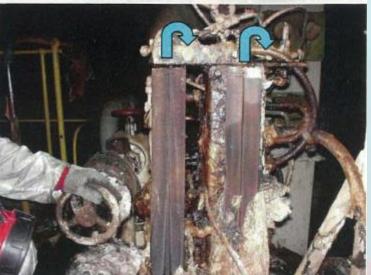
Condition of the 2nd FO Filter

Most severely burnt and its cover was completely burnt down

Replaced with the automatic back flushing filter with aluminum cast cover after the ship was built

The Classification Society did not mention the use of aluminum cast in E/R when the ship was built

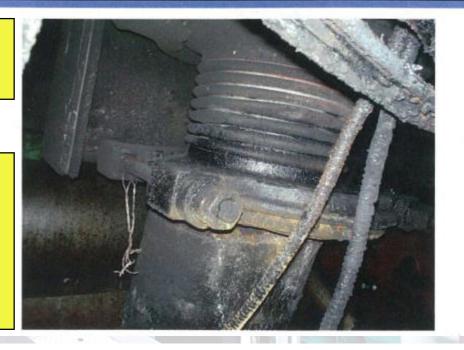
Condition of Exhaust Gas Expansion Joints of the M/E

Lagging may have been removed after the compliance survey

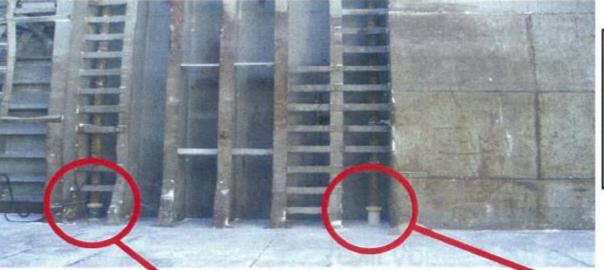
Condition of No.2 C/H (at Annual survey before the M/E damage)

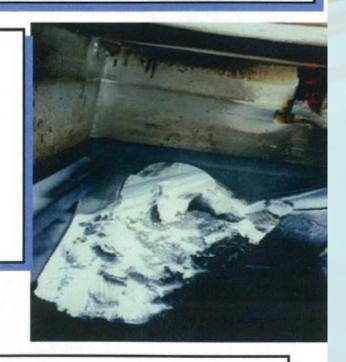
The remaining alumina was sandy like sands in an hourglass.

Left: Remaining alumina Above: FO tank with alumina (photograph of another ship)

Harmful alumina particles passed through and M/E was damaged.

- 4) When risk of contamination of FOT by alumina etc. exists
 - FO analysis
 - Use FO from other tanks
 - Parallel use of FO purifiers
- 5) Examples of countermeasures by shipping companies
- Modification of Air Vent Pipes from SGP to STPG(Sch-80) (new ship)
- Addition of flanges to Air Vent Pipes directly above FOT (existing ship)
 - → filling Air Vent pipes with water is effective to find if a hole exists

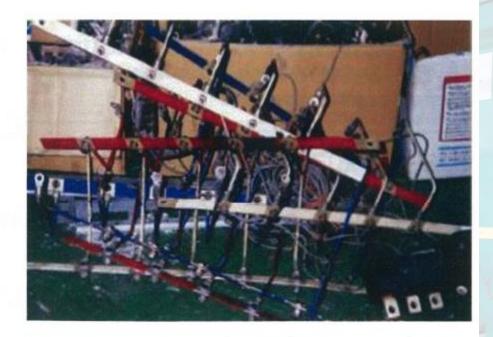
Most of electrical parts in 440V feeder panel became nonusable
